# **Environmental Assessment & Earth Change Plan/Environmental Assessment Report**

## **Improvements to Tranberg Road and Parking Areas Sandy Point National Wildlife Refuge St. Croix United States Virgin Islands**

*Prepared by the*  
U.S. Department of Transportation  
Federal Highway Administration  
Eastern Federal Lands Highway Division

**June 2009**

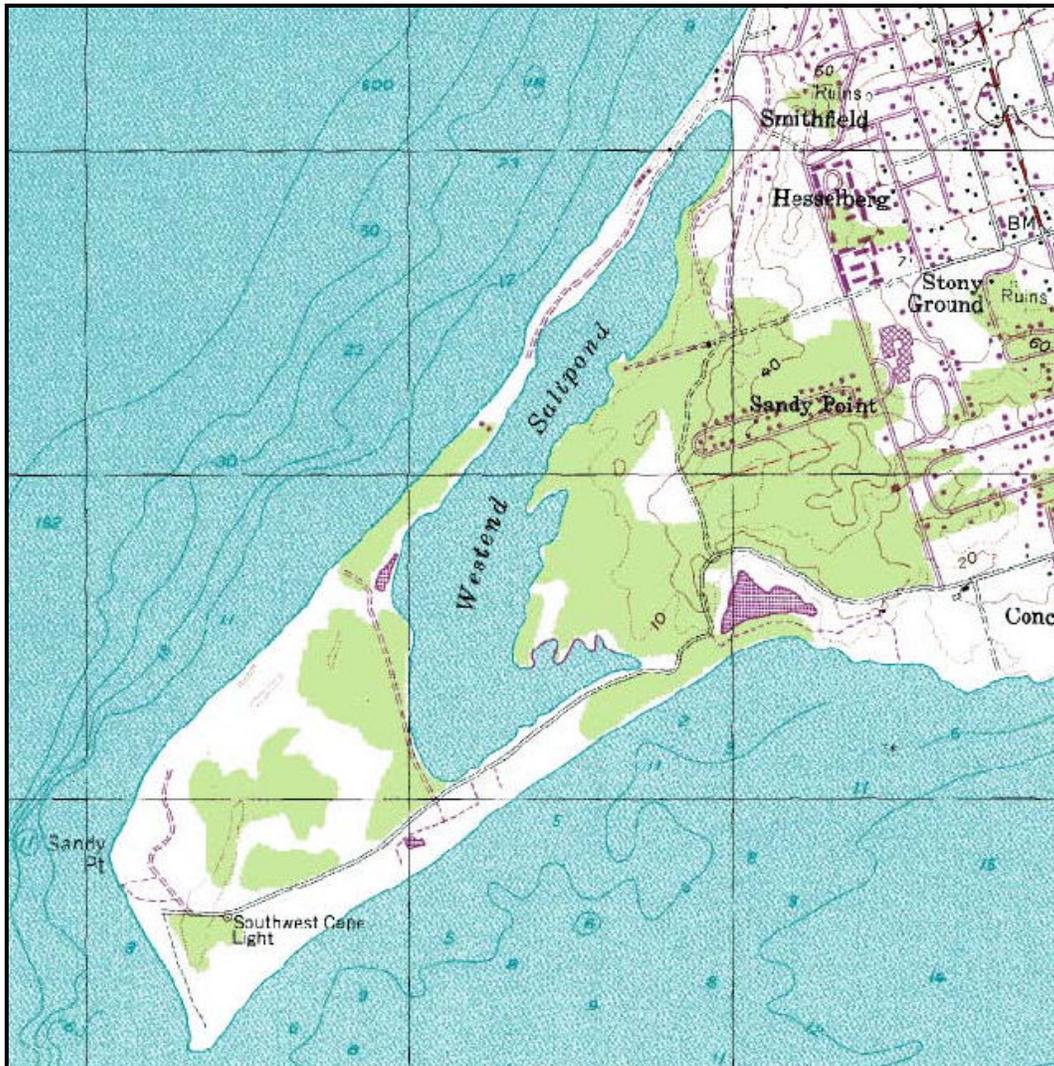
*Figure 1. The Refuge contains little topographic relief. Tranberg Road runs from the entrance of the Refuge to the very western most edge.*

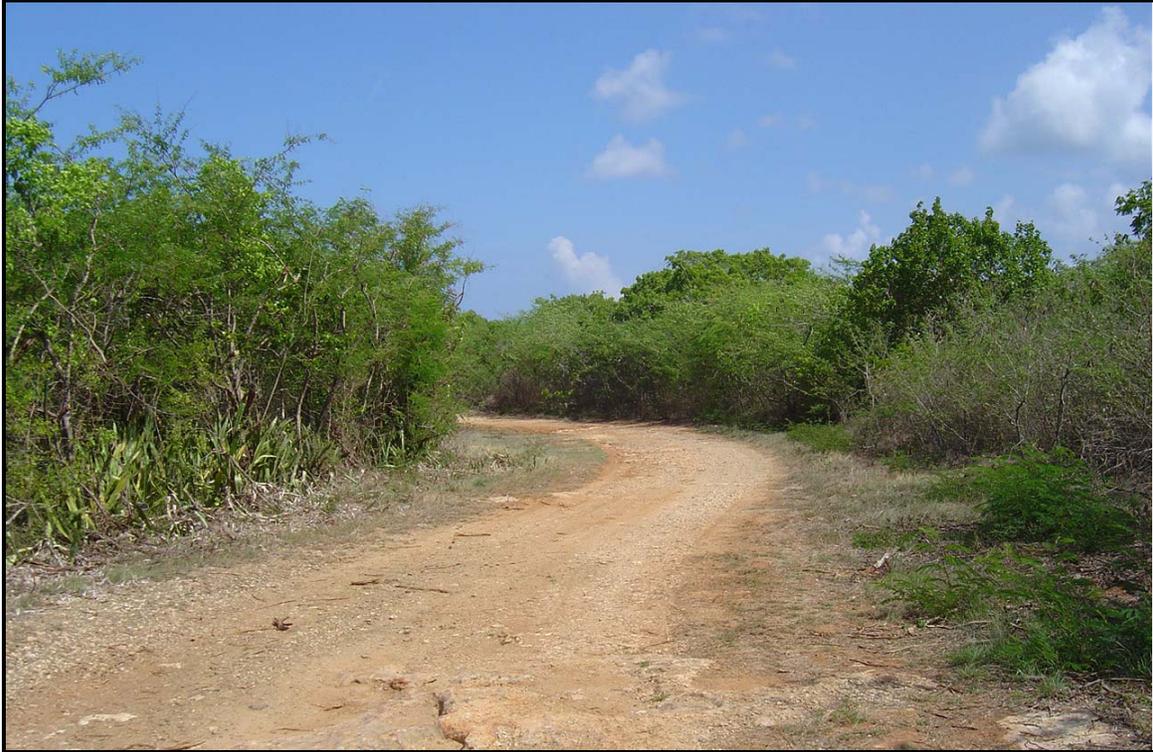
*Figure 2. View of varying width road with exposed bedrock and variable surface.*

Tranberg Road, the primary road through Sandy Point NWR, has a varying width which poses a potential hazard to motorists in multiple locations within the Refuge. Poor drainage along the roadway has resulted in multiple ruts and potholes.

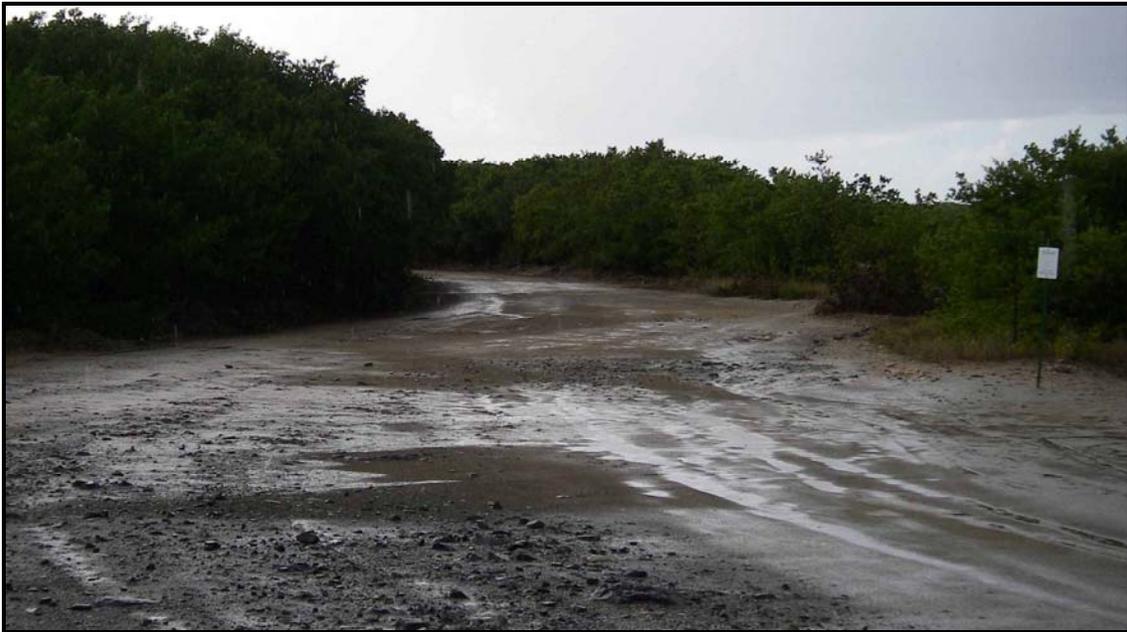
*Figure 3. Water from the West End Salt Pond flows across Tranberg Road creating difficult driving conditions.*

Localized flooding occurs on Tranberg Road in the vicinity of the West End Salt Pond. The roadway floods seasonally after heavy rain events. When the hypersaline mud on the road surface comes into contact with vehicles, it causes the vehicles to rust. Premature replacement of Refuge vehicles occurs due to accelerated rust conditions, resulting in elevated operational costs to the refuge and potential vehicle safety hazards for other motorists.

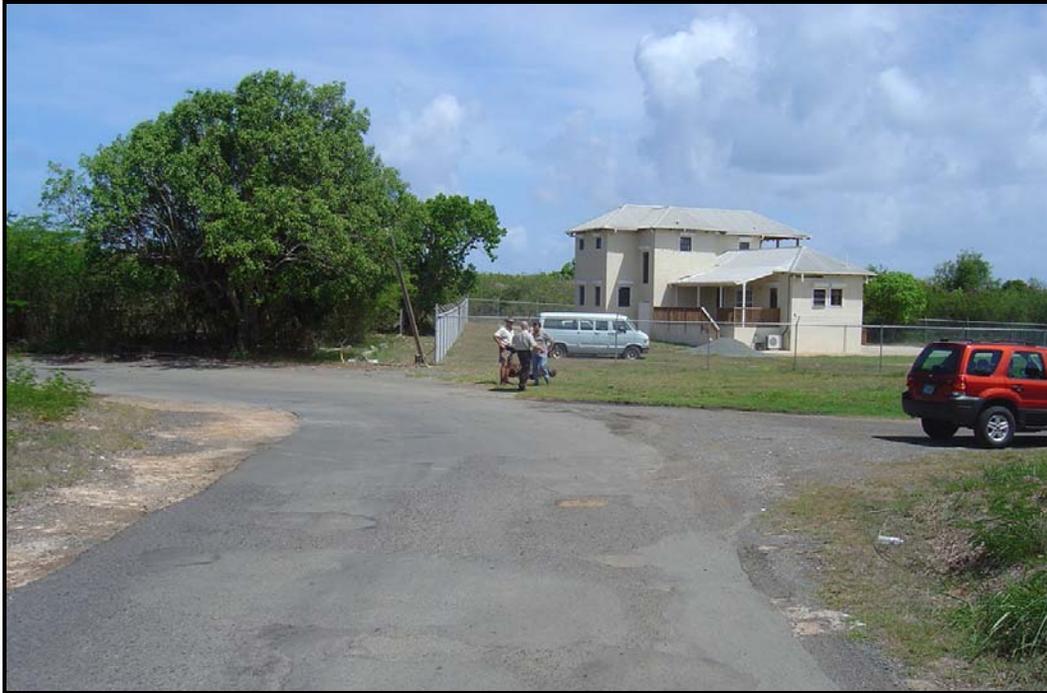
*Figure 4. View looking south along the paved two-lane road that extends westward from Melvin Evans Highway at a dangerous curve near Refuge Headquarters.*

The entrance to the Refuge lies on a dangerous curve of a two-lane paved road that extends directly west from the western terminus of Melvin Evans Highway. Refuge staff have reported numerous vehicle incidents where cars have not made the curve and crashed onto Refuge property, occasionally damaging Refuge facilities. The hazards from this current configuration would be amplified with any proposed parking area that lies adjacent to the outside radius of this curve, which is the only site available for visitor parking at the Refuge Headquarters building.

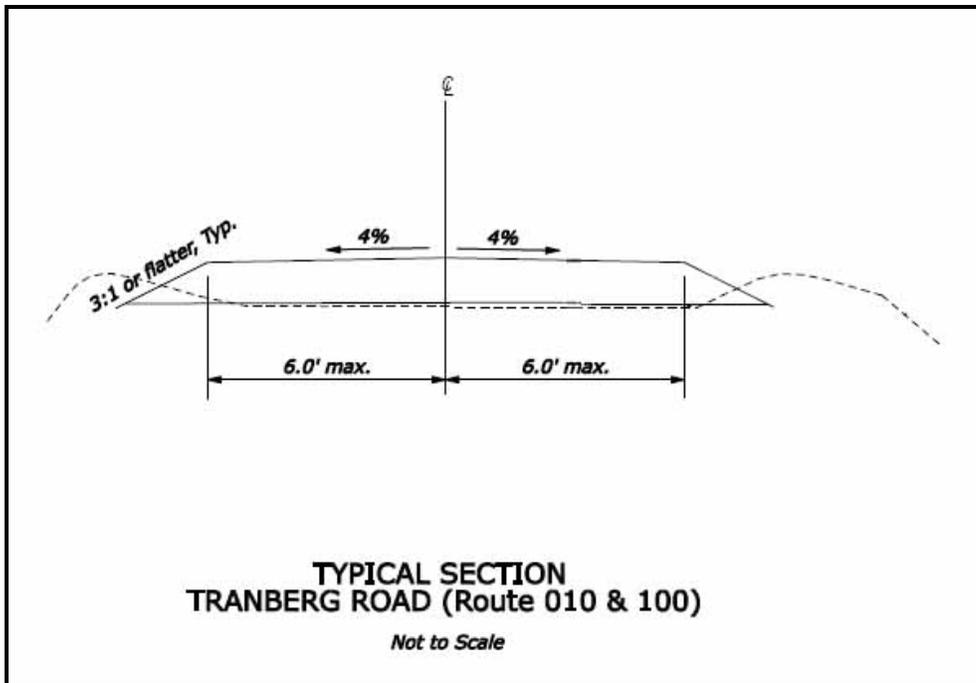
Figure 5. The typical pavement section would be used for the placement of aggregate material along Tranberg Road. The material would be placed within the previously disturbed area of the existing roadway.

The Action Alternative would improve the existing Tranberg Road, construct two new roadway segments, create new parking, and enhance existing parking at the Refuge. The two new roadway segments would be the construction of a loop at the end of Tranberg Road, and the realignment of a portion of the road that is currently located off of Refuge property. The roadway repair would occur within the existing roadway prism that was previously disturbed during the original construction of the existing Tranberg Road, with the exception of the realignment portion. The existing road would be scarified to create an even surface to serve as the roadbed. Approximately 8 inches of aggregate would be placed on the roadbed to achieve a specified roadway elevation. Creating the roadway elevation would improve drainage of water from the roadway surface, and would provide a uniform driving surface.

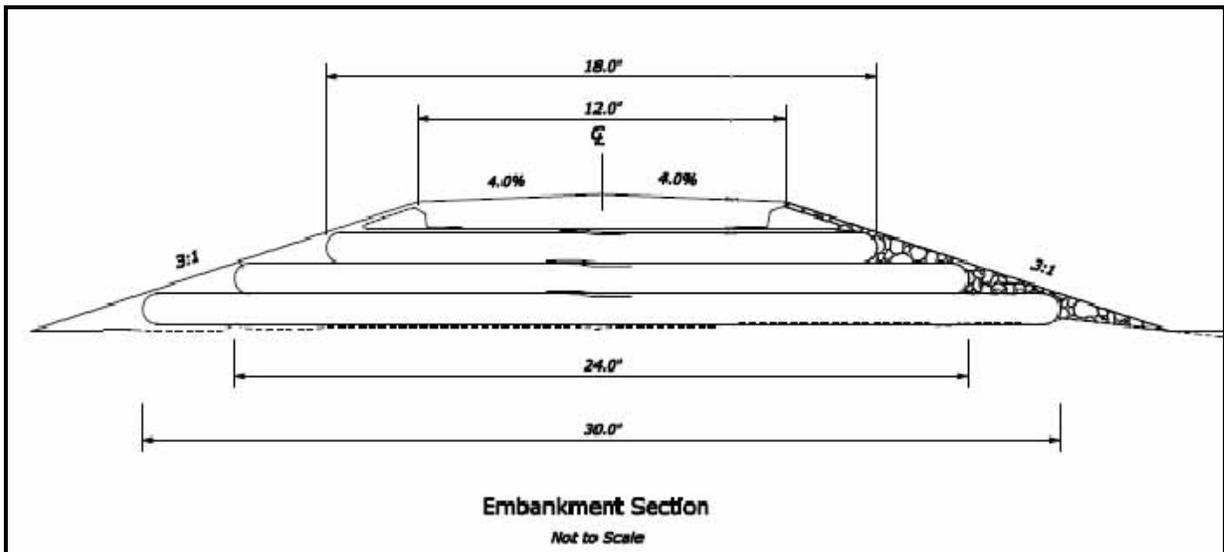
Figure 6. The embankment section would be used in the portion of the roadway along the West End Salt Pond that is currently experiencing flooding.

Approximately 0.4 of a mile of Tranberg Road near the southeastern corner of the West End Salt Pond would be raised approximately 3 feet to prevent seasonal flooding of the roadway.

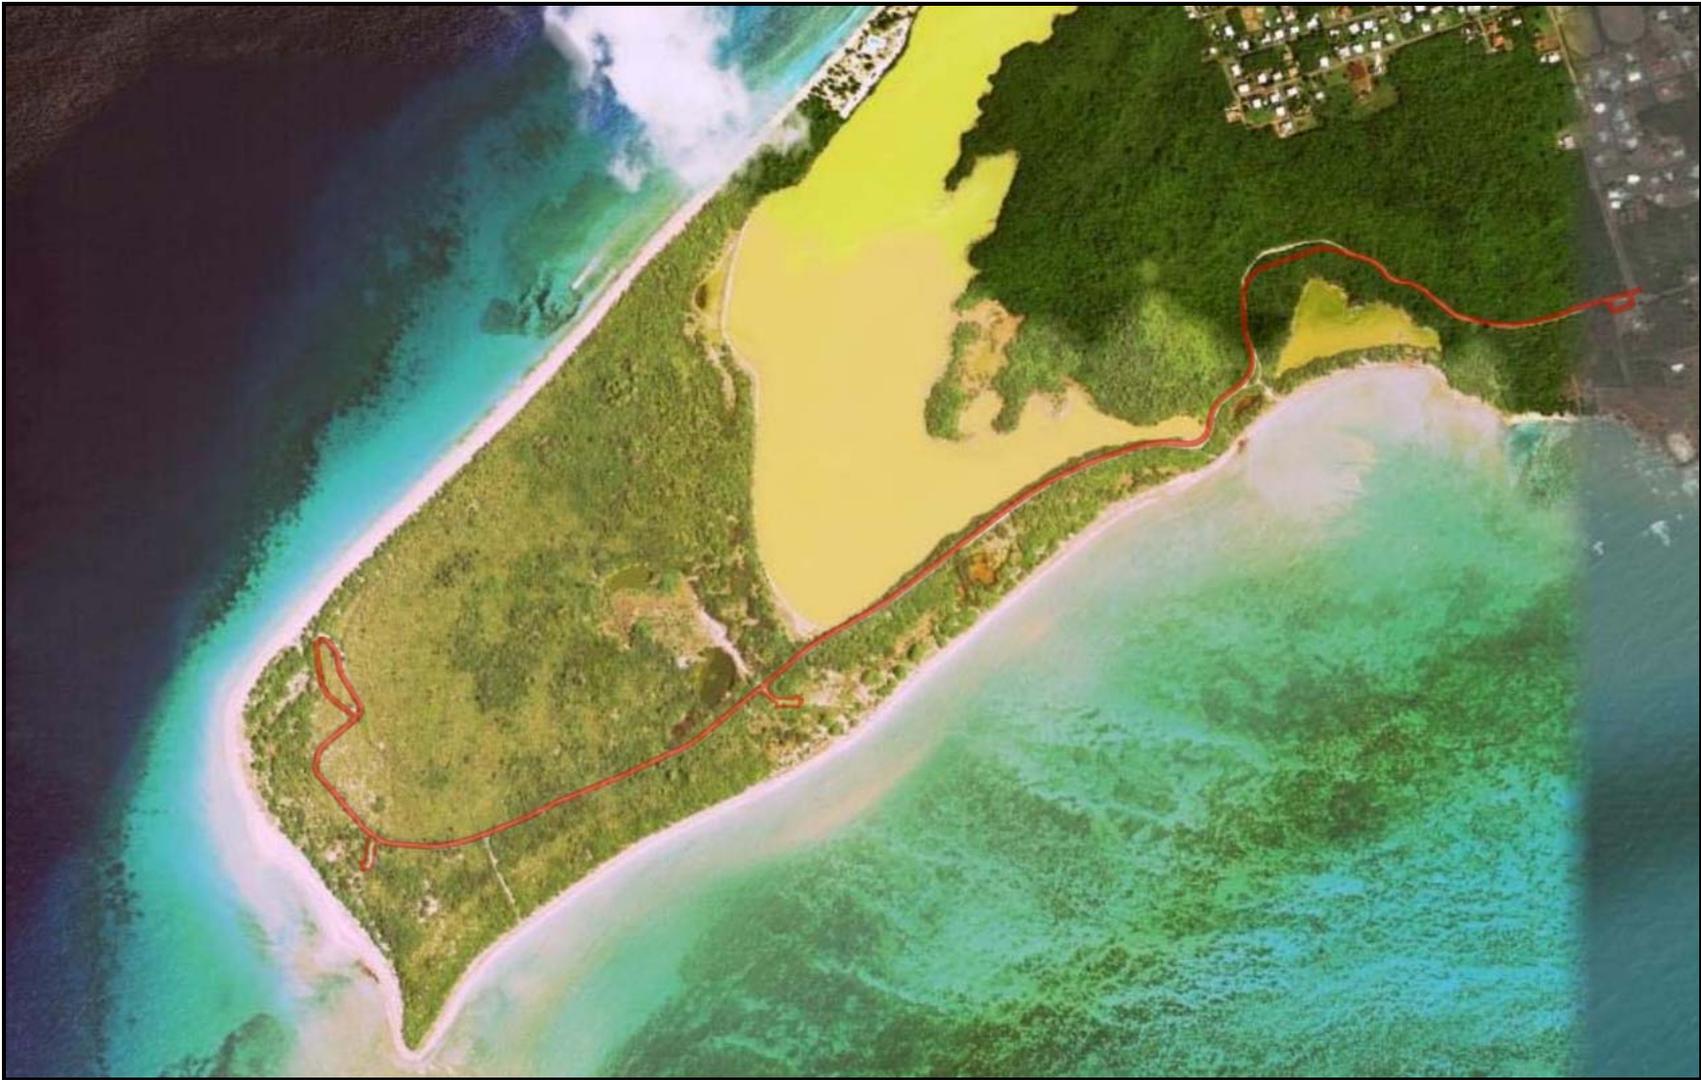
*Figure 7. Location Map showing the parking areas proposed for improvement and new alignment*

Additional parking would be created at Parking Areas 900, 902, and 904. Parking is currently available at Parking Area 901, but vehicle capacity would be expanded by formalizing vehicle site layout. Vehicle parking is currently available at Parking Area 902 and capacity would be expanded. Limited parking is available in the vicinity of Parking Area 904. However, the area would be reconfigured to create a loop at the end of the roadway, which will expand available parking along the loop.

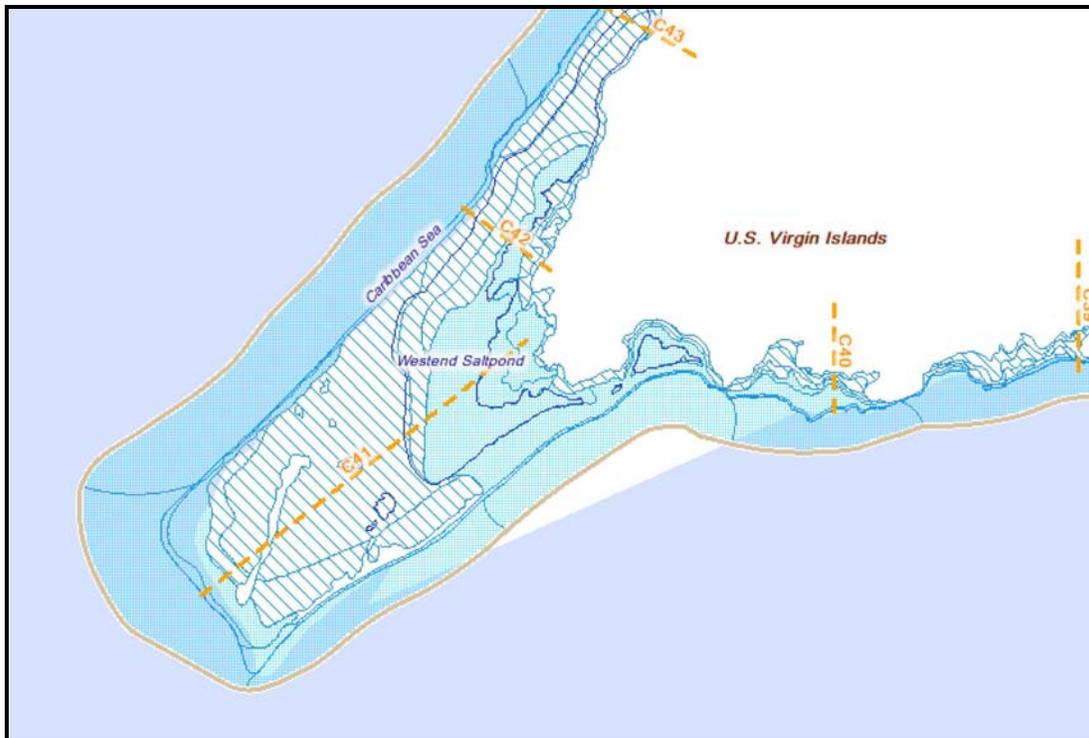
Figure 12. Floodplains are shown in relation to the study area.

The project is located in a Zone AE and VE floodplain. Zones AE and A1-A30 are the flood insurance rate zones that correspond to the 1-percent annual chance floodplains that are determined in the Flood Insurance Study by detailed methods of analysis. Zone VE is the flood insurance rate zone that corresponds to areas within the 1-percent annual chance coastal floodplain that have additional hazards associated with storm waves.

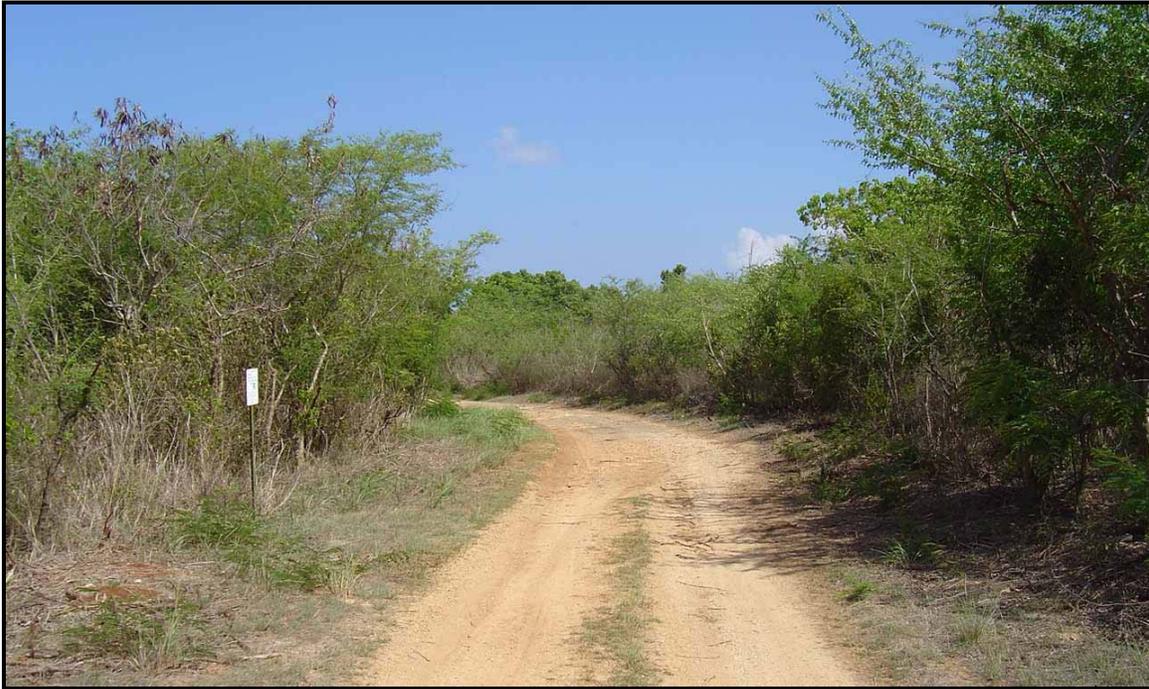
Figure 13. This view of Tranberg Road shows the typical roadside vegetation, dense shrubland.

Most of the Refuge, about two thirds, is covered with dense shrubland. Most of the dense shrubland is likely a sere (successional phase), and through natural succession would likely succeed eventually to dry forest. The shrubland consists of species such as: buttonwood, bay lavender, bay cedar, *Grnodea littoralis*, sea grape, and manchineel. Approximately one-quarter of the Refuge consists of the Westend Salt Pond. The remaining 10-15 percent of the Refuge is divided among the dry forest, herbaceous, sparse vegetation and woodland categories.
