*Heartland Corridor, Walton Virginia to  
Columbus Ohio*

# Preliminary Engineering Phase Report

ANTLER NO. 1  
TUNNEL –  
MP N403.71  
MOHEGAN, WV

October 14, 2005, Rev. 2

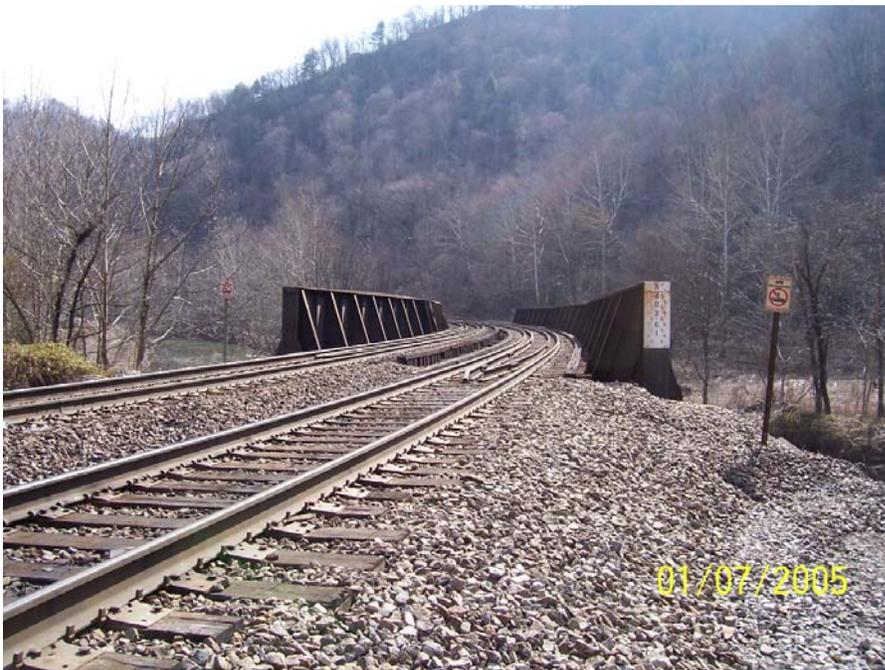
Photo No. 2 – Looking from East Portal

The tunnel is 613' long with a concrete lining and a width of approximately 30'. It is a double-width tunnel for two tracks. There are no signs of utilities inside of the tunnel, however track circuits could be buried in ballast. Most of the construction joints are generally open and leaking water. Spalling is common around the construction joints, typically 6" to 12" on each side of the joints.

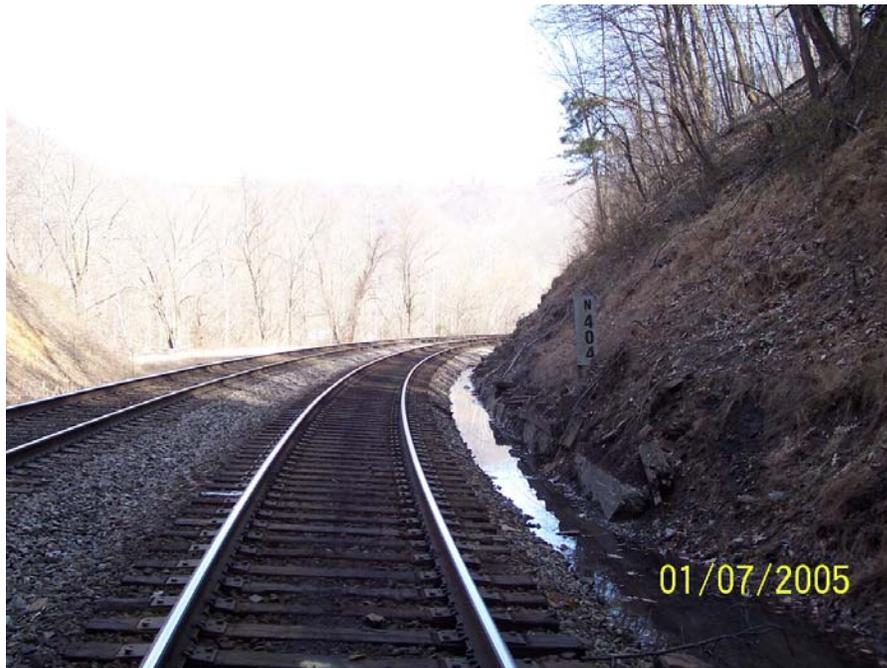
Photo No. 4. – Looking from West Portal

The track is continuous welded rail of conventional design with wooden crossties at approximately 19" on center and a stone ballast section. The rail is typically 141 AB or 132RE on 15" tie plates and fastened with rail spikes and anchors. The track curves right 5.9 degrees with a superelevation of 3.5" throughout the length of the tunnel. There are drainage ditches along each wall and in between the tracks. Standing water is present in the north ditch. The water in the tunnel was tested and its pH reading was 7.6. This is a fairly neutral reading and indicates that the water is not unusually corrosive. Ballast on Main #2 is fouled and the track is pumping mud near the north ditch. The ballast from this tunnel was tested and classified as being "Very Strong", requiring many blows of a geological hammer to break intact rock specimens. There is a gage rod present near the west portal which may be an indication of a gage problem through the curve

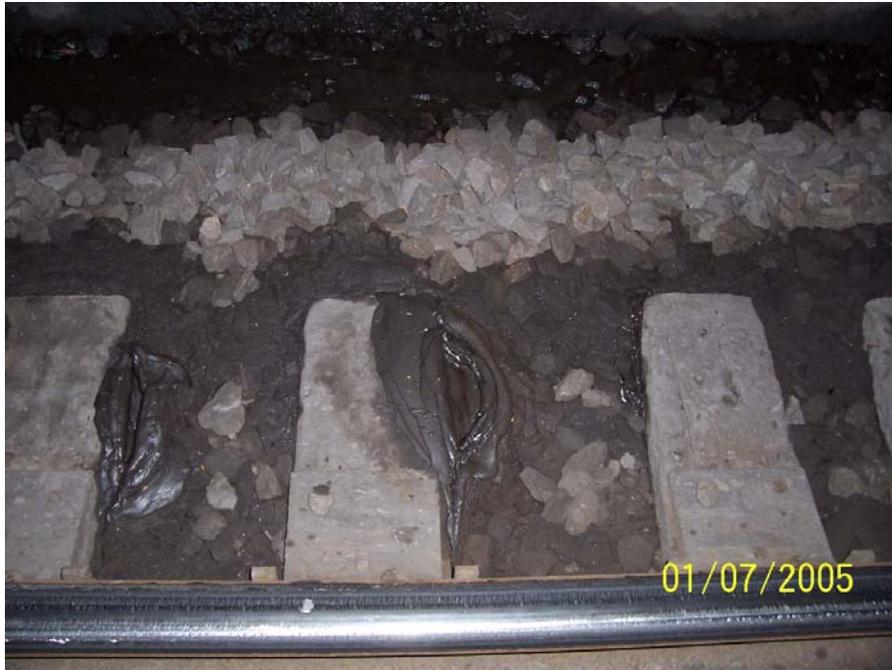
Photo No. 5. – Mud Pumping Through Ballast

Given the magnitude of the vertical encroachment, liner replacement of the tunnel crown is necessary for 100% of the length of the tunnel to achieve the required clearance. Modifications to the right wall, most likely by hydro-demolition, will be required to gain adequate horizontal clearance for the High-Wide portion of the clearance envelope. These modifications will be required for approximately 70% of the length of the tunnel on the right wall only. Detailed analysis into the necessity of, and method for, wall modifications will be done in final design. Additional investigations in the final design phase may determine that notching is possible for some of the tunnel. Drainage improvements are also recommended to help alleviate the ballast-fouling problem.

construction. The preliminary design also proposes to install a drainage system and undercut the track to replace the fouled ballast.

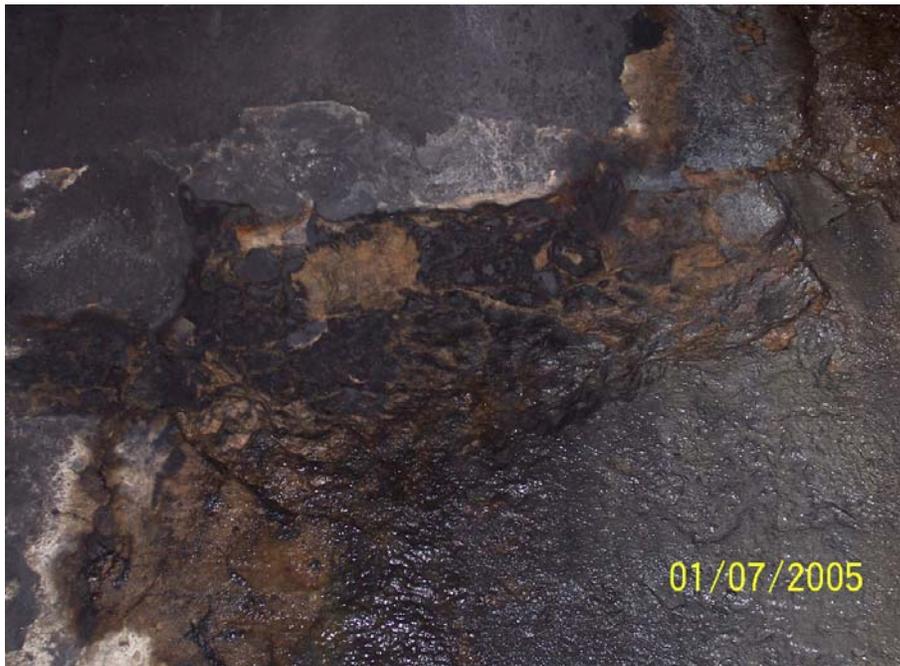
Photo No. 6. – Spall With Water Leaking

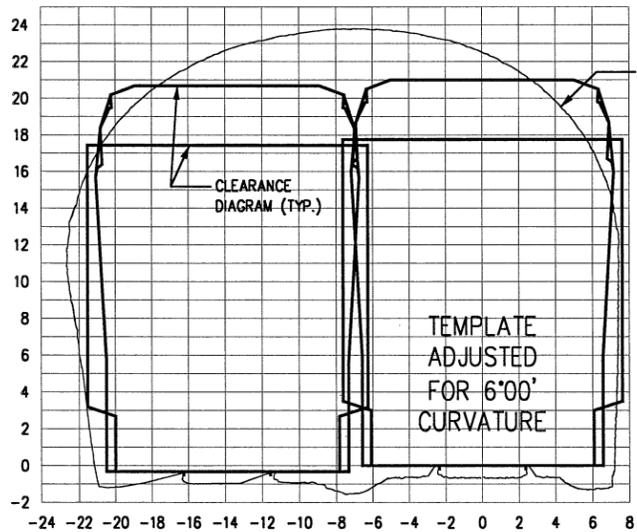
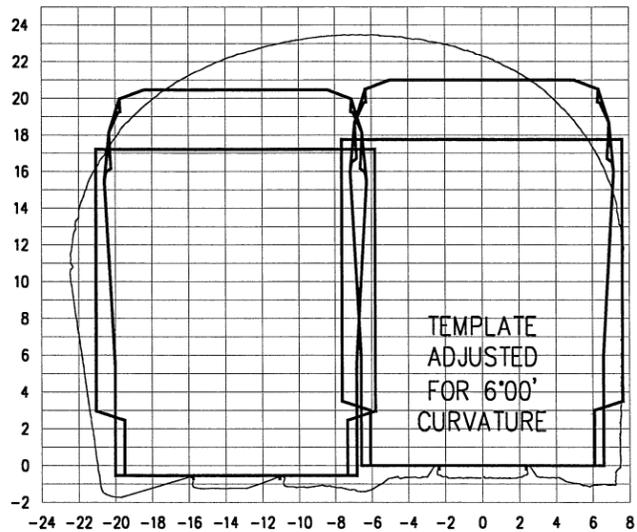
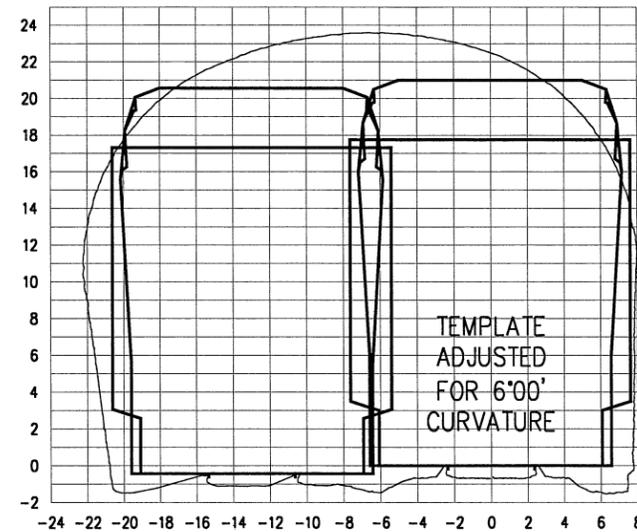
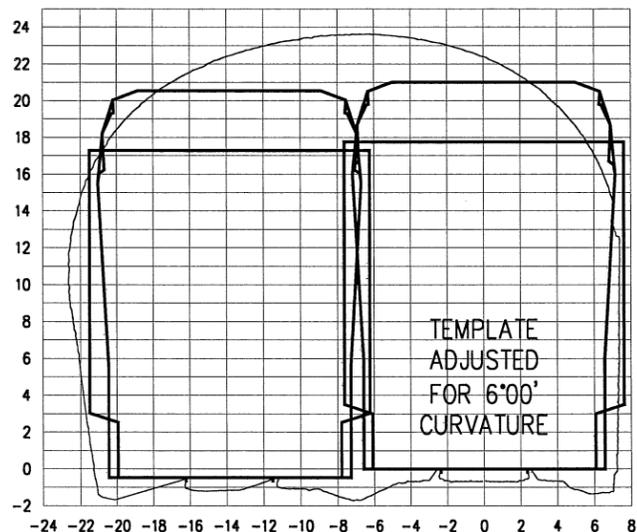
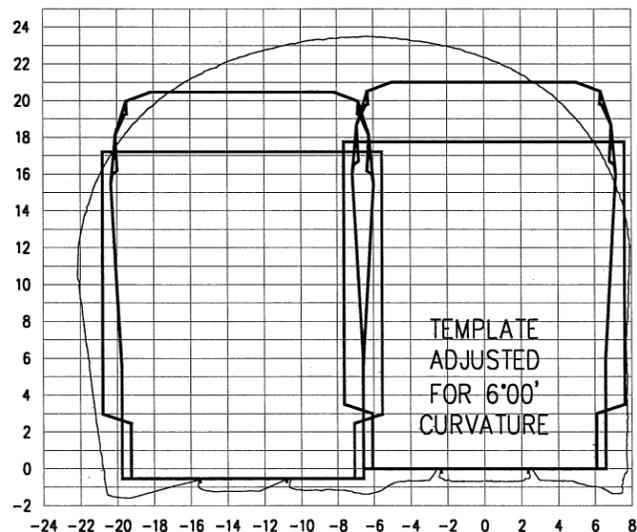
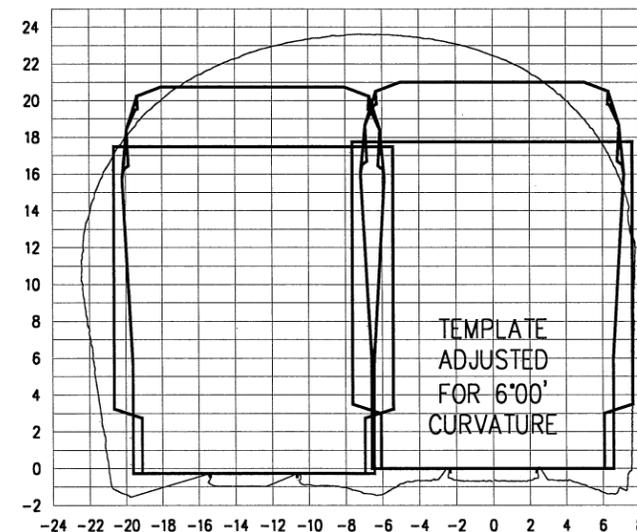
The laser car measurements indicate that the existing tunnel has inadequate horizontal clearance for the “High-Wide Load” portion of the composite clearance envelope. It encroaches on the right wall throughout the whole tunnel, up to 5” at the west portal. Horizontal clearance to the left wall is adequate. The tunnel has adequate horizontal clearance for the “Double Stack” portion of the envelope. For vertical clearance, the “Double Stack” portion of the envelope encroaches on both sides of the tunnel crown by an average of about 14” on the left wall and 25” on the right wall. For the “High-Wide Load,” encroachment on either side the crown averages about 5” on the left wall and 18” on the right wall, varying up to 21”, at points lower than the “Double Stack” envelope. Cross sections of the tunnel clearance encroachments are shown in the drawings at the end of this report. The maximum vertical encroachments are summarized in the table below:

Distance (ft) from East Portal	Crown Encroachment (radial inches)	
	Left Side	Right Side
0	16	26
102	13	26
201	14	24
302	12	23
402	13	25

Distance (ft) from East Portal	Crown Encroachment (radial inches)	
	Left Side	Right Side
501	13	26
601	15	25

1. HORIZONTAL DATUM IS PARALLEL TO TRACK. WHERE TRACK IS SUPERELEVATED, DATUM IS NOT PARALLEL WITH GROUND.
2. CROSS SECTION GIVEN FOR STA. 0+00 IS A COMPOSITE FOR THE TUNNEL FROM STA. 0+00 THROUGH 0+50. ALL OF THE SECTIONS FOLLOW THIS CONVENTION.

To obtain the desired clearance, the concrete liner in the tunnel crown must be demolished, the native rock excavated to the clearance limits plus the new liner thickness, and a new concrete liner installed. This method appears necessary considering that the amount of encroachment is nearly equal to the entire thickness of the liner for most of the right side of the tunnel crown. Partial demolition on the sides of the liner will be used to address the horizontal encroachments.
