*Heartland Corridor, Walton Virginia to
Columbus Ohio*

Preliminary Engineering Phase Report

**BIG SANDY NO. 1
TUNNEL –
MP NA 3.30
PANCO SIDING,
WV**

October 14, 2005, Rev. 2

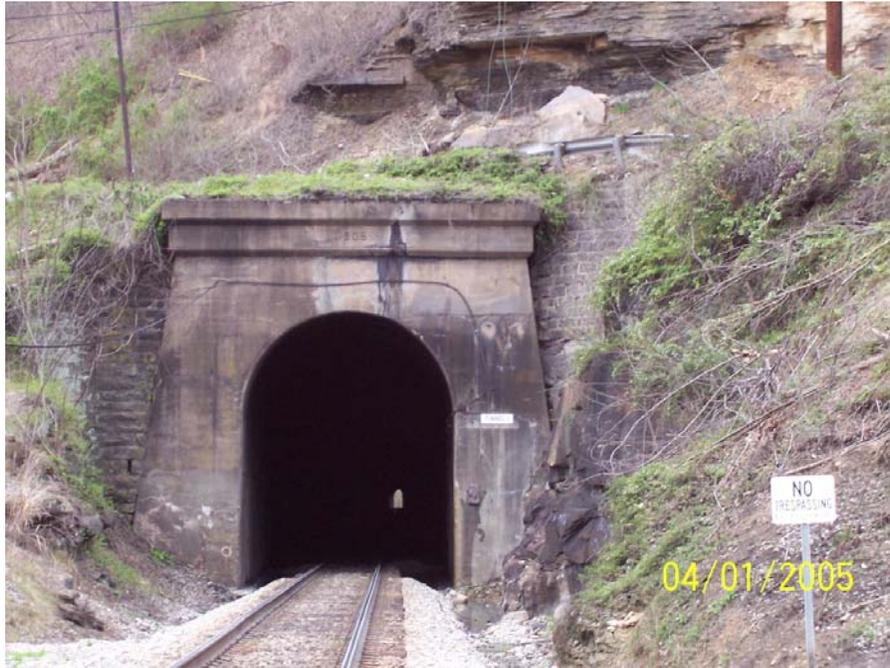
Photo 1. East Portal

The tunnel is 2,627' long with a concrete liner and a nominal width of 16.75'. It is a single width tunnel for one track. The liner is in good condition. Leaking and minor spalling, usually at the construction joints, is confined to within 150' of the east portal and 100' of the west portal. There was no leaking observed for the remainder of the tunnel. A signal cable is mounted on the face of the north wall. At the time of the initial inspection the ballast was in the process of being replaced. Excavation of the ballast exposed the footing; no undermining was observed.

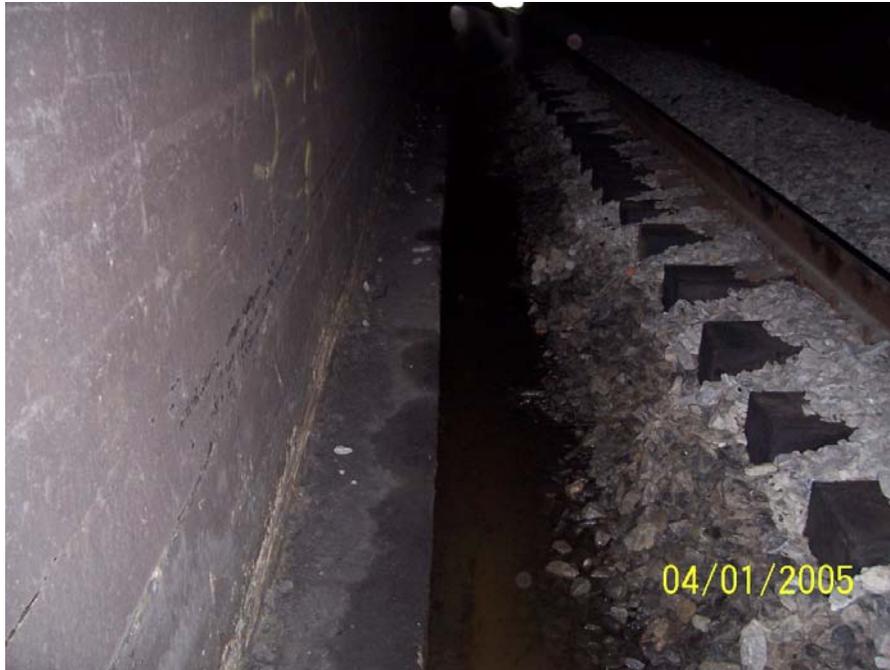
Photo 5. Exposed Footer with Standing Water South Side

A small portion of the tunnel invert material was excavated to fully expose the base of the tunnel liner footing. The footing thickness was found to be 15". The vertical distance from the top of rail to the base of the footing was measured at 38".

The preliminary design also proposes invert improvements consisting of ballast replacement by means of undercutting, track surfacing and lining and the installation of a new drainage system. Due to the proximity of the excavation required for the drainage trench to the tunnel footing, it is assumed that underpinning will be required to stabilize the wall during construction. The extent of underpinning will be further evaluated during final design.

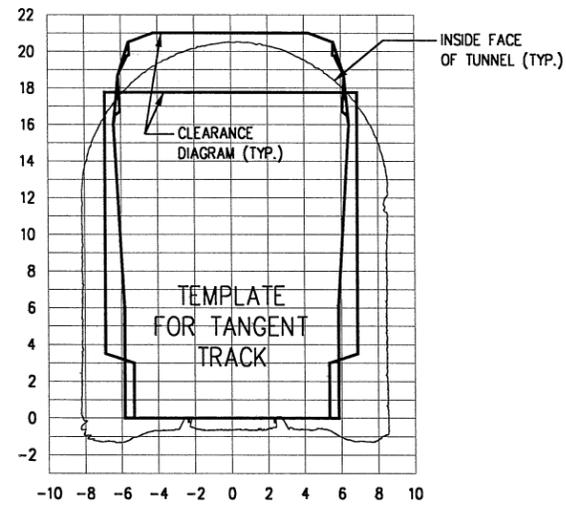
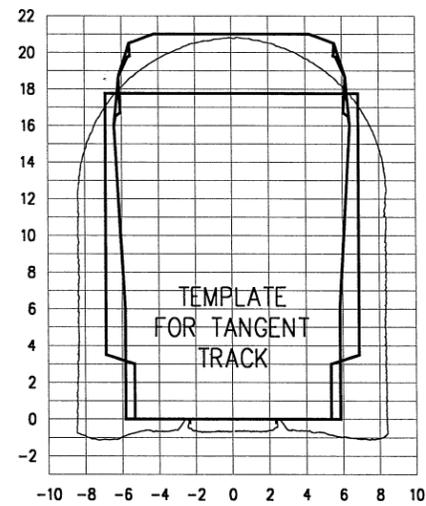
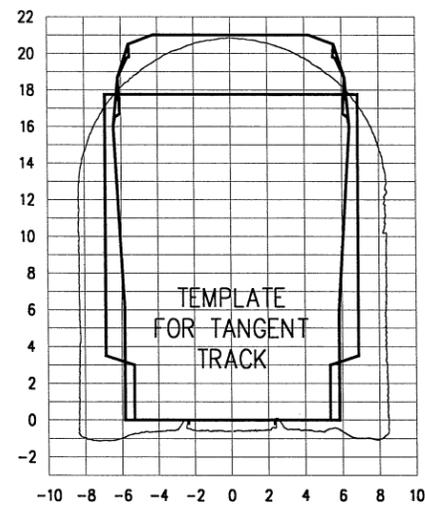
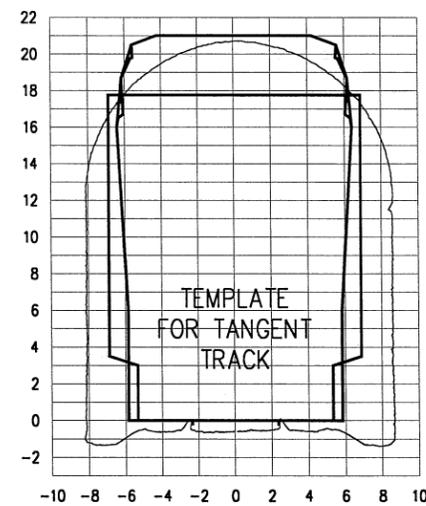
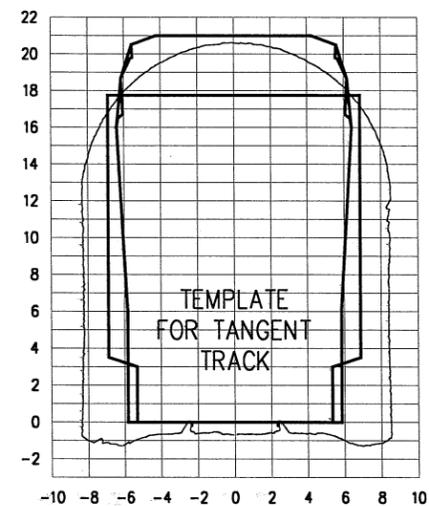
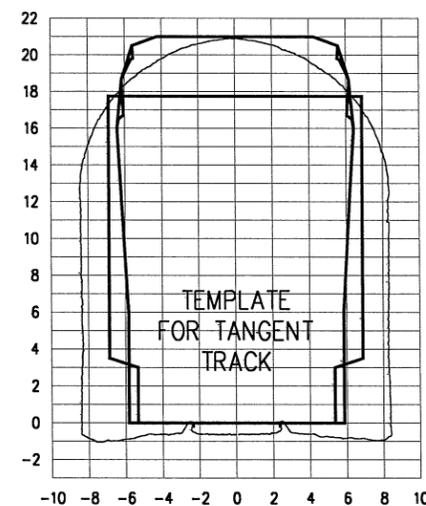
PI	DJL	8/5/05	PRELIMINARY ENGINEERING PHASE REPORT
REV	BY	DATE	DESCRIPTION
LOCATION BIG SANDY NO. 1, PANCO SDG, WV			
TITLE TUNNEL CLEARANCE CROSS SECTIONS - 1 OF 5			
DGN	PLO NO.	VRN	16561 FILE POST NA-3.30
DWN	FILE NO.	DRAWING NUMBER	
CHK	DATE	APRIL 29, 2005

For vertical clearance, the “Double Stack” portion of the envelope encroaches on either side of the tunnel crown by an average of 24” and varies up to 29”. At the crown itself there is encroachment by an average of 6” from the east portal to station 20+00. For the “High-Wide” portion of the clearance envelope, encroachment exists on left side of the crown by an average of 12” and on the right side of the tunnel crown (at points lower than the Double Stack portion) by an average of 18” and varying up to 21” throughout the tunnel. Cross sections of the tunnel clearance encroachments are shown in the drawings at the end of this report. The maximum encroachments are summarized in the table below:

1. HORIZONTAL DATUM IS PARALLEL TO TRACK. WHERE TRACK IS SUPERELEVATED, DATUM IS NOT PARALLEL WITH GROUND.
2. CROSS SECTION GIVEN FOR STA. 0+00 IS A COMPOSITE FOR THE TUNNEL FROM STA. 0+00 THROUGH 0+50. ALL OF THE SECTIONS FOLLOW THIS CONVENTION.

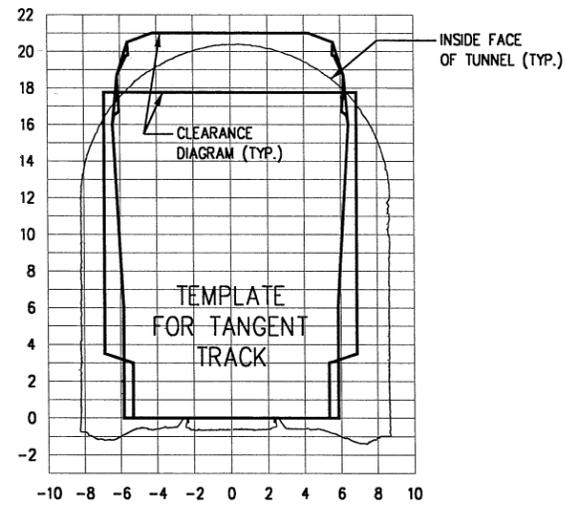
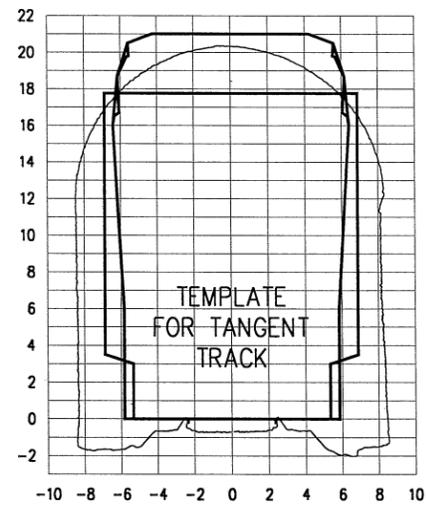
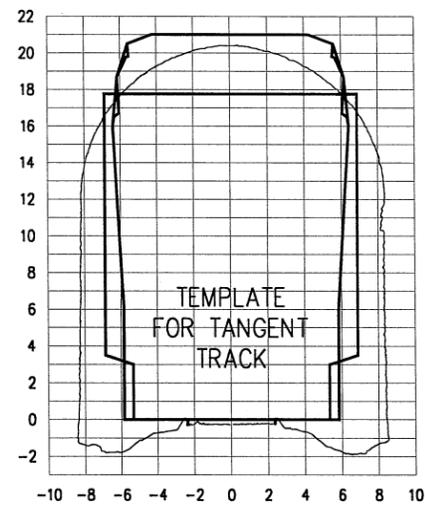
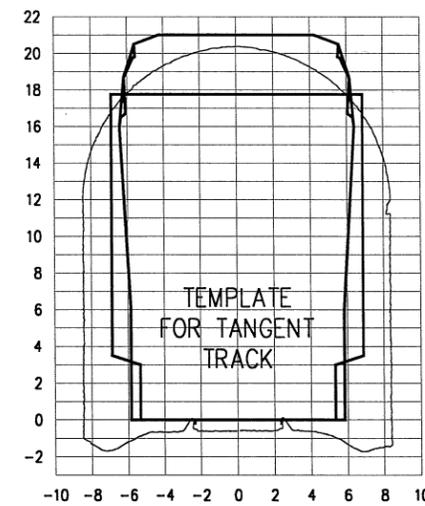
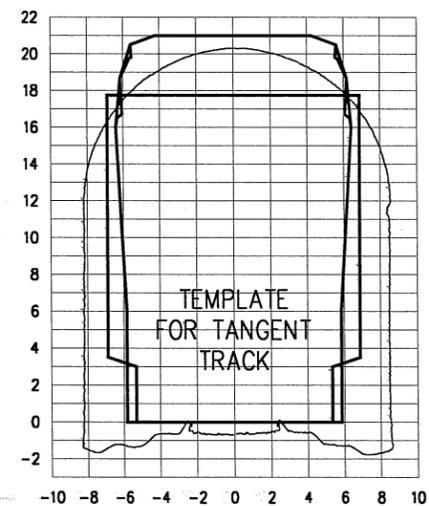
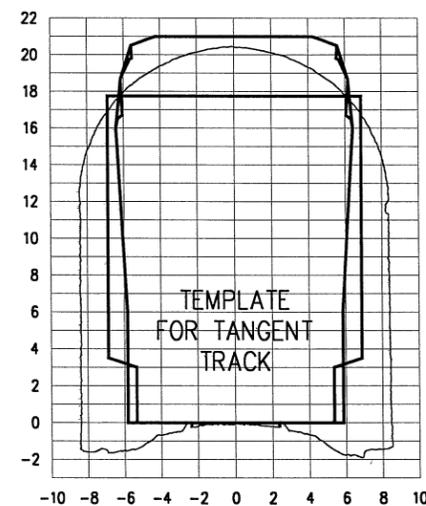
PT	D/JL	8/505	PRELIMINARY ENGINEERING PHASE REPORT
REV	BY	DATE	DESCRIPTION
LOCATION BIG SANDY NO. 1, PANCO SDG, WV			
TITLE TUNNEL CLEARANCE CROSS SECTIONS - 2 OF 5			
DGN	FILE NO.	16561	MILE POST NA-3.30
CHK	DATE	APRIL 29, 2005	DRAWING NUMBER

1. HORIZONTAL DATUM IS PARALLEL TO TRACK. WHERE TRACK IS SUPERELEVATED, DATUM IS NOT PARALLEL WITH GROUND.
2. CROSS SECTION GIVEN FOR STA. 0+00 IS A COMPOSITE FOR THE TUNNEL FROM STA. 0+00 THROUGH 0+50. ALL OF THE SECTIONS FOLLOW THIS CONVENTION.

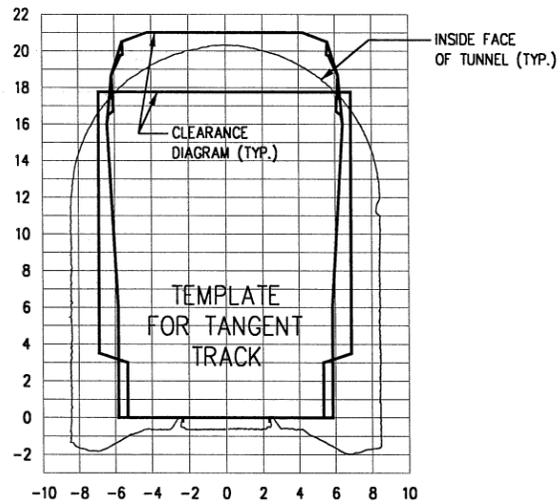
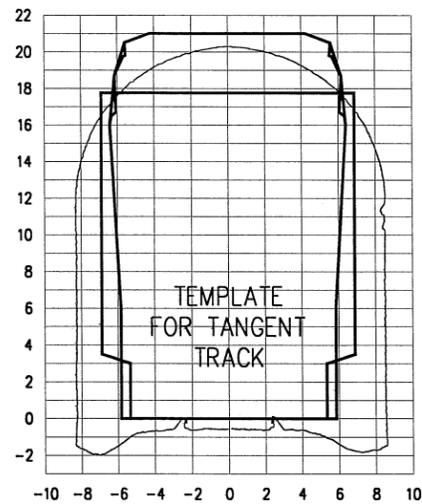
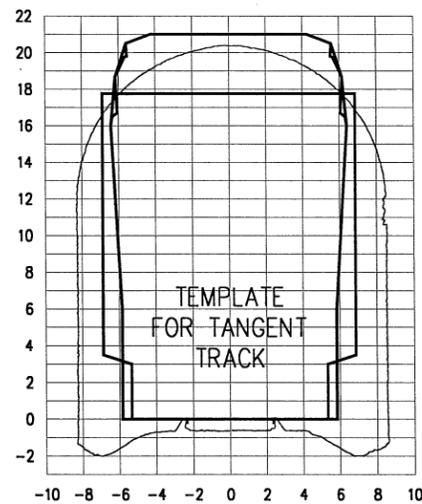
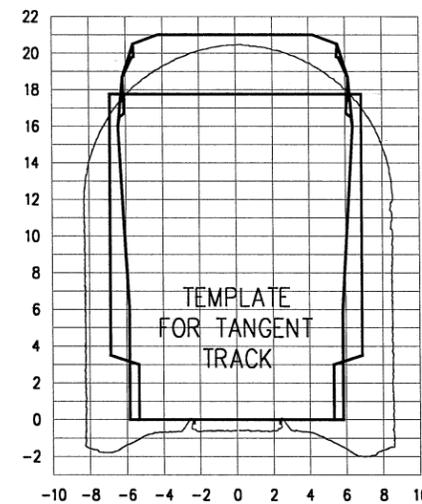
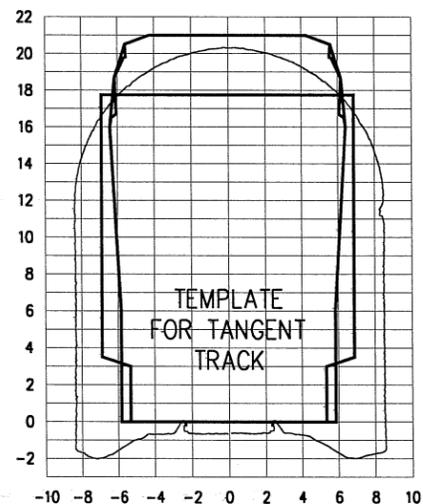
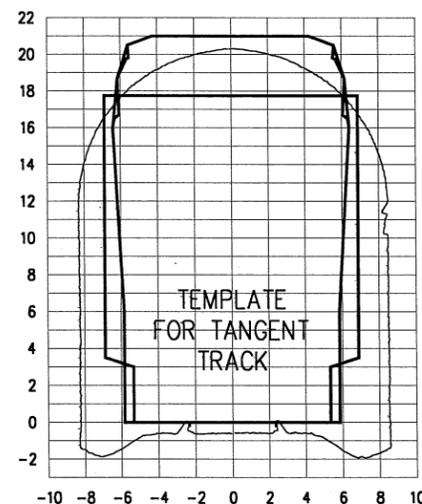
PI	DJI	8/5/05	PRELIMINARY ENGINEERING PHASE REPORT
REV	BY	DATE	DESCRIPTION
PROJECT: BIG SANDY NO. 1, PANCO SDG, WV			
TITLE: TUNNEL CLEARANCE CROSS SECTIONS - 3 OF 5			
DSN	P.T.D. NO.	DRW	16561
DMN	P.T.L. NO.	DATE	APRIL 29, 2005
CHK	DATE	FILE POST	NA-3.30
		DRAWING NUMBER

1. HORIZONTAL DATUM IS PARALLEL TO TRACK. WHERE TRACK IS SUPERELEVATED, DATUM IS NOT PARALLEL WITH GROUND.
2. CROSS SECTION GIVEN FOR STA. 0+00 IS A COMPOSITE FOR THE TUNNEL FROM STA. 0+00 THROUGH 0+50. ALL OF THE SECTIONS FOLLOW THIS CONVENTION.

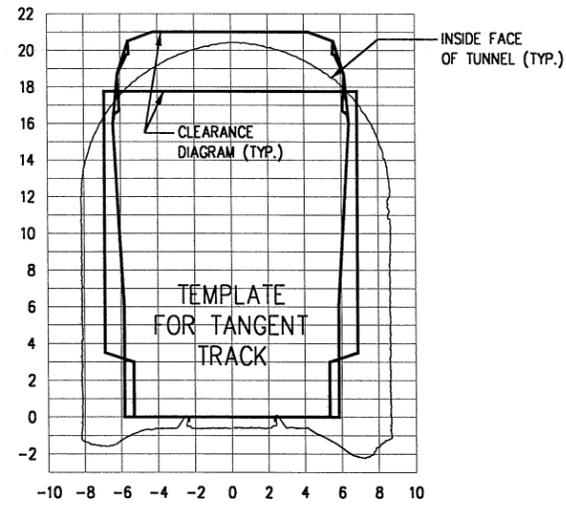
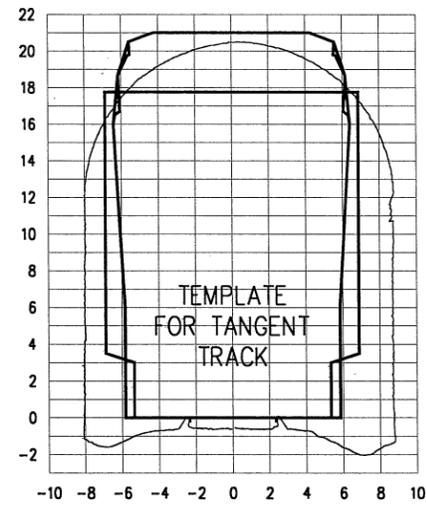
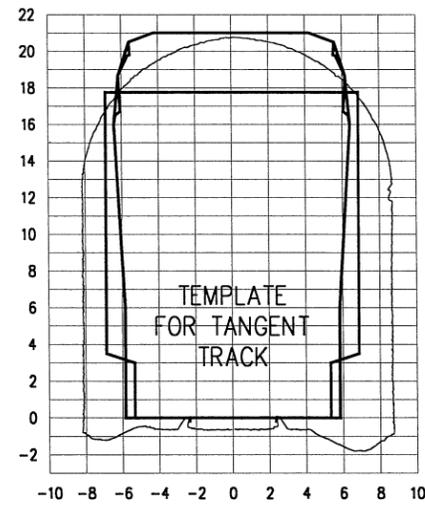
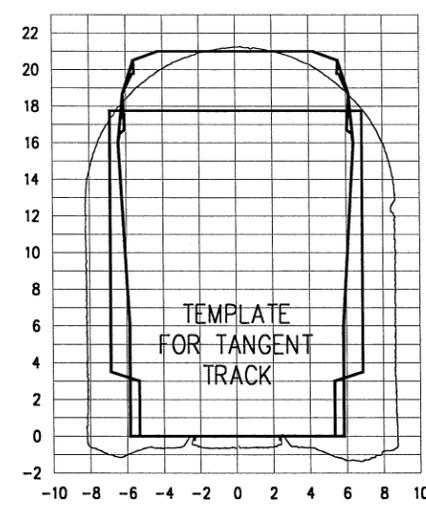
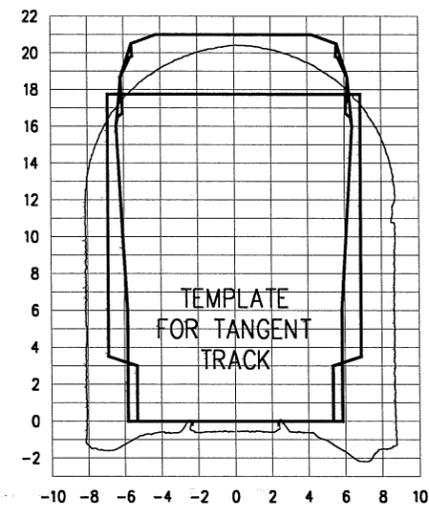
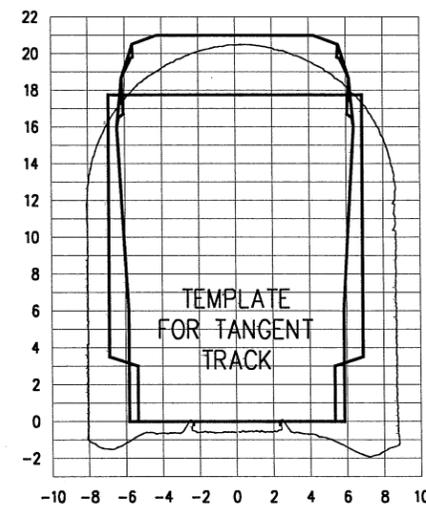
- HORIZONTAL DATUM IS PARALLEL TO TRACK. WHERE TRACK IS SUPERELEVATED, DATUM IS NOT PARALLEL WITH GROUND.
- CROSS SECTION GIVEN FOR STA. 0+00 IS A COMPOSITE FOR THE TUNNEL FROM STA. 0+00 THROUGH 0+50. ALL OF THE SECTIONS FOLLOW THIS CONVENTION.

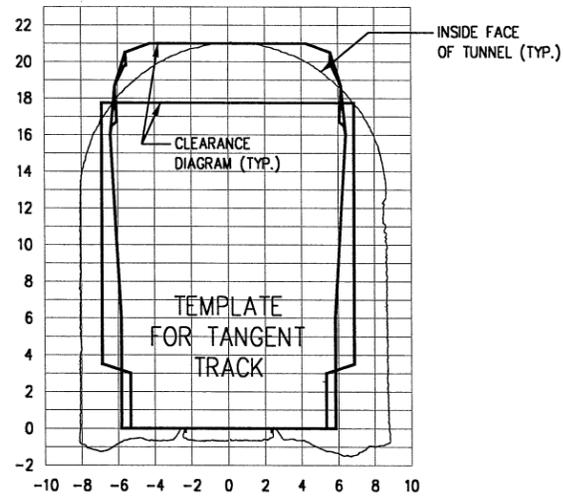
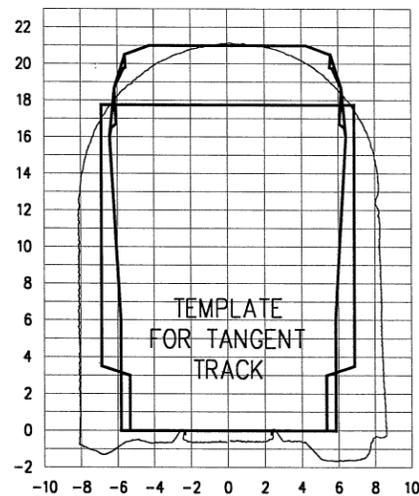
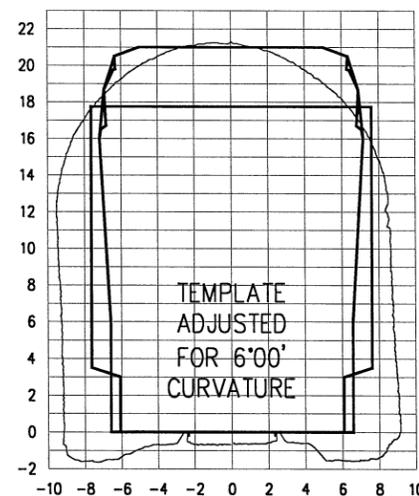
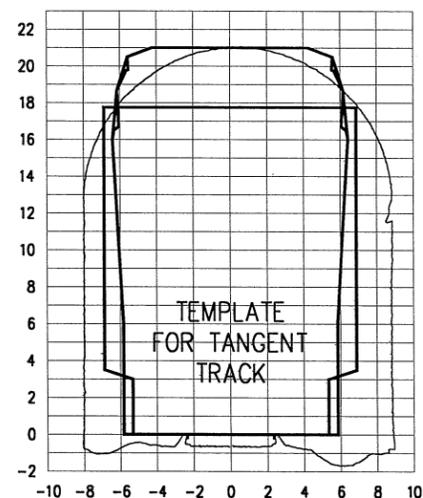
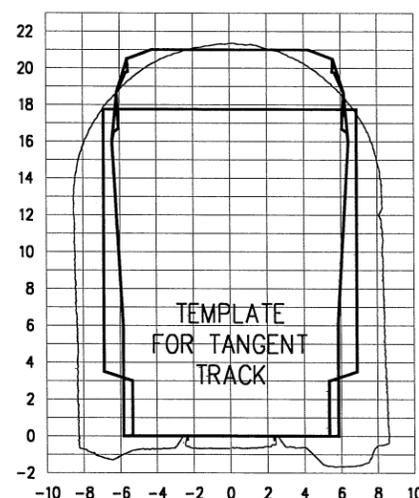
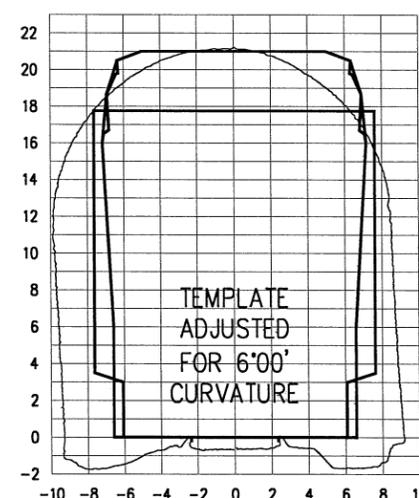
PI	DJL	8505	PRELIMINARY ENGINEERING PHASE REPORT
REV	BY	DATE	DESCRIPTION
LOCATION BIG SANDY NO. 1, PANCO SDG, WV			
TITLE TUNNEL CLEARANCE CROSS SECTIONS - 5 OF 5			
DGN	PTD NO.	VRN	16561 TITLE POST NA-3.30
DWN	FILE NO.	DRAWING NUMBER	
CHK	DATE	APRIL 29, 2005

- HORIZONTAL DATUM IS PARALLEL TO TRACK. WHERE TRACK IS SUPERELEVATED, DATUM IS NOT PARALLEL WITH GROUND.
- CROSS SECTION GIVEN FOR STA. 0+00 IS A COMPOSITE FOR THE TUNNEL FROM STA. 0+00 THROUGH 0+50. ALL OF THE SECTIONS FOLLOW THIS CONVENTION.

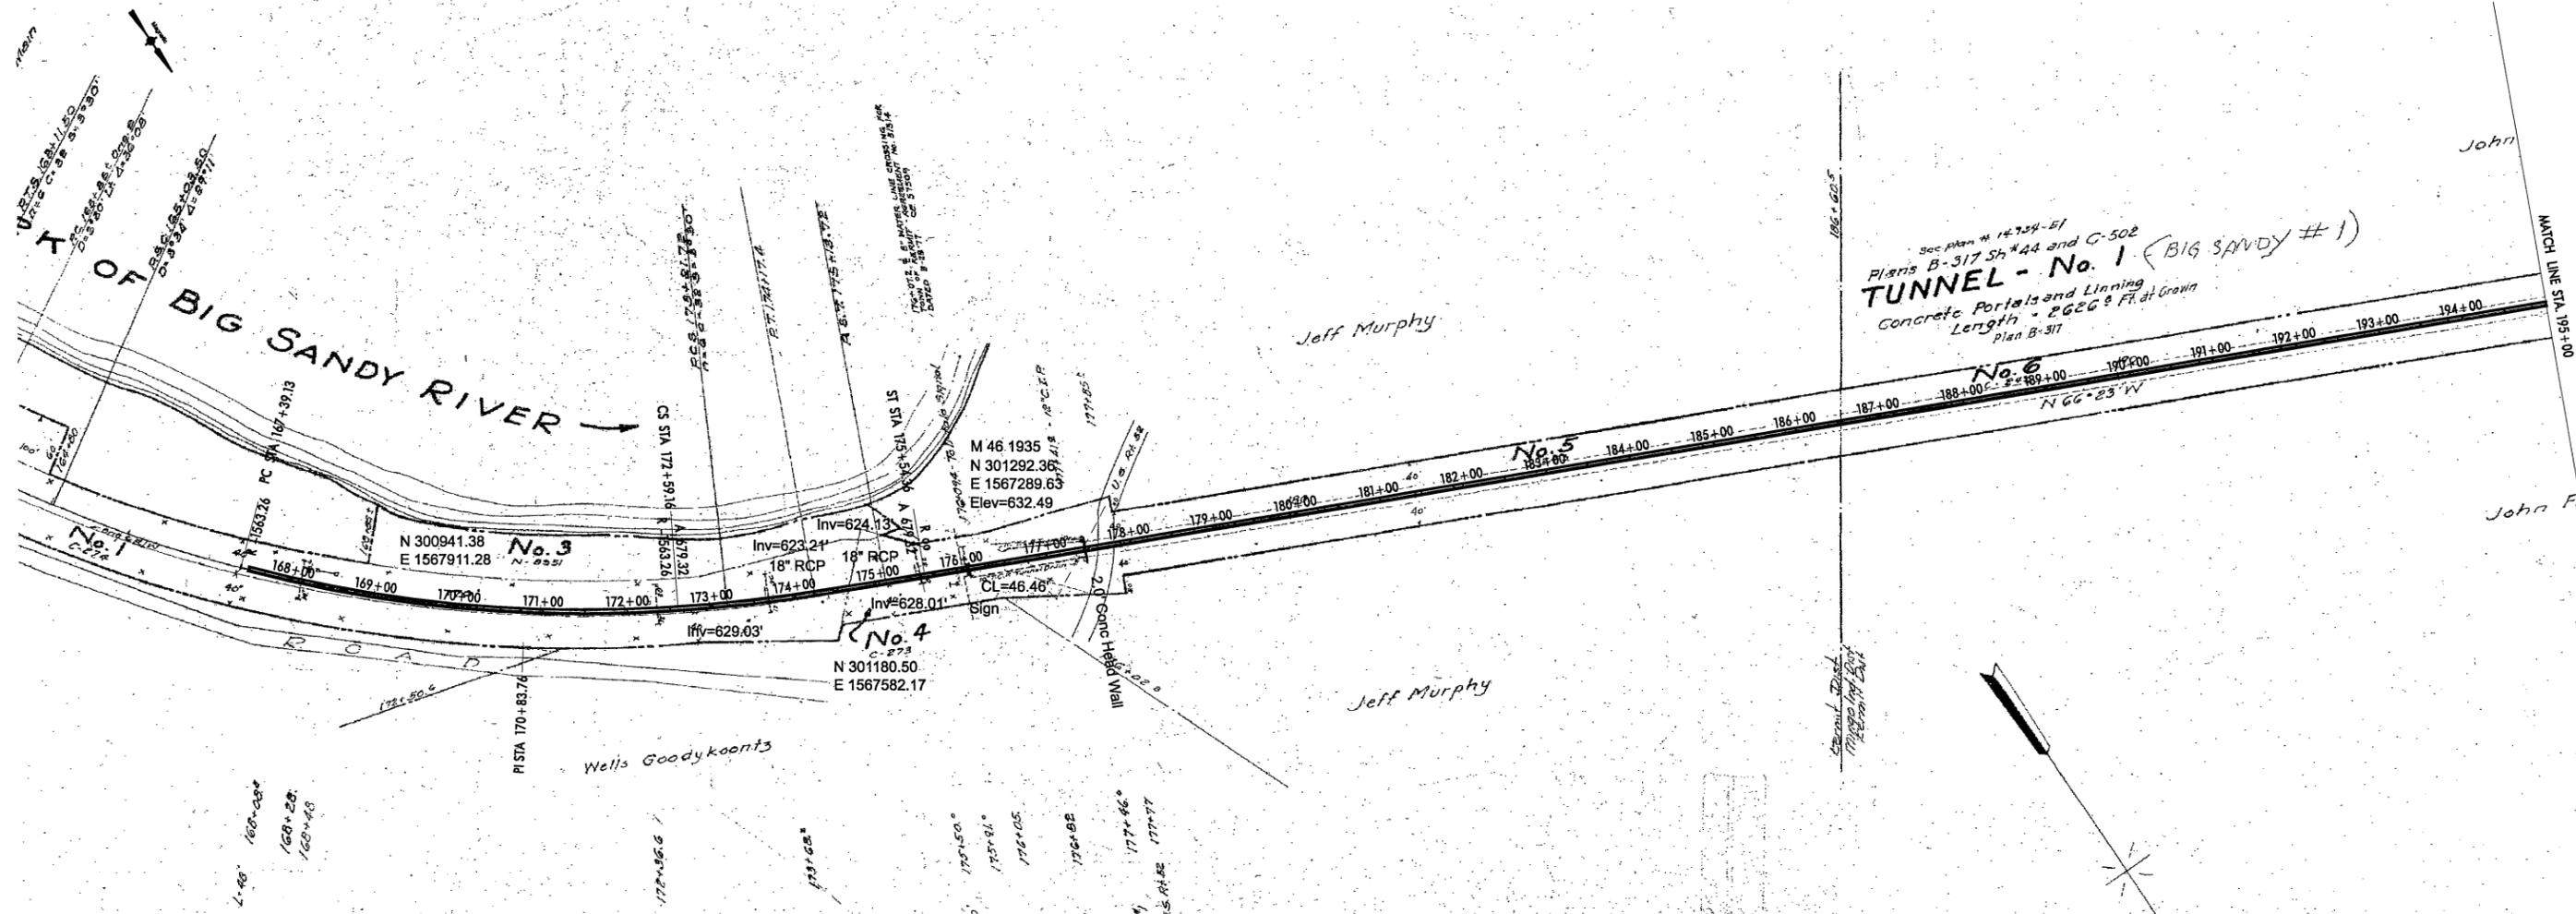
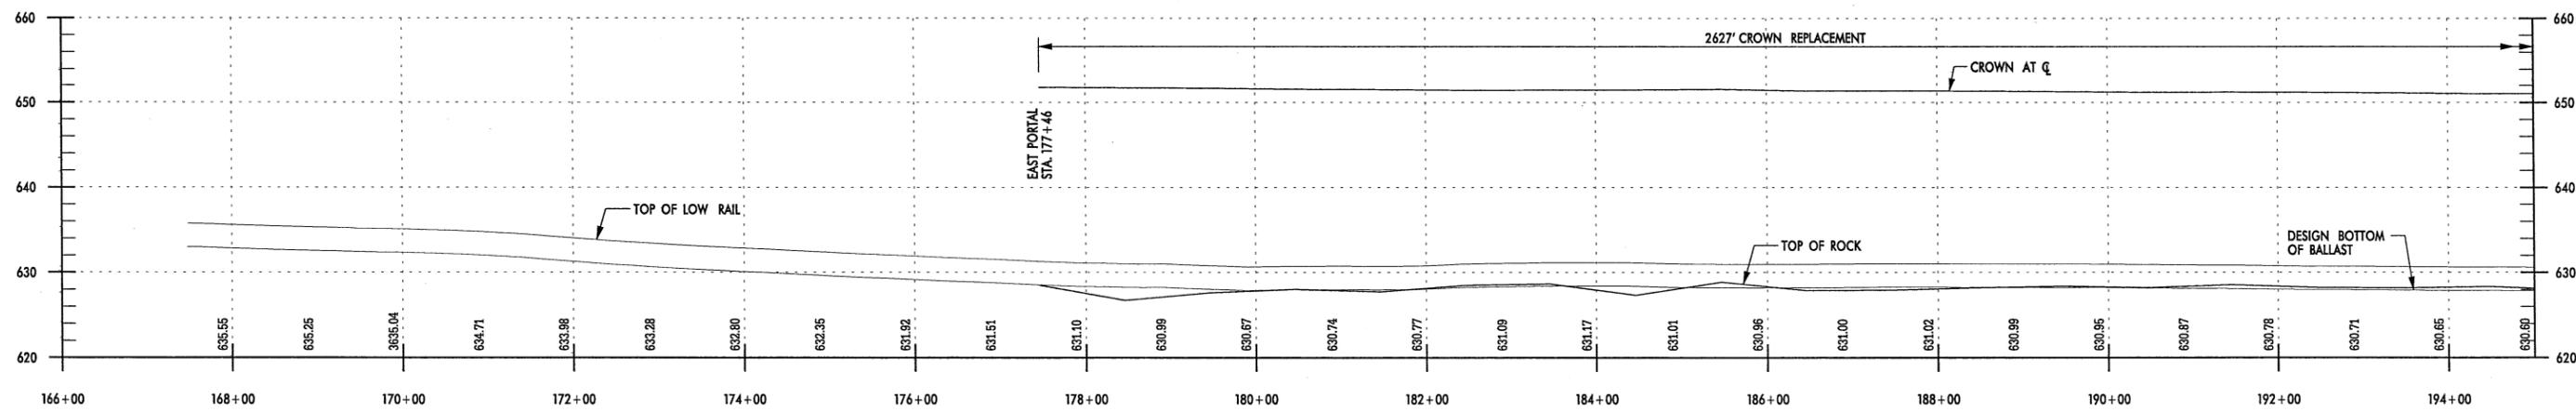
TITLE: **PLAN AND PROFILE SHEET 1 OF 2**

BIG SANDY NO. 1 PLAN
 SCALE: 1"=100'

BIG SANDY NO. 1 PROFILE
 SCALE: 1"=100' HORIZ.
 1"=10' VERT.

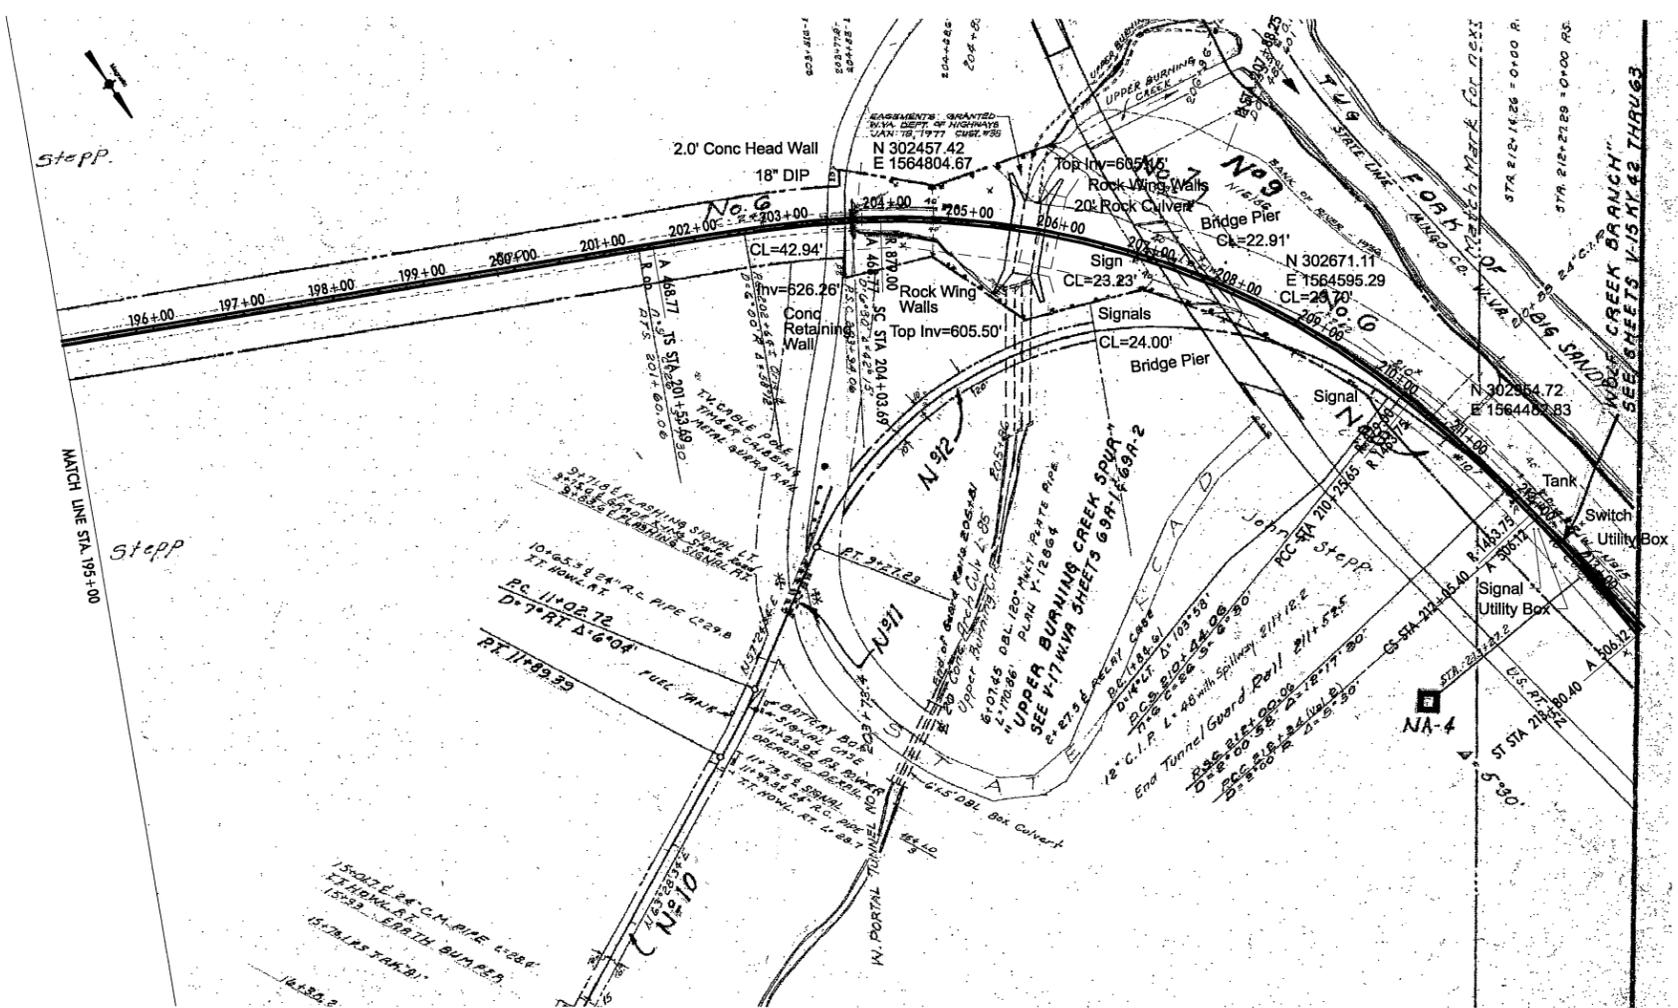
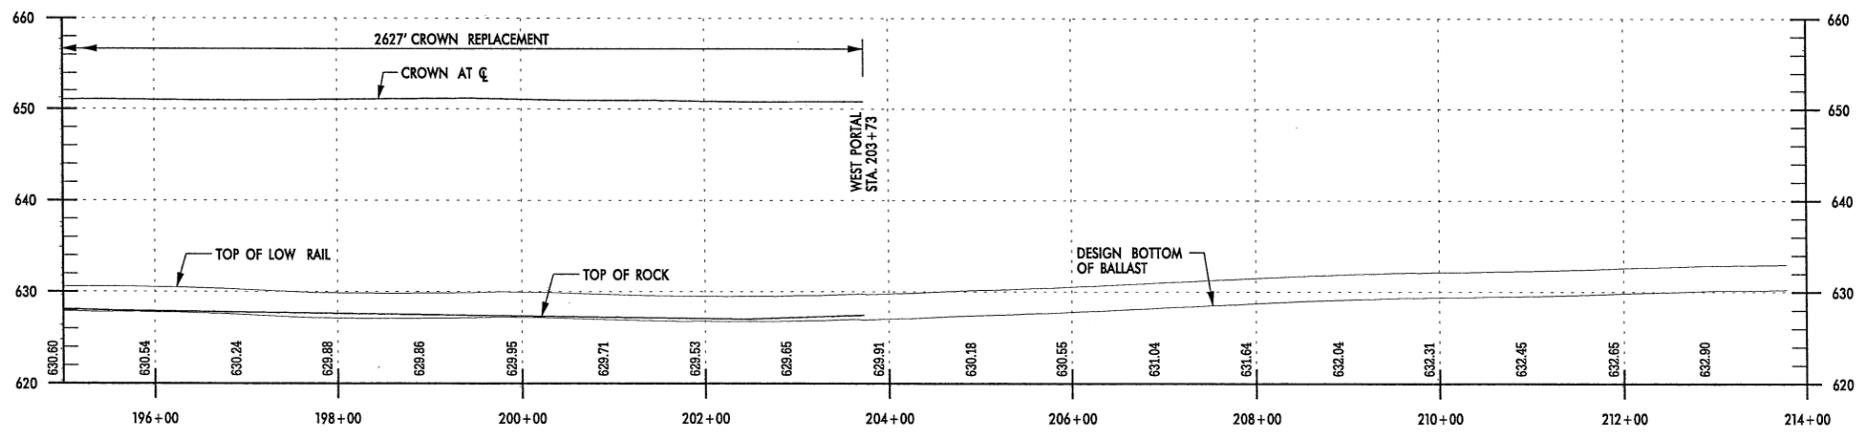
BIG SANDY NO. 1 PLAN
SCALE: 1"=100'

BIG SANDY NO. 1 PROFILE
SCALE: 1"=100' HORIZ.
1"=10' VERT.
