*Heartland Corridor, Walton Virginia to  
Columbus Ohio*

## **Preliminary Engineering Phase Report**

**HATFIELD MAIN #2  
TUNNEL –  
MP N462.09  
SPRIGG, WV**

October 14, 2005, Rev. 2

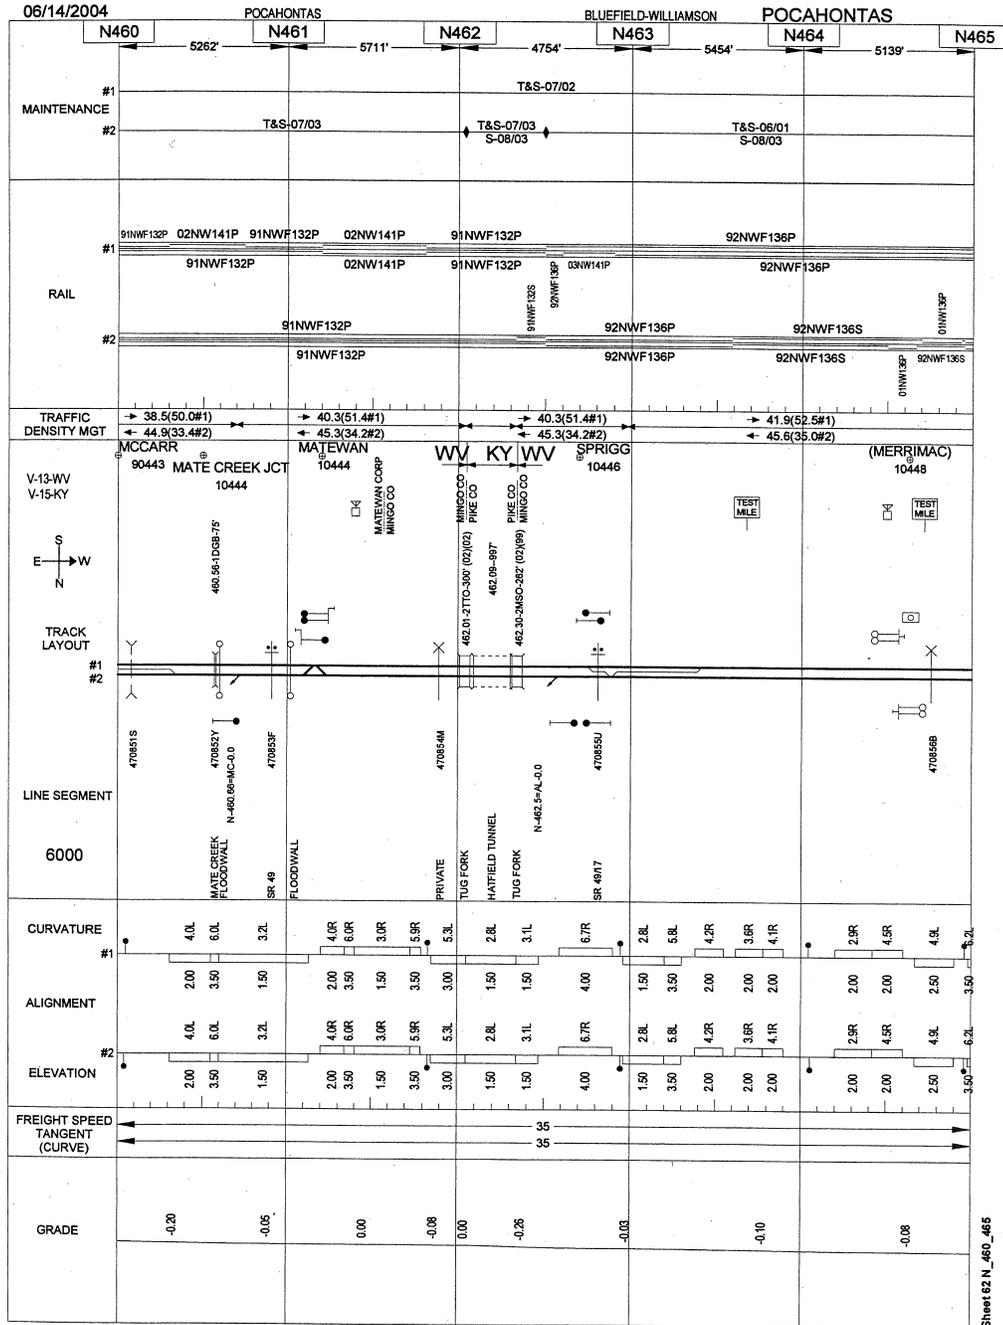
### 6. TRACK CHART

**Statistics: Pocahontas Division**  
**Single-width Tunnel Main #2**  
**Length = 997'**  
**Unlined**  
**Degree of Curvature = 2.8 LT (per Track Chart)**  
**Superelevation = 1.5" (per Track Chart)**

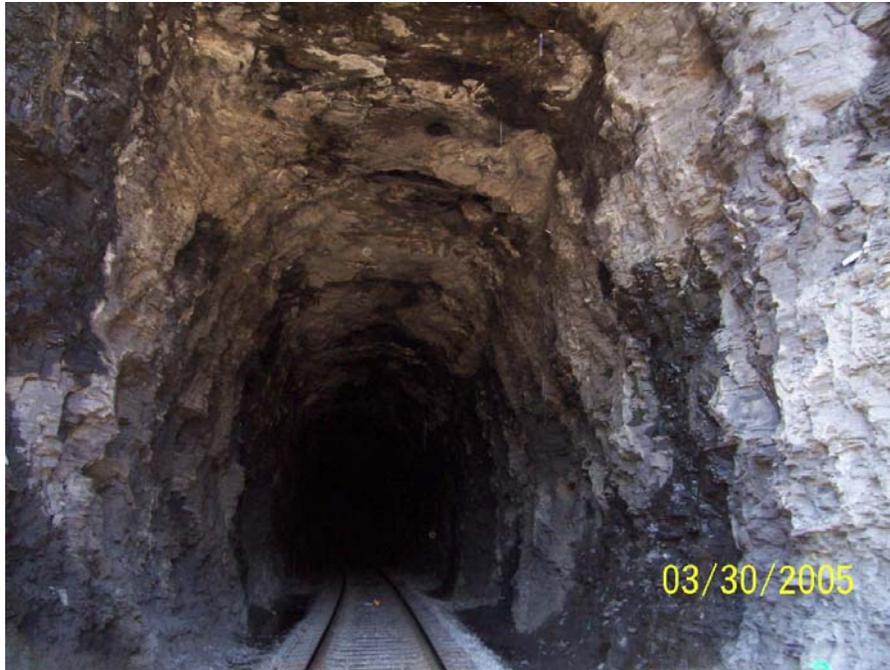
This unlined single-track tunnel is 997' long with a nominal width of 17'. There are fallen pieces of rock evident along the track and it is understood that the railroad occasionally brings equipment into the tunnel to scale any loose rock. There is water leaking approximately 36' and 100' in from the west portal and 10' in from the east portal. Rock fall sensors are mounted on the ties both outside of and in between the rails.

Photo 5. Crown and Walls

Given the history of rock fall from the crown of the tunnel, simply removing the crown would provide clearances, but would leave the existing conditions relatively unchanged. We therefore recommend that the roof be lined with rock dowels and shotcrete at the proper clearances. The installation of the roof lining would allow removal of the rock fall detectors, thereby lowering maintenance costs and improving the reliability of the line.

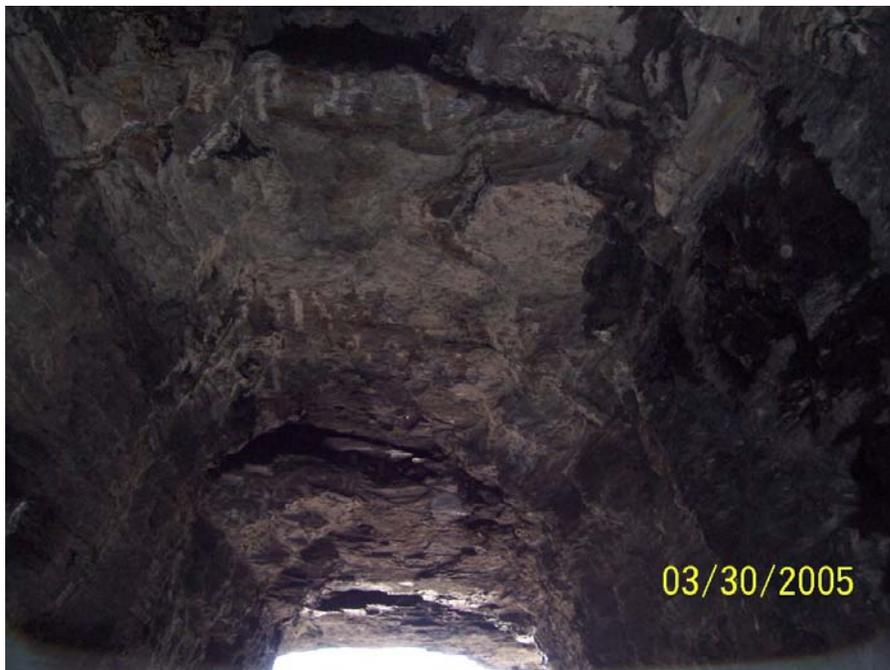
Photo 6. Crown

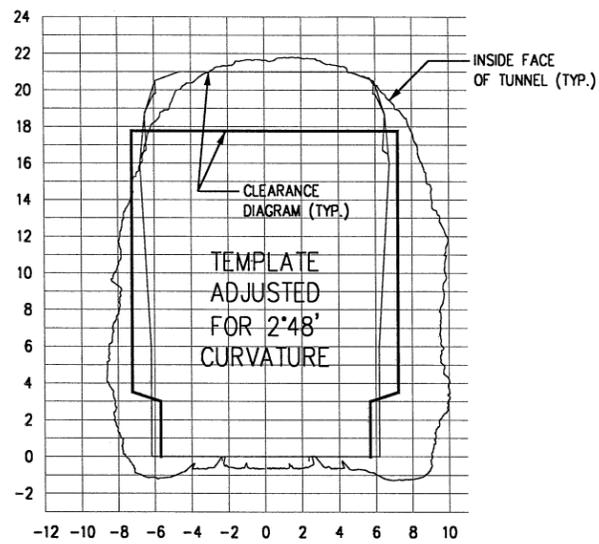
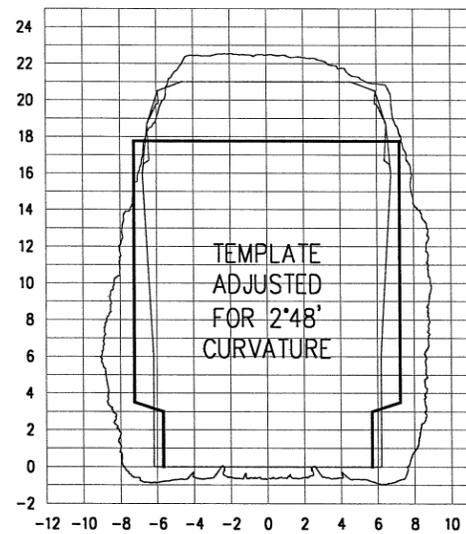
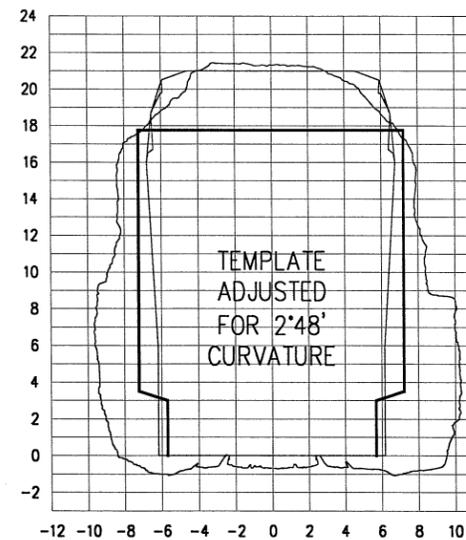
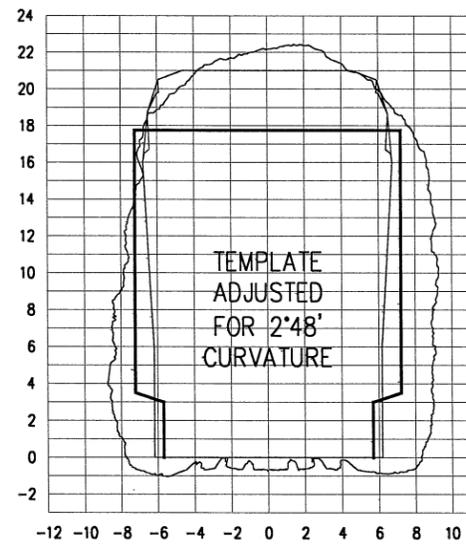
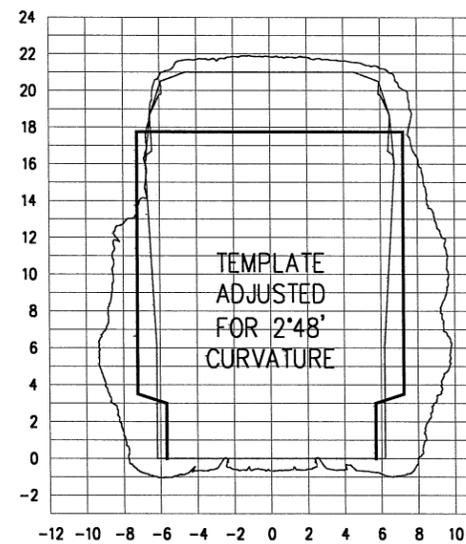
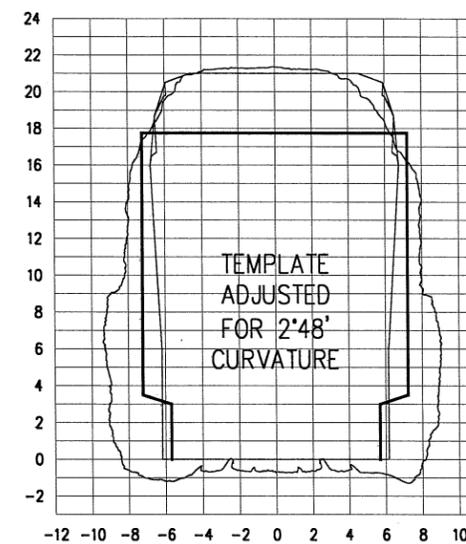
PI	D.J.L.	8/505	PRELIMINARY ENGINEERING PHASE REPORT
REV	BY	DATE	DESCRIPTION
LOCATION	HATFIELD MAIN #2 TUNNEL, SPRIGG, WV.		
TITLE	TUNNEL CLEARANCE CROSS SECTIONS - 1 OF 3		
DES	F.T.D.	W.R.W.	12030 & 16343 WYLE POST N-462.09
DWN	FILE NO.	DRAWING NUMBER	
CHK	DATE	APRIL 22, 2005

The laser car measurements indicate that the existing tunnel has adequate horizontal clearance except for a minor encroachment on the right at station 5+02. There is inadequate vertical clearance for both the “Double Stack Load” and the “High-Wide Load” portions of the composite clearance envelope. For the “Double Stack” portion of the envelope, encroachment on both sides of the tunnel crown averages about 12”, and varies up to 20”. For the “High-Wide Load”, encroachment on the left side of the crown averages about 4”, the right side averages 8”, and varies from 0” to 18” at points lower than the Double Stack template throughout the tunnel. At the center of the tunnel crown itself, there are no encroachments except from station 7+01 to station 7+50 and from station 9+01 to the west portal (station 9+50) where the “Double Stack Load” portion of the composite clearance envelope encroaches from approximately 3” to 6”. Cross sections of the tunnel clearance encroachments are shown in the drawings at the end of this report. The maximum encroachments are summarized in the table below:

Distance (ft) from East Portal	Crown Encroachment (radial inches)	
	Left Side	Right Side
0	16	2
102	12	5
201	8	0
301	16	15
401	13	15
502	12	23
601	20	23
701	12	17
802	14	13
901	18	21
950	14	15
