*Heartland Corridor, Walton Virginia to
Columbus Ohio*

Preliminary Engineering Phase Report

**Hemphill No. 1
Tunnel –
MP N400.15
Hemphill, WV**

October 14, 2005, Rev. 2

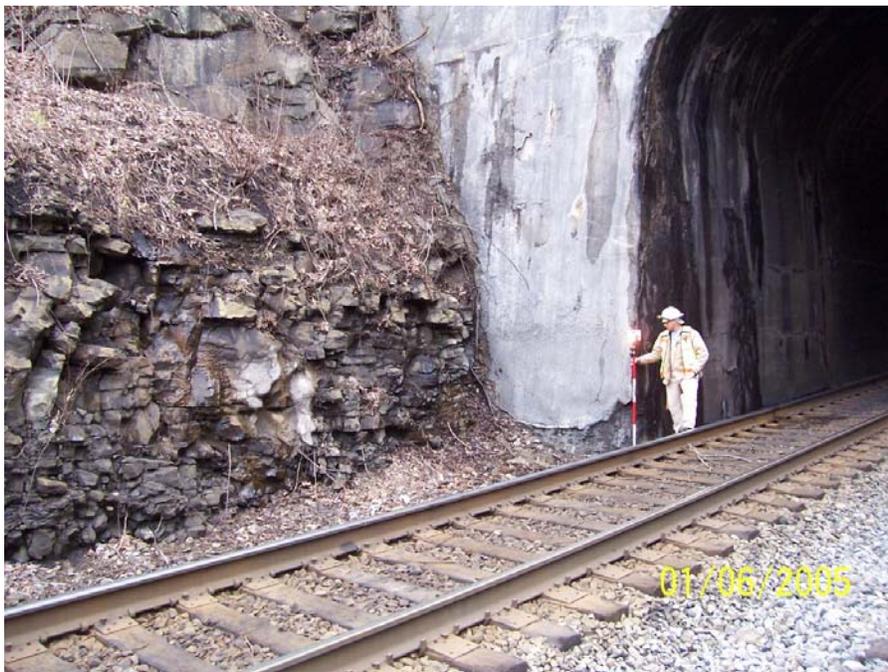
The tunnel was excavated through the medium- to thick-bedded fine-to medium grained sandstone of the New River Formation. The sandstone is locally interbedded with thin-bedded sandstone, siltstone, shale, and coal. Bedding is subhorizontal and gently rolls back and forth towards the northwest and southeast. Beds of thin-bedded sandstone and shale up to five feet thick were infrequently noted within the sandstone. Joints in the rock cuts are typically steeply dipping and widely spaced. Most joints are less than 15 feet in length and are not through-going across the exposure face.

The rock quality designation, Q, at the portals was determined to be 18. A Q rating between 10 and 40 is considered “Good” with 10 bordering on “Fair” and 40 bordering on “Very Good.” A sample of rock was taken from the portal and tested.

Photo No. 4 – Rock face north side of west portal

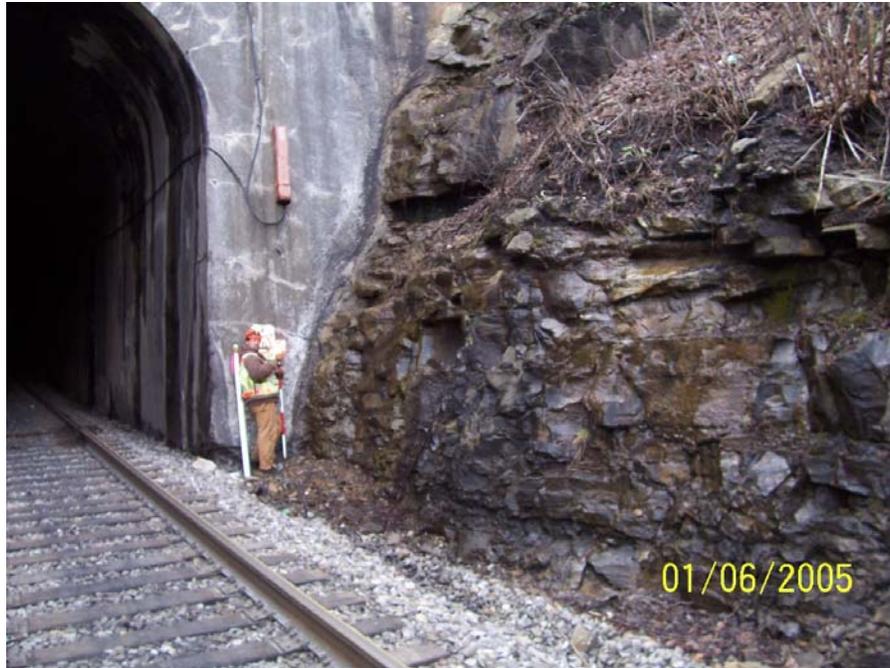
Photo No. 5 – Rock face south side west portal

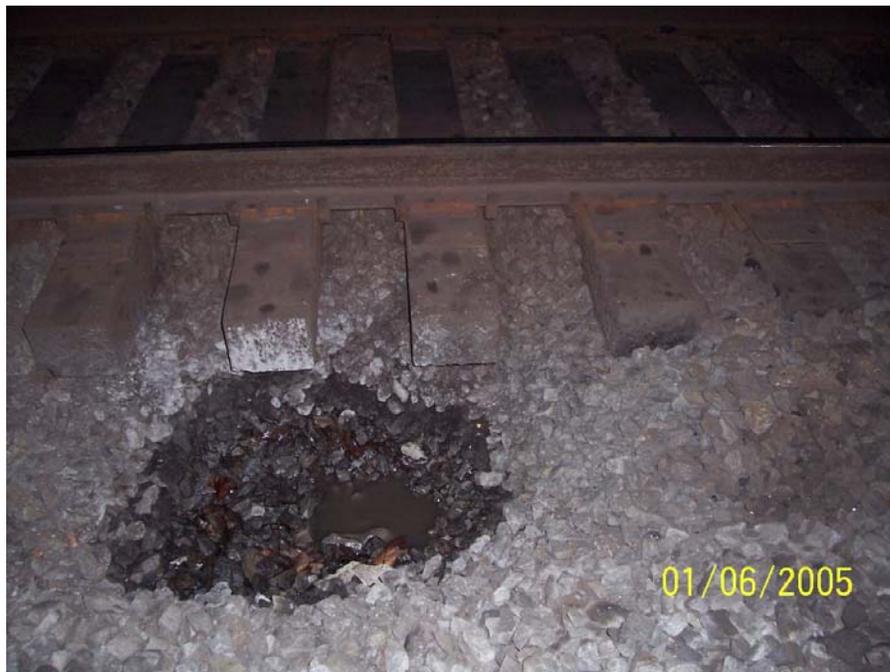
pumping of fines observed. The rail is typically 141 AB on 15” tie plates and fastened with rail spikes. The track is tangent throughout the tunnel. A 2’x2’ sink hole was noted in the ballast – see photo 6.

Photo No. 6 – Hole forming in ballast, between tracks 1 & 2

Given the magnitude of the vertical encroachment, installing rock dowels and using the deep notching method is the most feasible and economical solution to provide adequate vertical clearance throughout the tunnel. Drainage improvements are also recommended to help alleviate the ballast-fouling problem.

The existing track structure is planned to be flooded with ballast to the top of the rail to provide access into the tunnel for the contractor to work and to protect the track during the construction. The preliminary design also proposes to install a new drainage system and undercut the track to improve drainage.

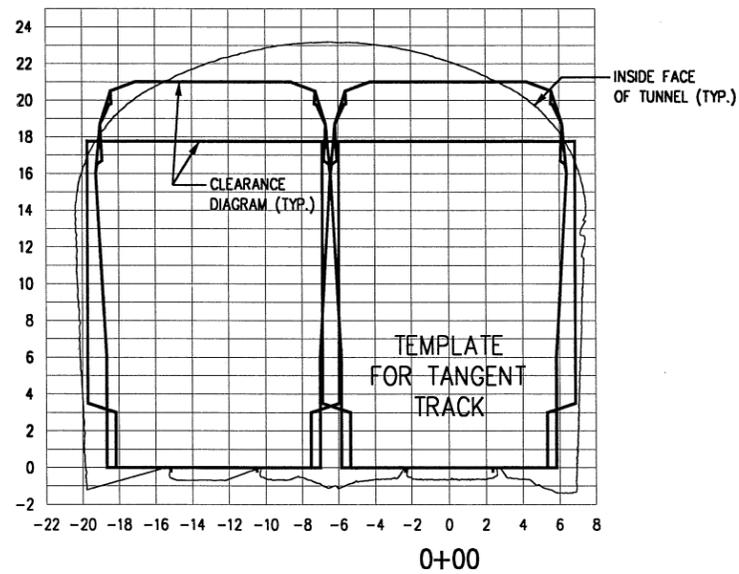
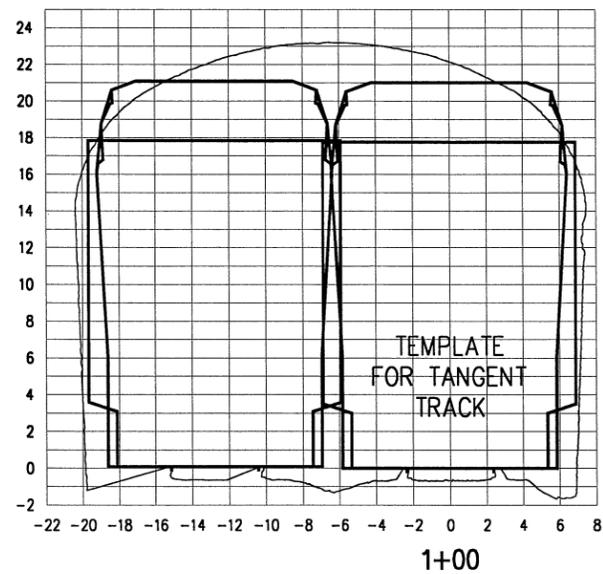
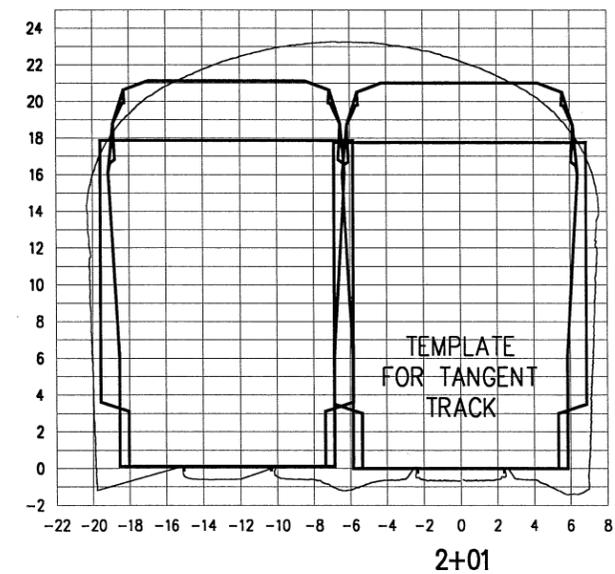
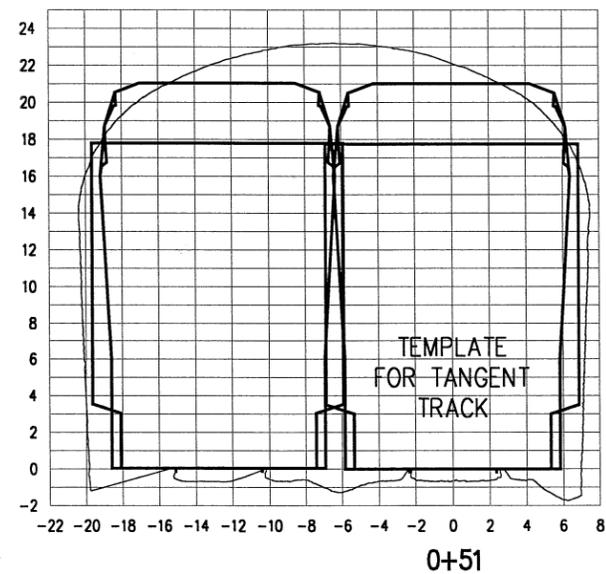
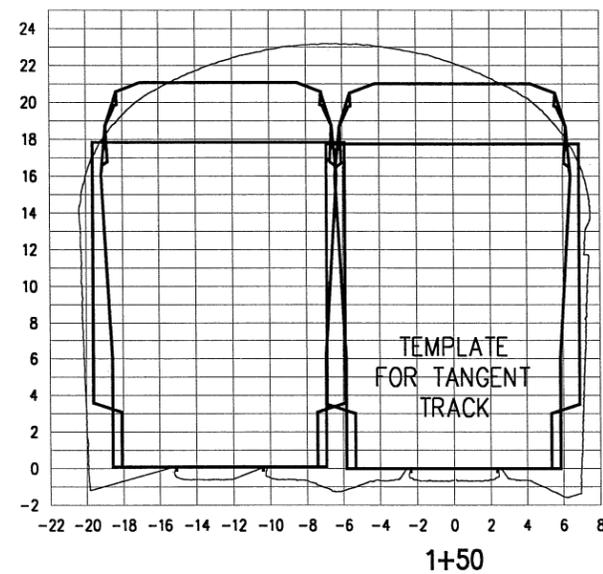
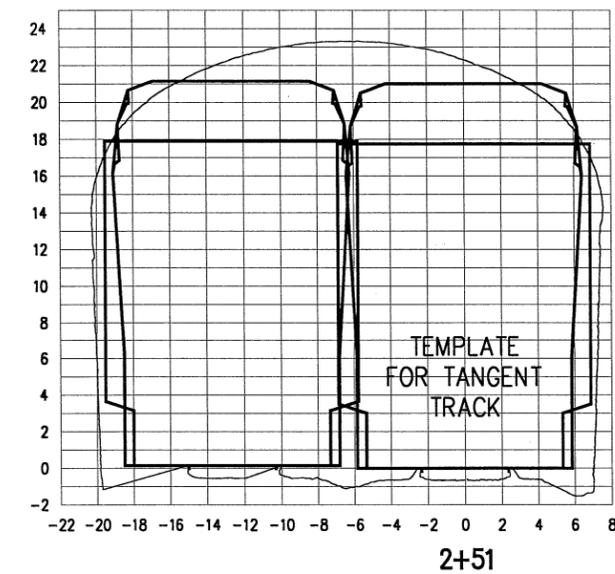
The laser car measurements indicate that the existing tunnel has adequate horizontal clearance, but inadequate vertical clearance for both the “Double Stack” and the “High-Wide Load” portions of the composite clearance envelope. For the “Double Stack” portion of the envelope, encroachment on both sides of the tunnel crown averages about 13”, and varies up to 15”. For the “High-Wide Load”, encroachment on each side of the crown averages about 4” and varies from 0” to 7” at points lower than the Double Stack template throughout the entire tunnel. Cross sections of the tunnel clearance encroachments are shown in the drawings at the end of this report. The maximum vertical encroachments are summarized in the table below:

Distance (ft) from East Portal	Crown Encroachment (radial inches)	
	Left Side	Right Side
0	14	15
100	14	14
201	14	13
300	12	12
401	12	11
501	12	10
601	13	10
701	13	11
801	13	13
850	13	15
