*Heartland Corridor, Walton Virginia to  
Columbus Ohio*

# Preliminary Engineering Phase Report

Laurel  
Tunnel  
MP  
N414.09  
Rogers, WV

October 14, 2005, Rev. 2

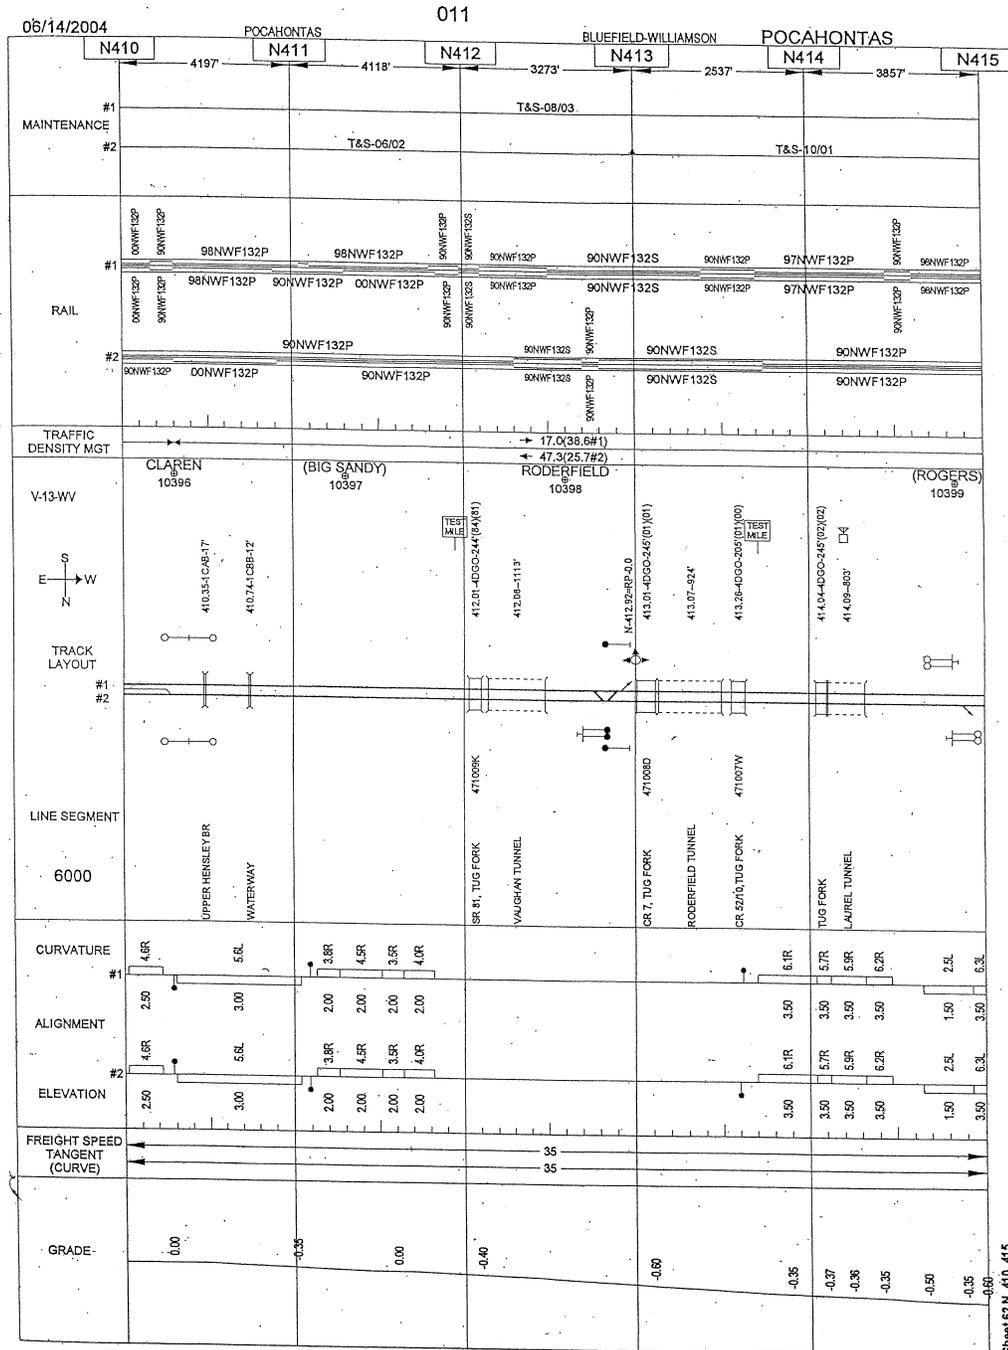
Sheet 62 N\_410\_415

**Statistics: Pocahontas Division**  
**Double-width Tunnel for Main #1 and Main #2**  
**Length = 803'**  
**Concrete lined**  
**Degree of Curvature = 5.9 RT (per Track Chart)**  
**Superelevation = 3.5" (per Track Chart)**

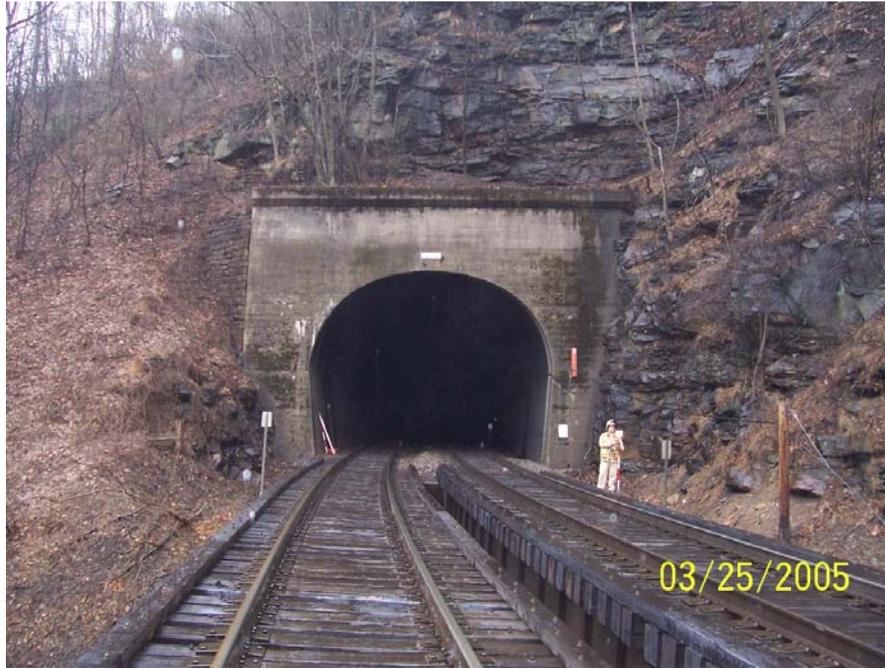
Photo No. 1 – East Portal

The tunnel is 803’ long with a concrete lining and a width of approximately 30’. It is a double-width tunnel for two tracks. The track circuit cable is mounted on the north wall of the tunnel lining. The tunnel lining is generally in good condition and dry, with only a few joints at the portals being wet.

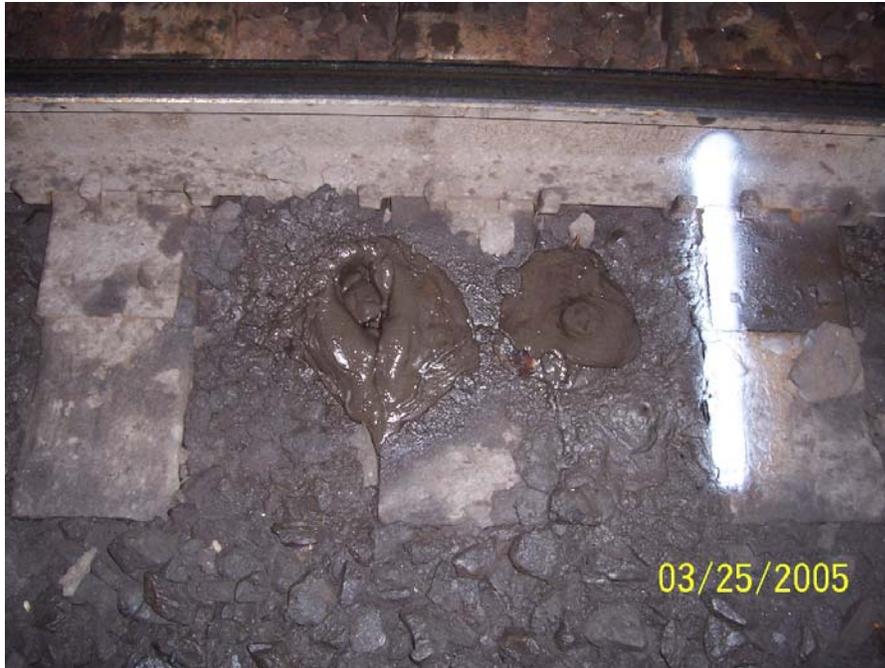
Photo No. 5. – Mud Pumping Through Ballast

The track is continuous welded rail of conventional design with wooden cross-ties at approximately 19" on center and a stone ballast section. The rail is typically 132RE on 18" tie plates and fastened with rail spikes and anchors at every tie. The track curves right 5.9 degrees with a superelevation of 3.5" on both tracks. There are drainage ditches along each wall and in between the tracks, and drainage appears to be a problem as standing water is present in the ditches, causing pumping on both tracks. The water in the tunnel was tested and its pH reading was 8.18. This is a fairly neutral reading and indicates that the water is not unusually corrosive. The ballast, which is approximately 2' below the top of tie, is in generally poor condition. The ballast from this tunnel was tested and classified as being "Very Strong", requiring many blows of a geological hammer to break intact rock specimens. Most of the foundation is exposed on the south side of the tunnel where the pumping exists.

The preliminary design uses replacement of the liner crown. The existing track structure is planned to be flooded with ballast to the top of the rail to provide access into the tunnel for the contractor to work and to protect the track during the construction. The preliminary design also proposes to install a new drainage system and undercut the track to replace the fouled ballast.

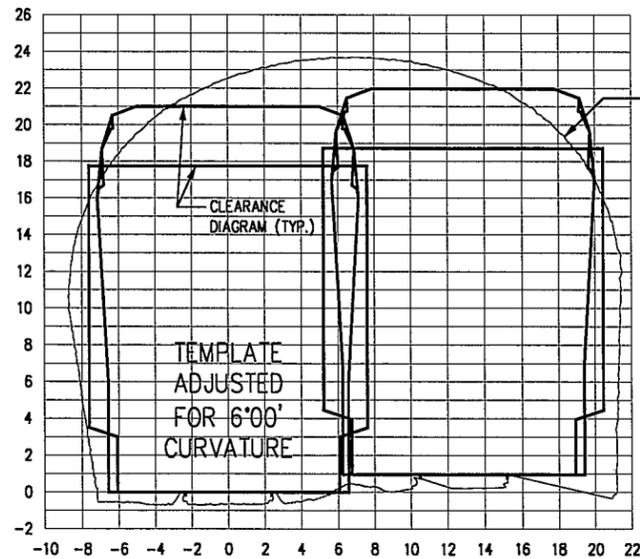
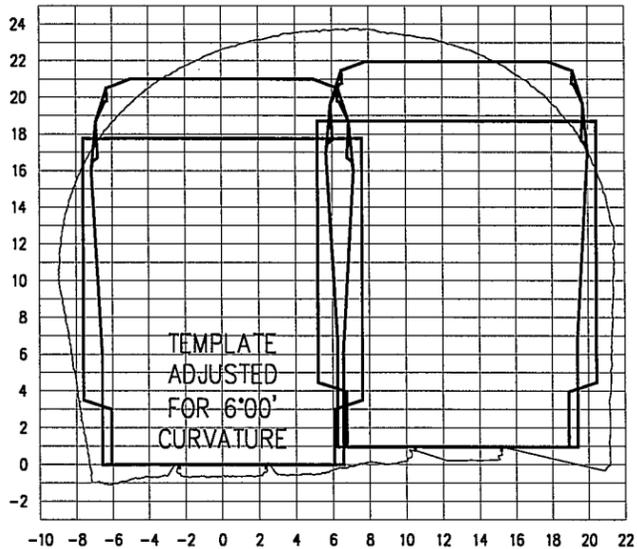
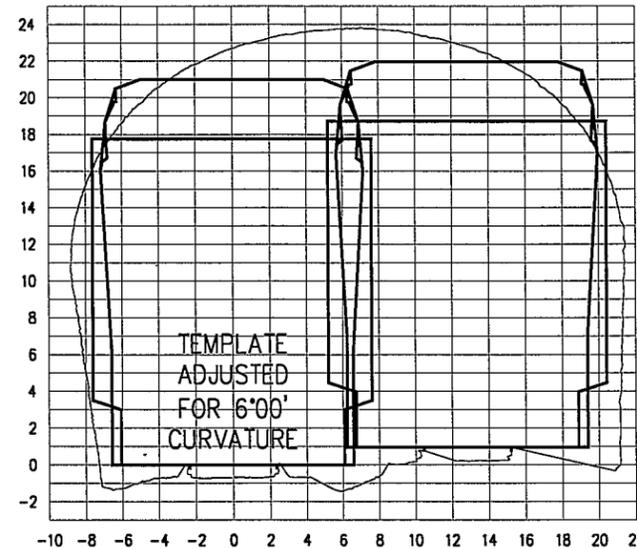
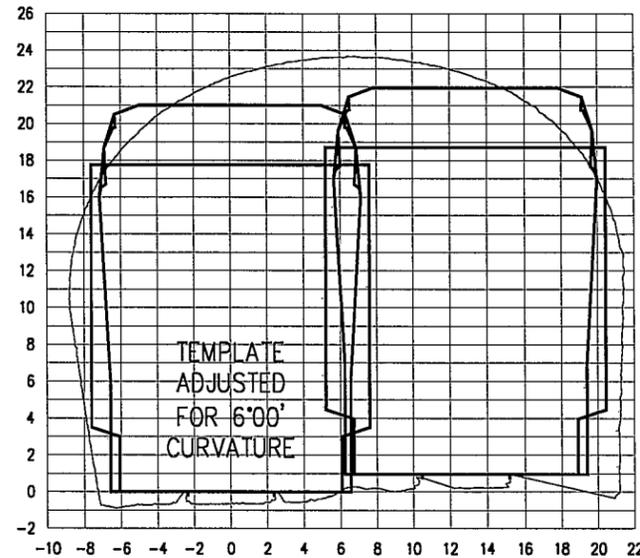
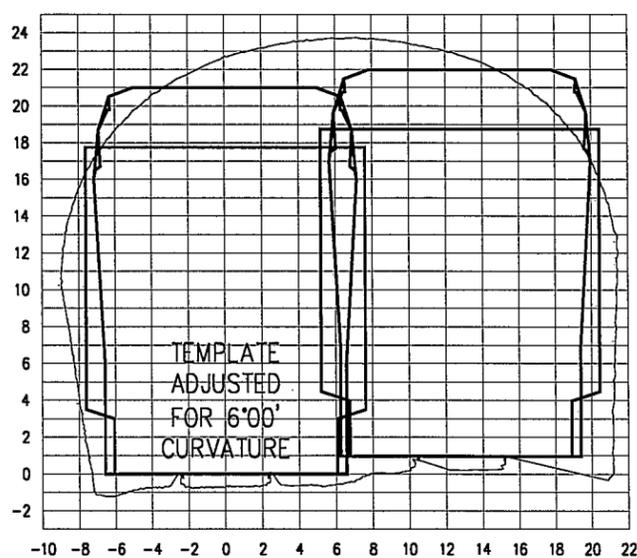
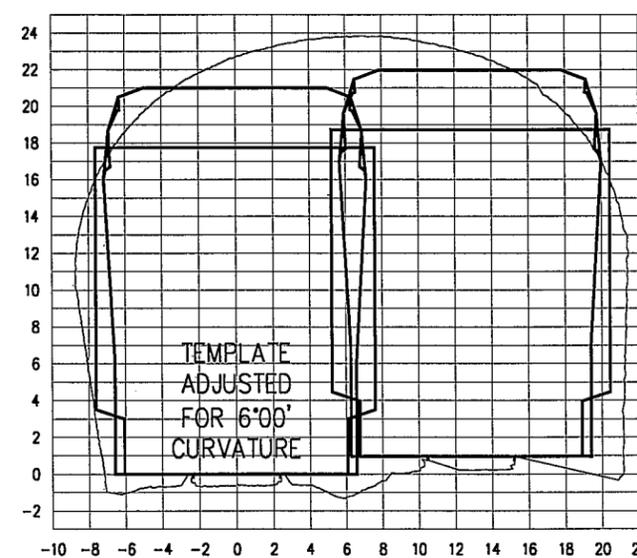
PI	D.J.L.	7/29/05	PRELIMINARY ENGINEERING PHASE REPORT
REV. BY	DATE	DESCRIPTION	
LOCATION	LAUREL TUNNEL, ROGERS, WV		
TITLE	TUNNEL CLEARANCE CROSS SECTIONS - 1 OF 3		
DWN	PID NO.	PRN	1629301 & 16294
DWN	FILE NO.	DRAWING NUMBER	N-414.09
CHK	DATE	APRIL 22, 2005

The laser car measurements indicate that the existing tunnel has adequate horizontal clearance for both the “High-Wide Load” and the “Double-Stack Load” portions of the composite clearance envelope throughout the tunnel. For vertical clearance, the “Double Stack” portion of the envelope encroaches on the sides of the tunnel crown by about 15” to 18” on the left wall and about 22” to 25” on the right wall. The “High-Wide” portion of the envelope encroaches on the sides of the tunnel crown (at points lower than the “Double Stack”) by an average of about 8” on the left wall (varies 6”-10”) and 16” on the right wall (varies 15”-17”). Cross sections of the tunnel clearance encroachments are shown in the drawings at the end of this report. The maximum vertical encroachments are summarized in the table below:

Distance (ft) from East Portal	Crown Encroachment (radial inches)	
	Left Side	Right Side
0	20	25
101	18	25
201	18	25
301	16	23
401	14	18
502	16	23
602	15	23
702	13	23
754	15	25

- NOTES:
- HORIZONTAL DATUM IS PARALLEL TO TRACK. WHERE TRACK IS SUPERELEVATED, DATUM IS NOT PARALLEL WITH GROUND.
  - CROSS SECTION GIVEN FOR STA. 0+00 IS A COMPOSITE FOR THE TUNNEL FROM STA. 0+00 THROUGH 0+50. ALL OF THE SECTIONS FOLLOW THIS CONVENTION.

Given the magnitude of the vertical encroachment, liner replacement of the tunnel crown is necessary to achieve the required clearance in the tunnel. Investigations in the final design phase may determine that notching is feasible for some of the tunnel. Drainage improvements are also recommended.

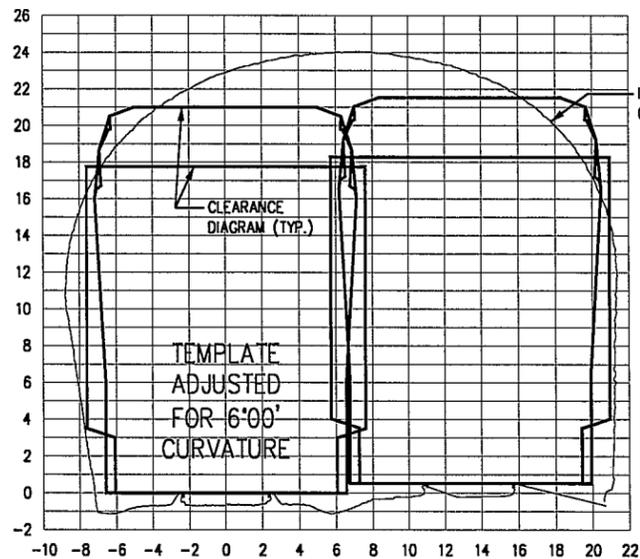
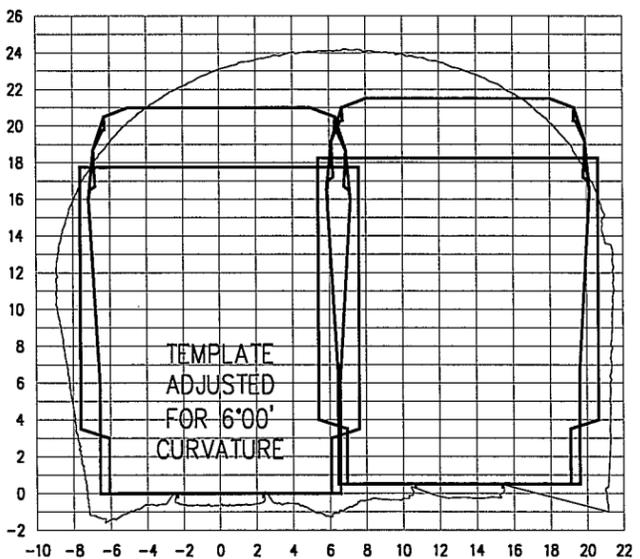
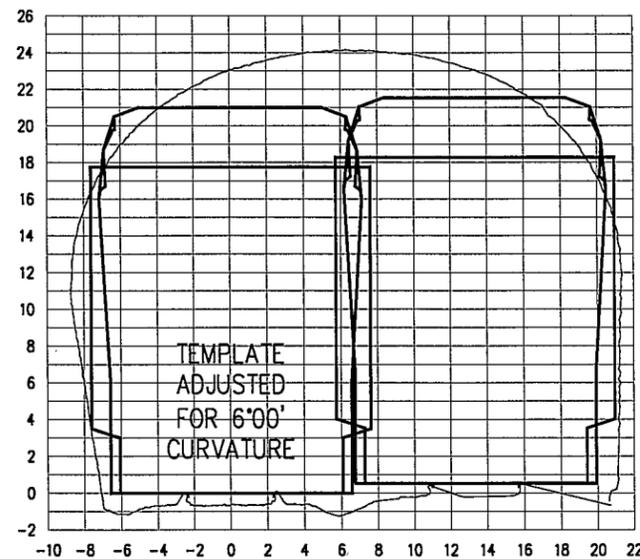
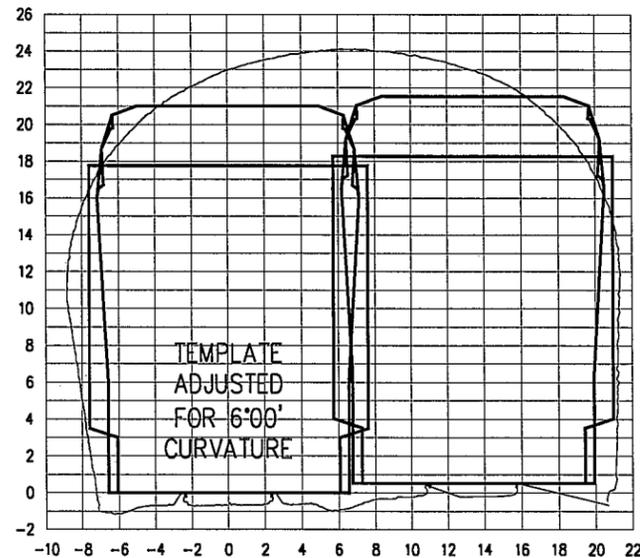
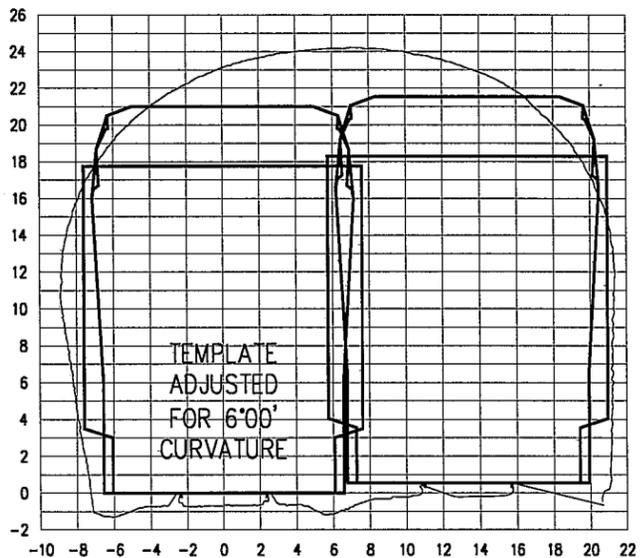
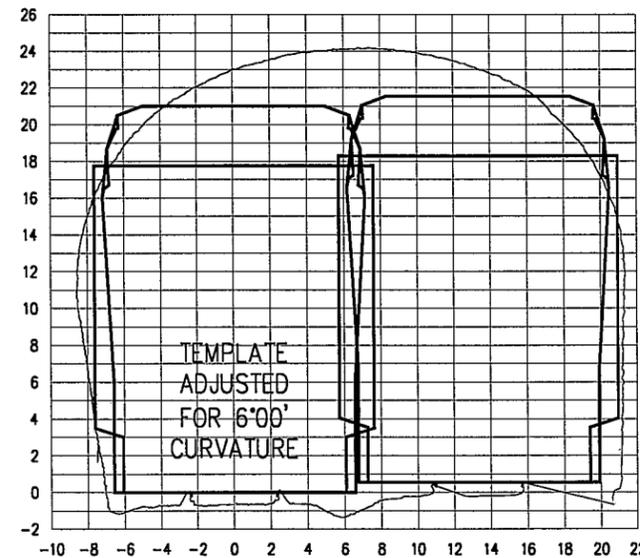
PI	D.J.L.	7/29/05	PRELIMINARY ENGINEERING PHASE REPORT
REV	BY	DATE	DESCRIPTION
LOCATION	LAUREL TUNNEL, ROGERS, WV		
TITLE	TUNNEL CLEARANCE CROSS SECTIONS - 2 OF 3		
DWN	P.D. NO.	FRN	1628301 & 16284
DWN	P FILE NO.	DRAWING NUMBER	
CHK	DATE	APRIL 22, 2005

- NOTES:
1. HORIZONTAL DATUM IS PARALLEL TO TRACK. WHERE TRACK IS SUPERELEVATED, DATUM IS NOT PARALLEL WITH GROUND.
  2. CROSS SECTION GIVEN FOR STA. 0+00 IS A COMPOSITE FOR THE TUNNEL FROM STA. 0+00 THROUGH 0+50. ALL OF THE SECTIONS FOLLOW THIS CONVENTION.

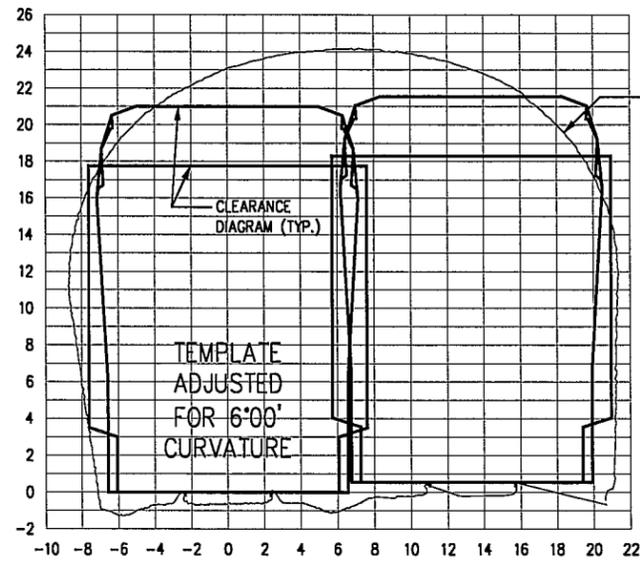
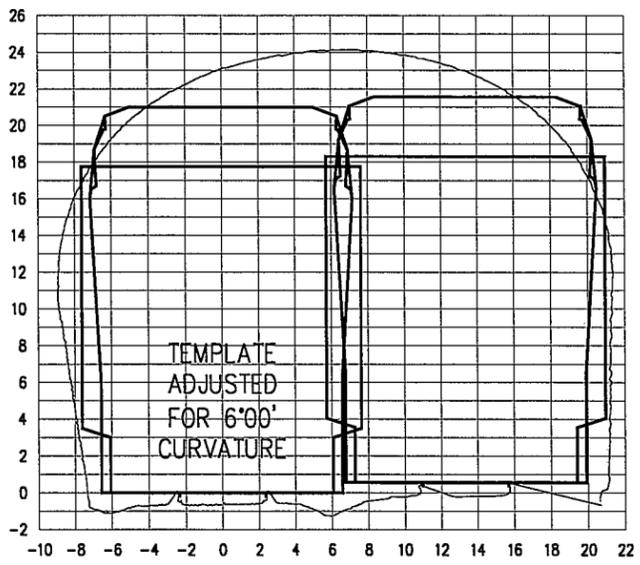
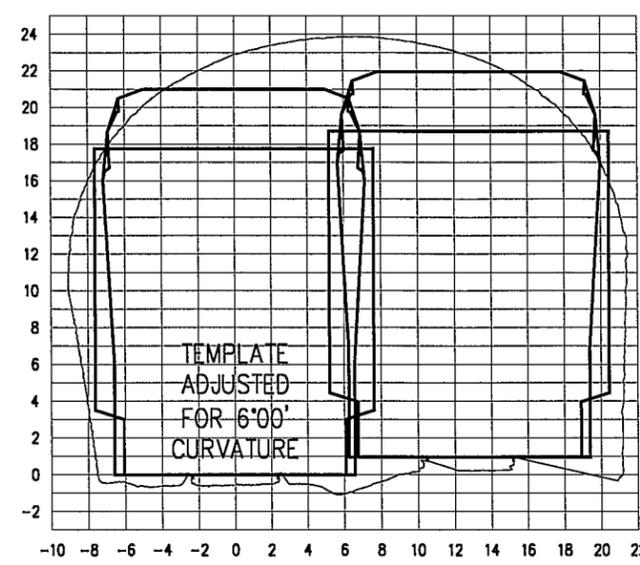
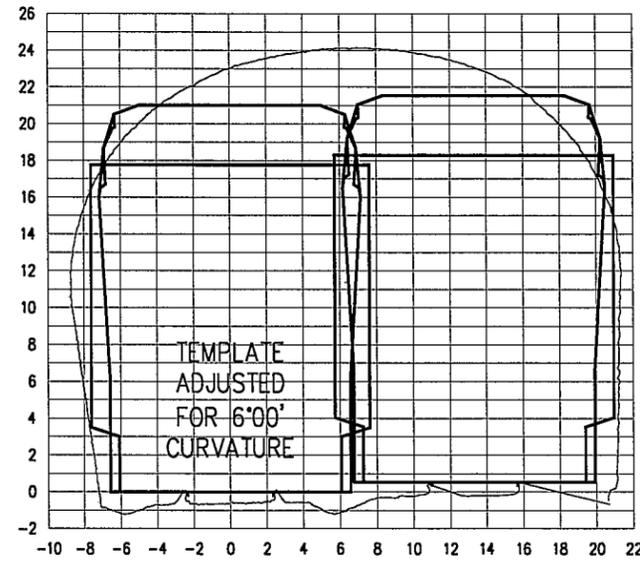
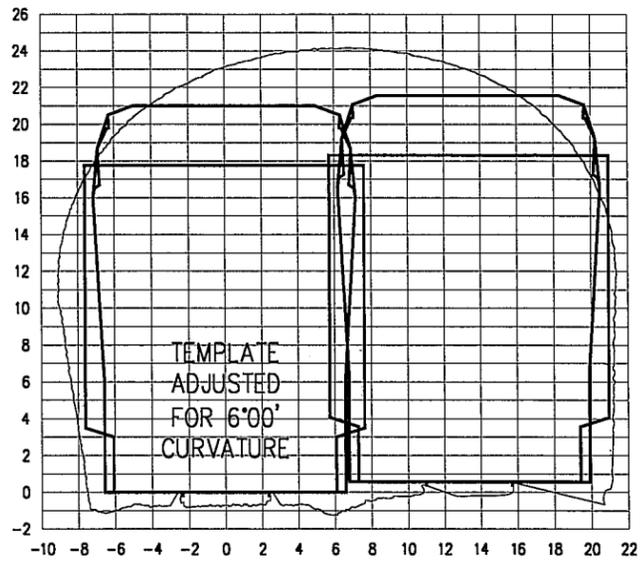
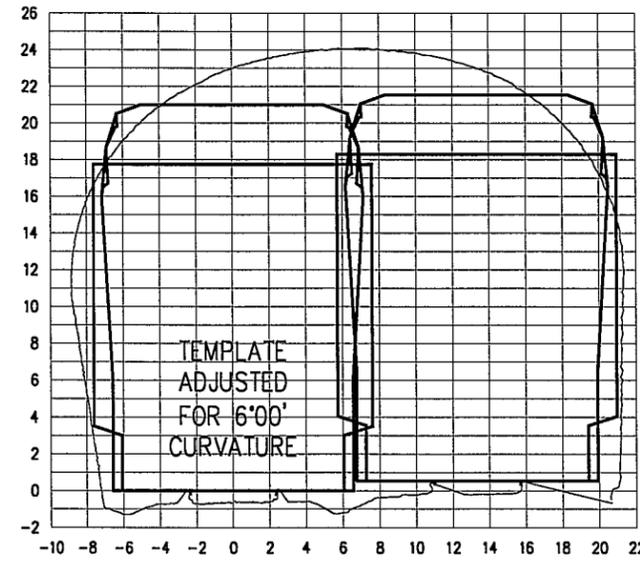
FILE NO.	1629301 & 16294	TITLE POST	N-414.09
DATE	APRIL 22, 2005	DRAWING NUMBER	
LOCATION: LAUREL TUNNEL, ROGERS, WV TITLE: TUNNEL CLEARANCE CROSS SECTIONS - 3 OF 3

- NOTES:
- HORIZONTAL DATUM IS PARALLEL TO TRACK, WHERE TRACK IS SUPERELEVATED, DATUM IS NOT PARALLEL WITH GROUND.
  - CROSS SECTION GIVEN FOR STA. 0+00 IS A COMPOSITE FOR THE TUNNEL FROM STA. 0+00 THROUGH 0+50. ALL OF THE SECTIONS FOLLOW THIS CONVENTION.

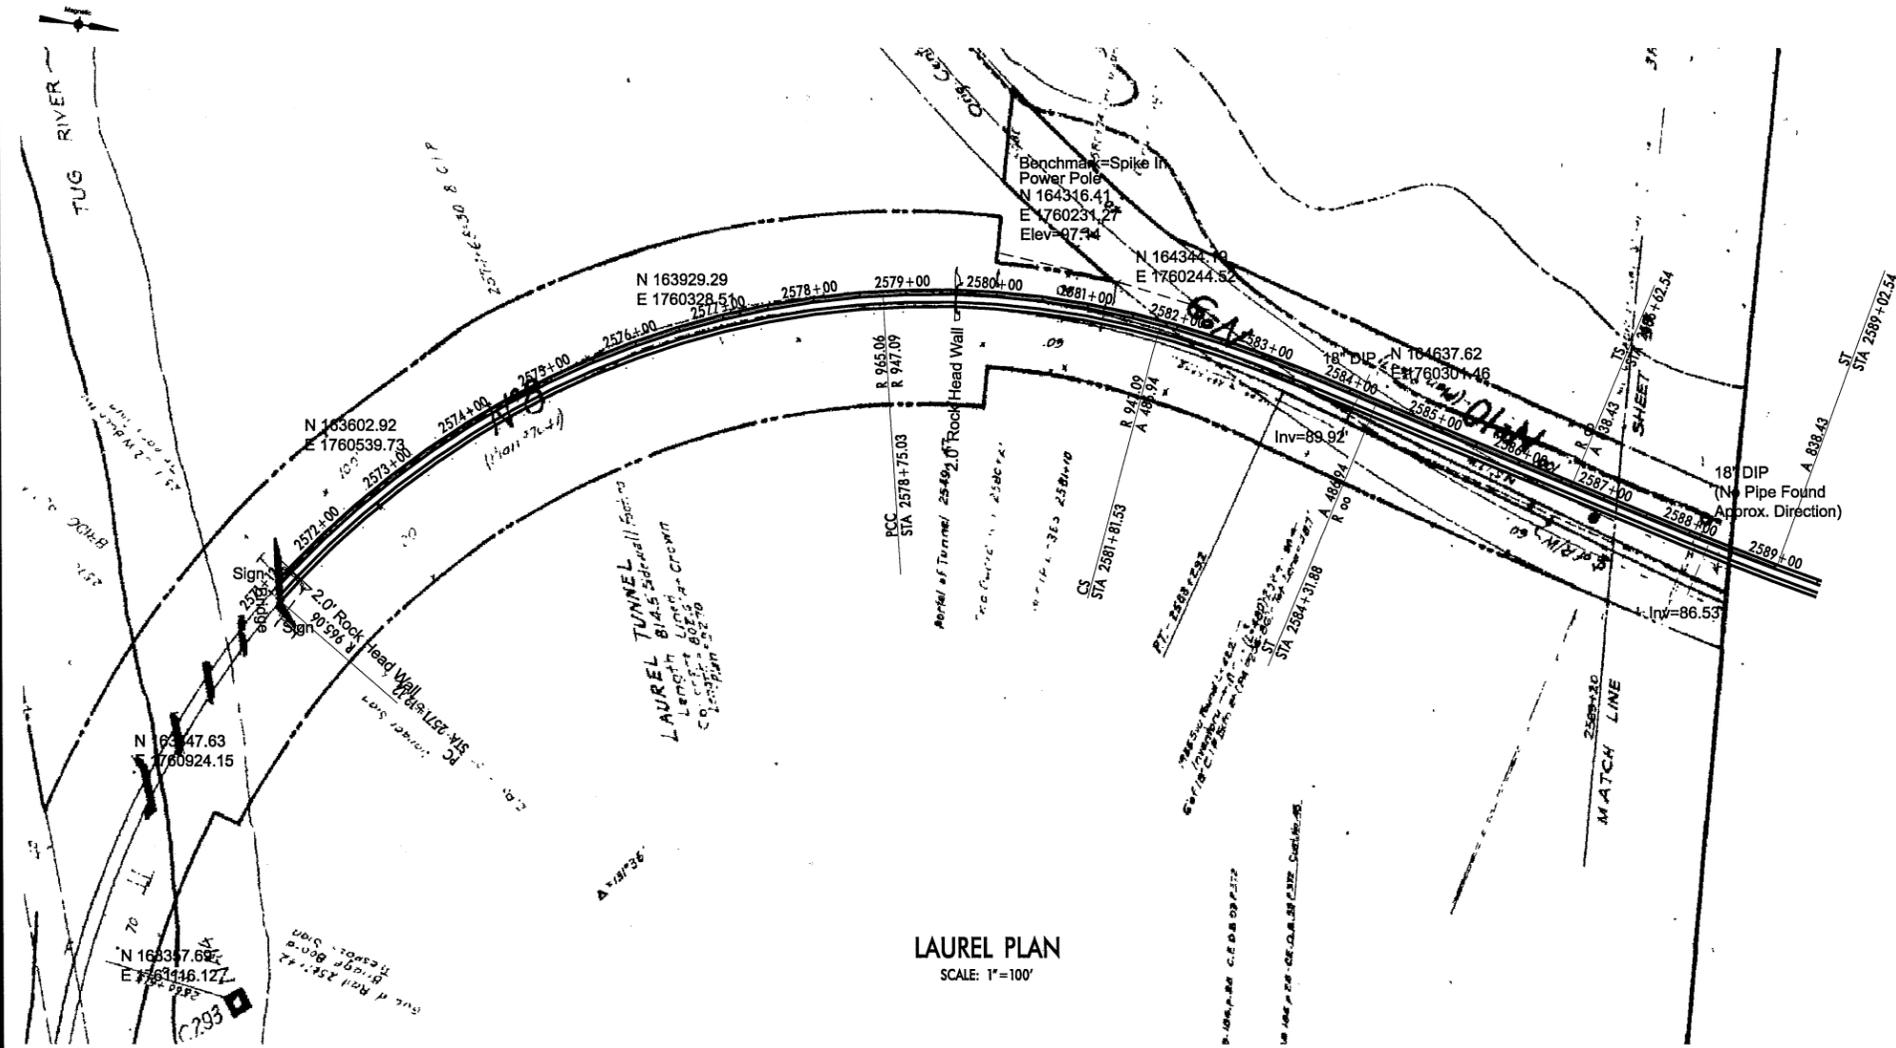
LAUREL PLAN  
SCALE: 1"=100'

STATION	NORTHING	EASTING	
Element: Circular			
PC (11)	2571+12.12	163466.87	1760706.96
PI (12)	2575+14.97	163684.50	1760367.96
CC (13)	2578+75.03	164078.56	1760284.30
Radius:	965.06		
Delta:	45°18'52"	Right	
Degree of Curvature (Chord):	5°56'23"		
Length:	763.25		
Length (Chord):	762.91		
Tangent:	402.85		
Chord:	743.51		
Middle Ordinate:	74.48		
External:	80.71		
Tangent Direction:	302°41'59"		
Radial Direction:	32°41'59"		
Chord Direction:	325°21'55"		
Radial Direction:	78°00'51"		
Tangent Direction:	348°00'51"		
Element: Circular			
PCC (13)	2578+75.03	164078.56	1760284.30
PI (14)	2580+29.70	164229.87	1760252.18
CC (14)	2581+81.53	164275.25	1761210.74
CS (20)	2581+81.53	164383.53	1760269.86
Radius:	947.09		
Delta:	18°33'03"	Right	
Degree of Curvature (Chord):	6°03'09"		
Length:	306.64		
Length (Chord):	306.50		
Tangent:	154.68		
Chord:	305.31		
Middle Ordinate:	12.38		
External:	12.55		
Tangent Direction:	348°00'51"
