*Heartland Corridor, Walton Virginia to
Columbus Ohio*

Preliminary Engineering Phase Report

**TWIN BRANCH NO. 1
TUNNEL –
MP N407.71
MOHEGAN, WV**

October 14, 2005, Rev. 2

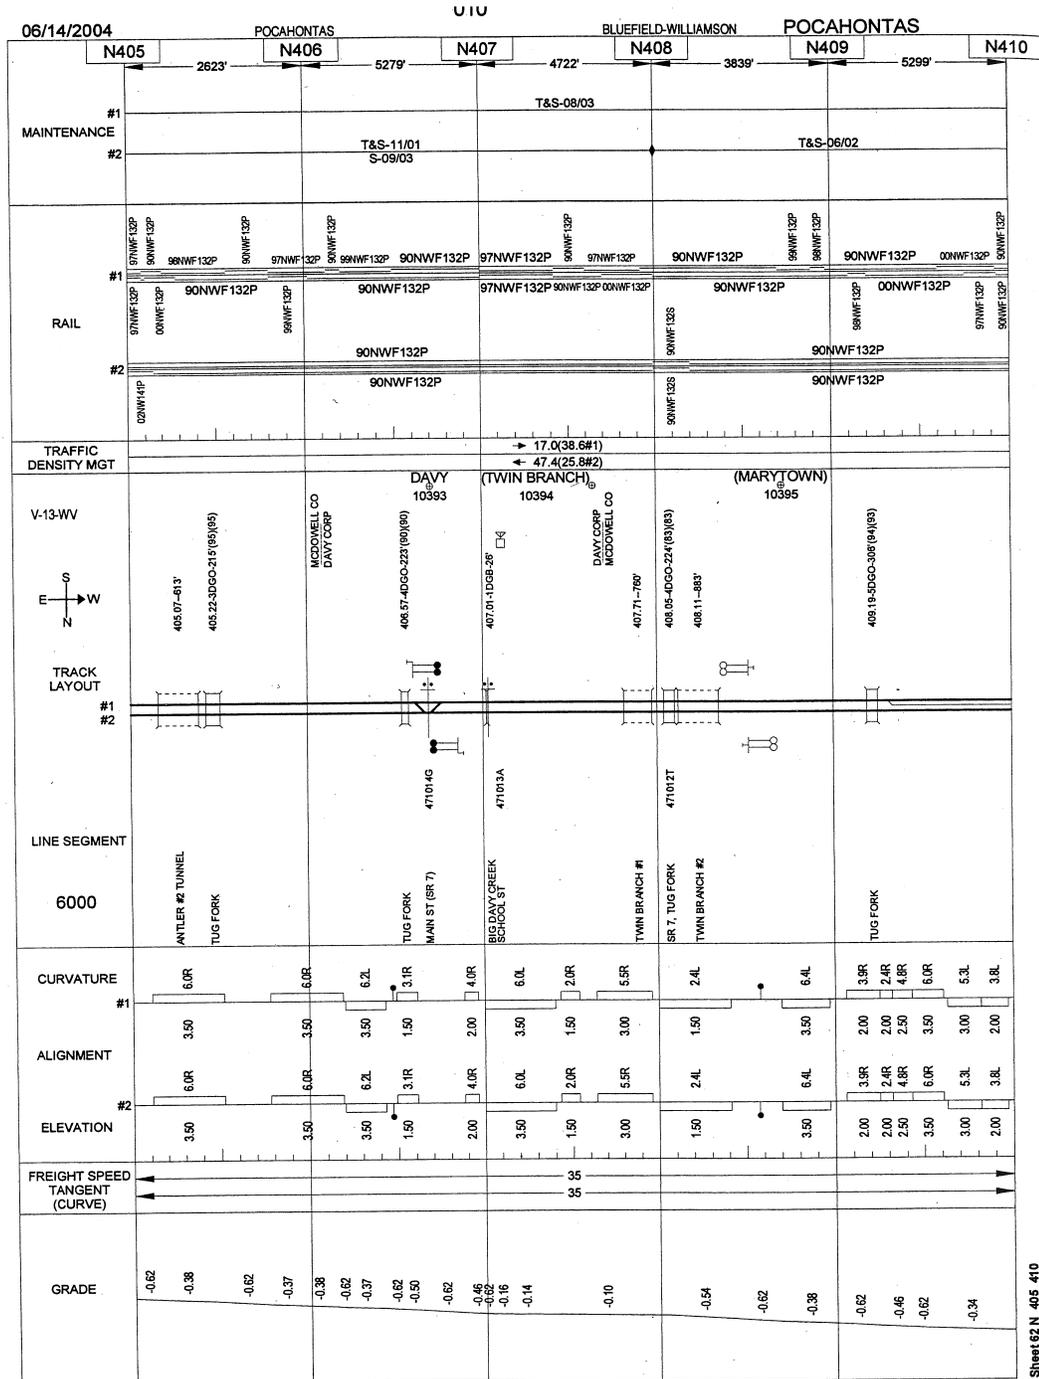
Sheet 62_N_405_410

The track is continuous welded rail of conventional design with wooden cross-ties at approximately 19" on center and a stone ballast section. The rail is typically 132RE on 18" tie plates and fastened with rail spikes and anchors at every tie. The track curves right 5.5 degrees with a superelevation of 3.0" on both tracks. The ballast is approximately 2' below top of tie and is fouled, and the majority of the top of the foundation along the north side of the tunnel is exposed. There are drainage ditches along each wall and in between the tracks, and drainage appears to be a problem as standing water is present in the north ditch, causing pumping on the low rail of Main #2. The water in the tunnel was tested and its pH reading was 7.74. This is a fairly neutral reading and indicates that the water is not unusually corrosive. The ballast from this tunnel was tested and classified as being "Very Strong", requiring many blows of a geological hammer to break intact rock specimens.

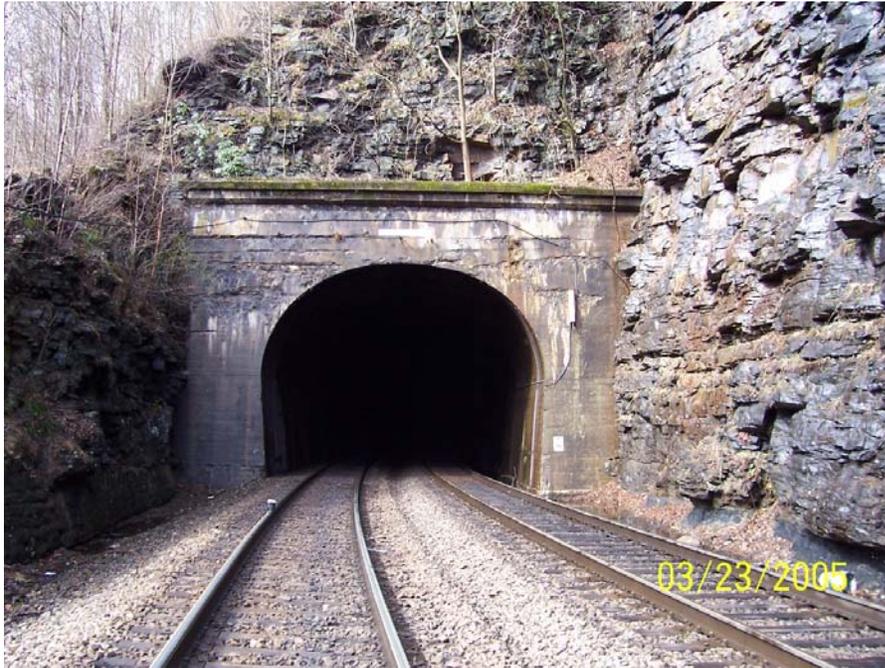
Photo No. 1 – East Portal

The tunnel is 760' long with a concrete lining and a width of approximately 30'. It is a double-width tunnel for two tracks. The track circuit is buried south of Main #1 east of the east portal and mounted on the north wall of the tunnel. The tunnel lining is in fair condition, with approximately fifty percent of the construction joints open and wet. The concrete face is spalling at the portals. Many of the liner cores identified potentially poorly consolidated concrete.

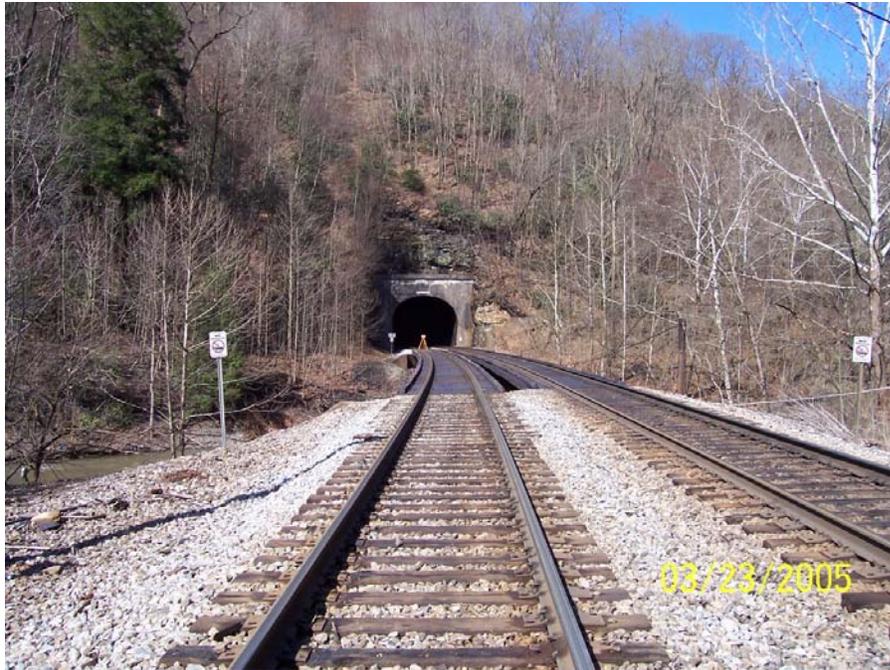
Photo No. 3. – West Portal

Beds of thin-bedded sandstone and shale up to five feet thick were infrequently noted within the sandstone. At the west portal of Twin Branch No. 1, the thin bedded sandstone and shale were undercut and were observed to slowly spall over time. A two-foot thick coal bed was noted at the base of the rock cut at the east portal of the Twin Branch No. 1 Tunnel and may also have been observed in the bottom of probes at the west portal. Joints in the rock cuts are typically steeply dipping and widely spaced. Most joints are less than 15 feet in length and are not through-going across the exposure face.

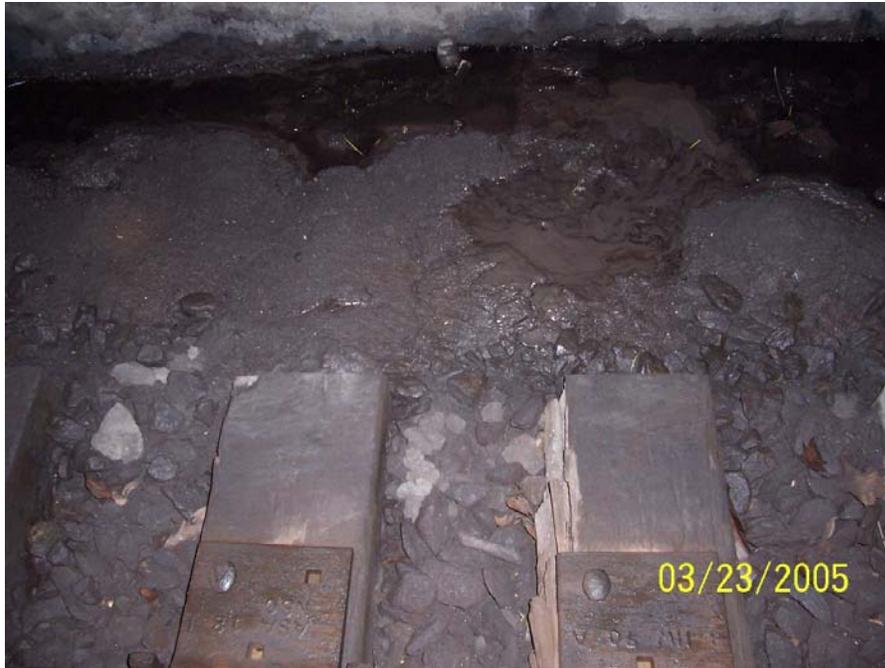
Photo No. 5. – Mud Pumping Through Ballast

The preliminary design uses replacement of the liner crown. The existing track structure is planned to be flooded with ballast to the top of the rail to provide access into the tunnel for the contractor to work and to protect the track during the construction. The preliminary design also proposes to install a new drainage system and undercut the track to replace the fouled ballast.

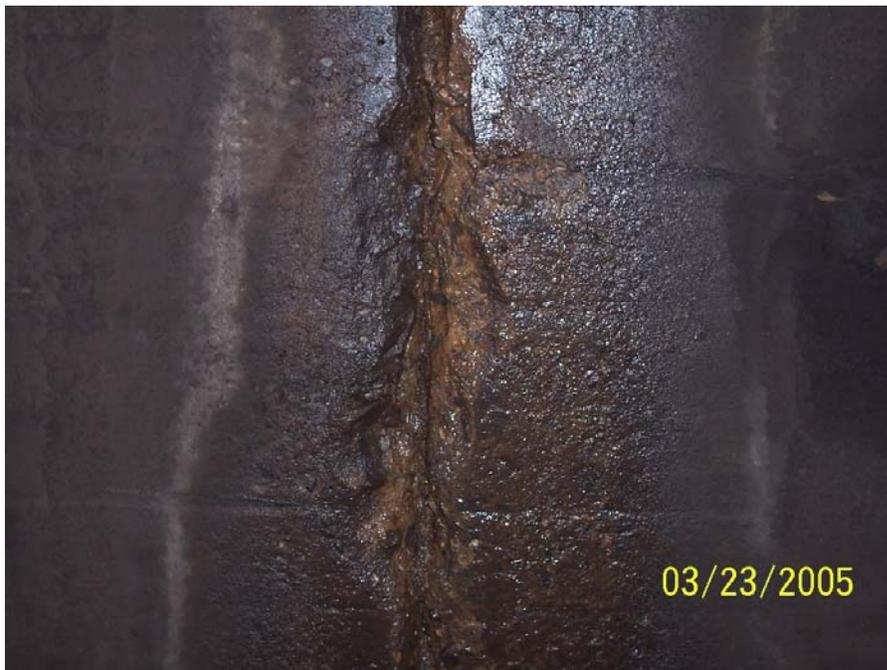
Photo No. 6. – Spalling and Water Leaking at Vertical Construction Joint

Given the magnitude of the vertical encroachment, liner replacement of the tunnel crown is necessary to achieve the required clearance in the tunnel. Additional investigations in the final design phase may determine that notching is possible for some of the tunnel. Drainage improvements are also recommended.

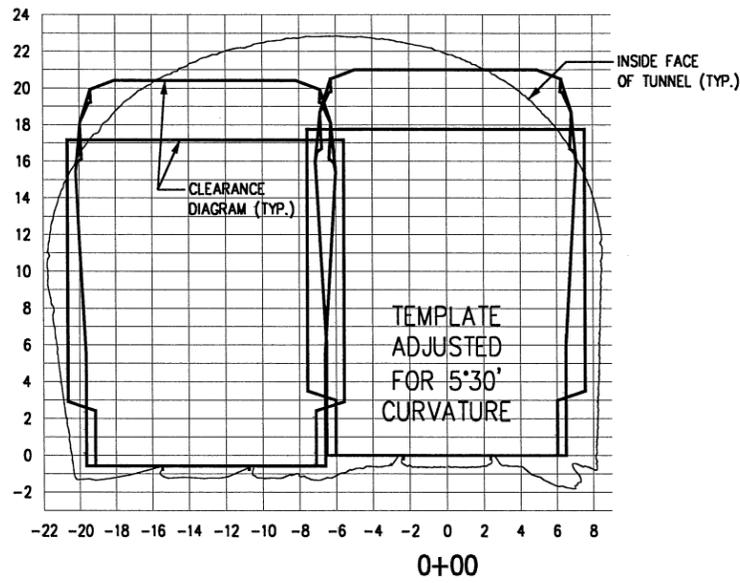
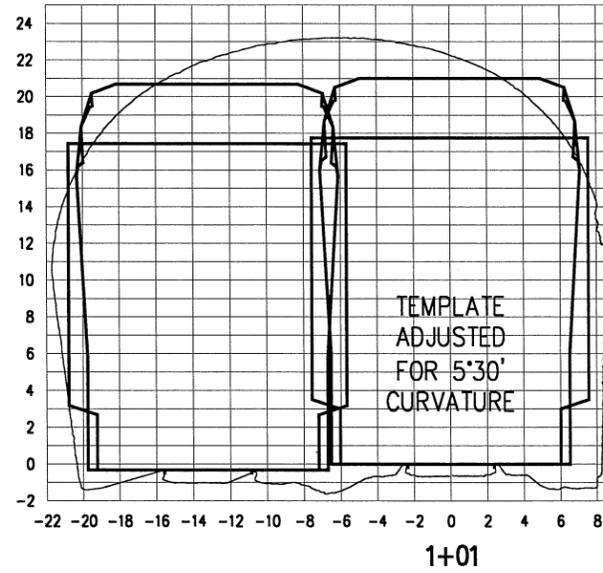
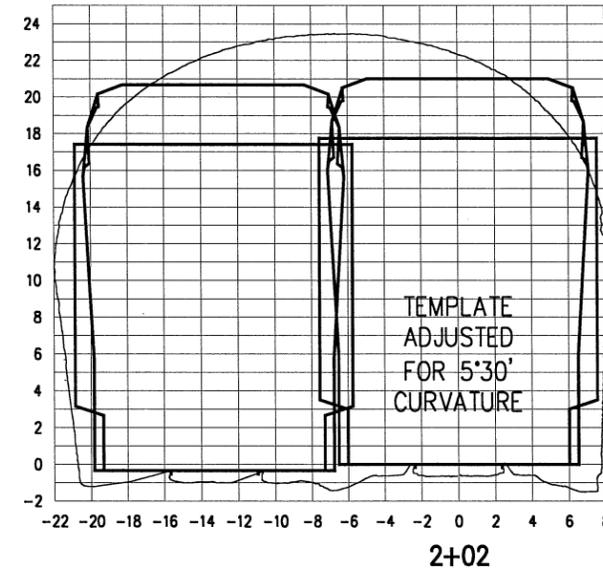
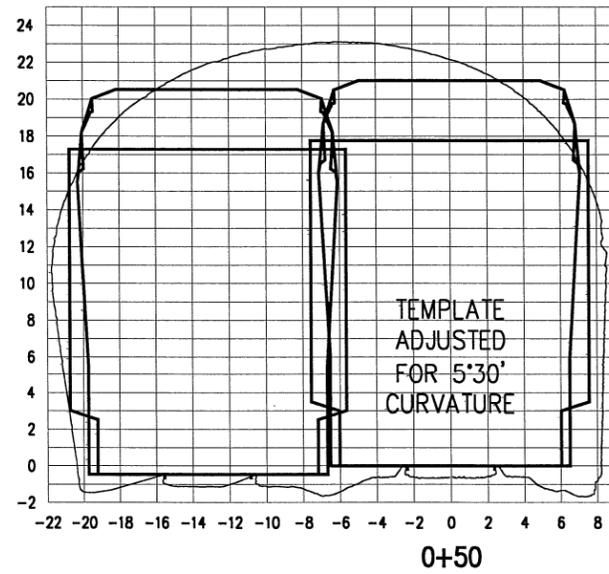
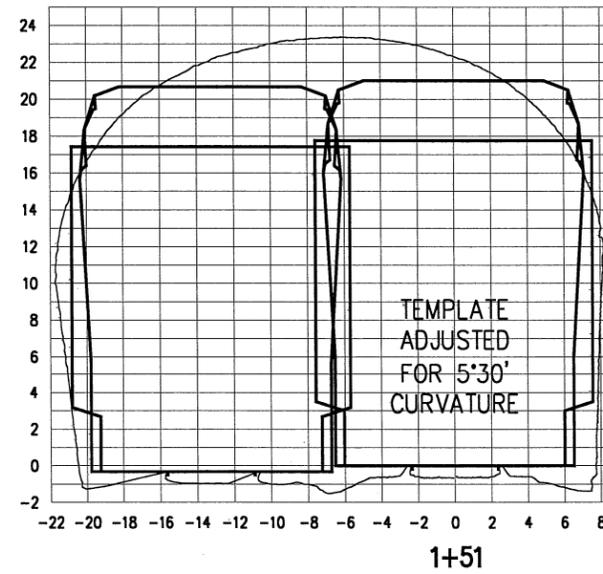
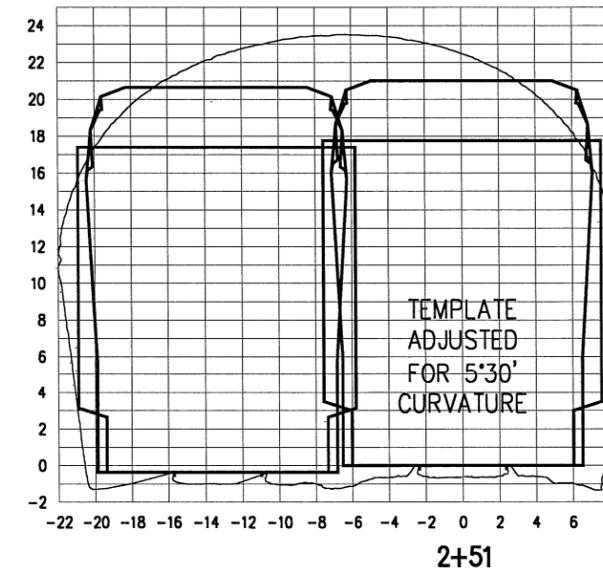
PI	D.J.L.	7/29/05	PRELIMINARY ENGINEERING PHASE REPORT
REV	BY	DATE	DESCRIPTION
LOCATION			
TWIN BRANCH NO. 1, TWIN BRANCH, WV			
TITLE			
TUNNEL CLEARANCE			
CROSS SECTIONS - 1 OF 3			
DEN	P.T.D. No.	BY	16289 TITLE POST N-407.71
DWN	FILE No.	DRAWING NUMBER	
CHK	DATE	APRIL 15, 2005

The laser car measurements indicate that the existing tunnel has adequate horizontal clearance for both the “High-Wide Load” and the “Double-Stack Load” portions of the composite clearance envelope throughout the entire tunnel. For vertical clearance, the “Double Stack” portion of the envelope encroaches on the sides of the tunnel crown by an average of about 18” on the left wall and 21” on the right, and varies up to a maximum of 25”. The “High-Wide” portion of the envelope encroaches on the sides of the tunnel crown (at points lower than the “Double Stack” envelope) by an average of about 9” on the left wall and 13” on the right, and varies up to a maximum of 16”. Cross sections of the tunnel clearance encroachments are shown in the drawings at the end of this report. The maximum vertical encroachments are summarized in the table below:

Distance (ft) from East Portal	Crown Encroachment (radial inches)	
	Left Side	Right Side
0	22	24
101	22	21
202	17	23
301	19	23
401	18	20
502	18	19
601	14	22

Distance (ft) from East Portal	Crown Encroachment (radial inches)	
	Left Side	Right Side
701	13	24
758	16	19
