*Heartland Corridor, Walton Virginia to
Columbus Ohio*

Preliminary Engineering Phase Report

Vaughan
Tunnel -
MP N412.08
Roderfield, WV

October 14, 2005, Rev. 2

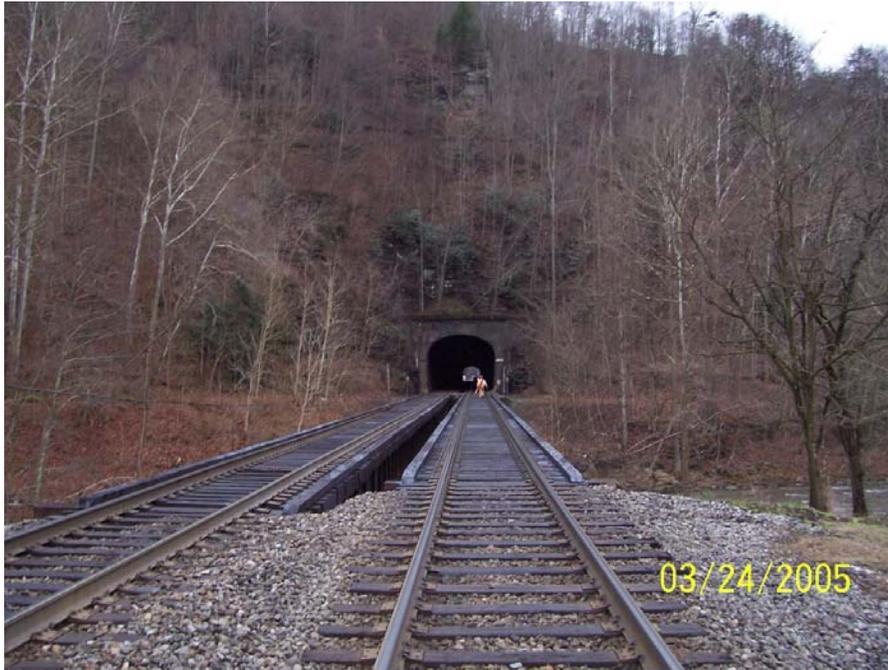
Photo1. East Portal

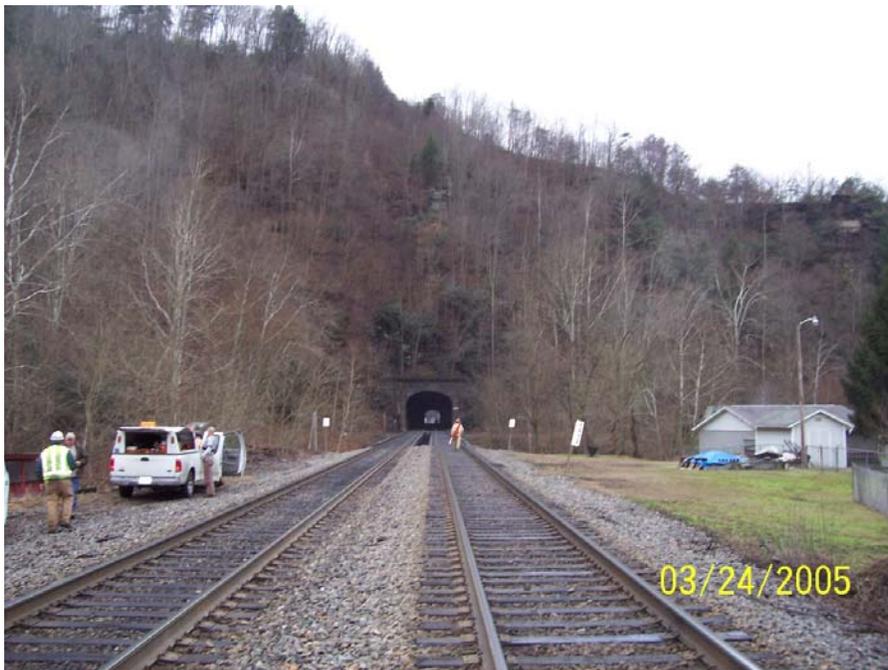
Photo 2. View Outside of East Portal

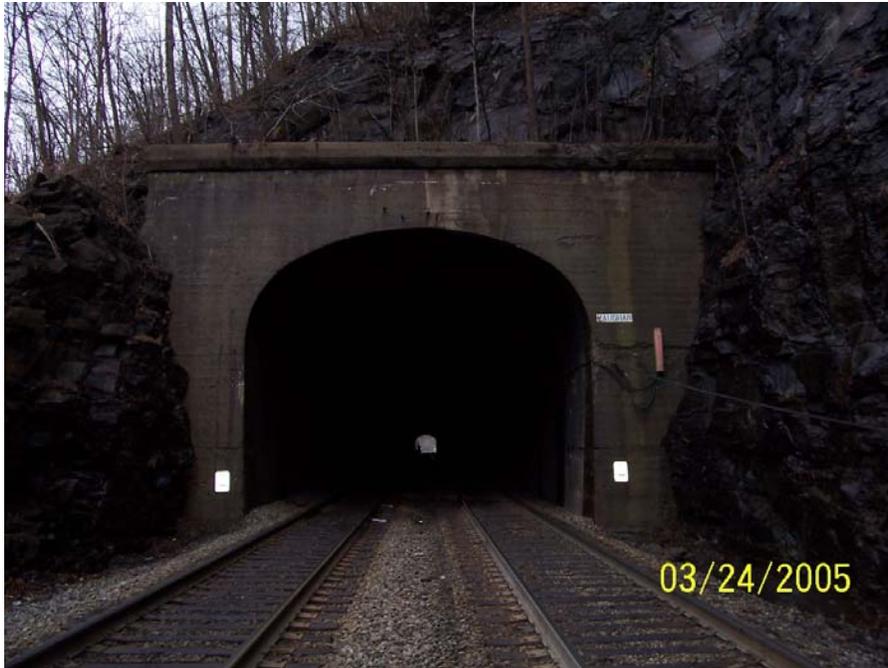
Photo 3. West Portal

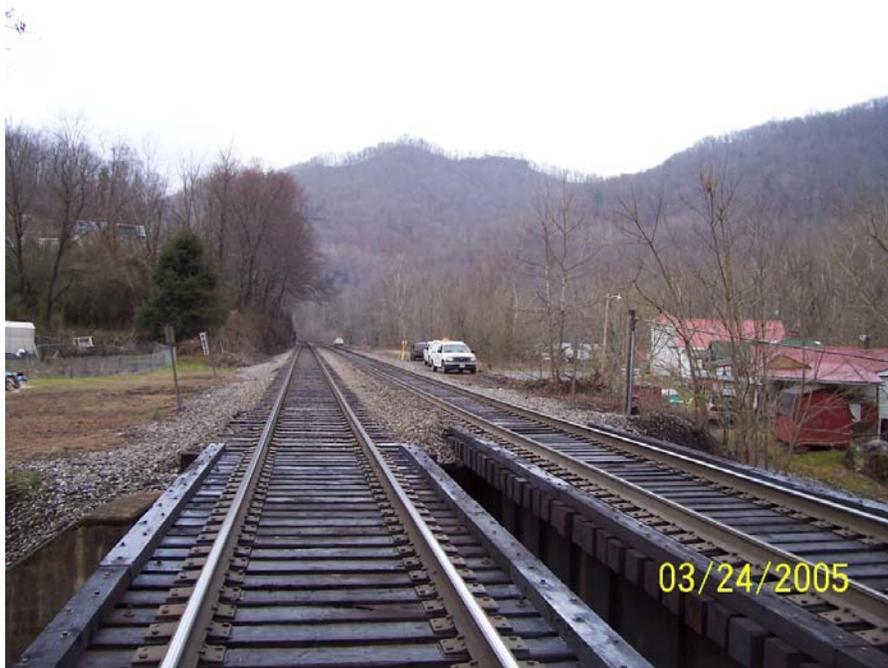
Photo 4. View from West Portal

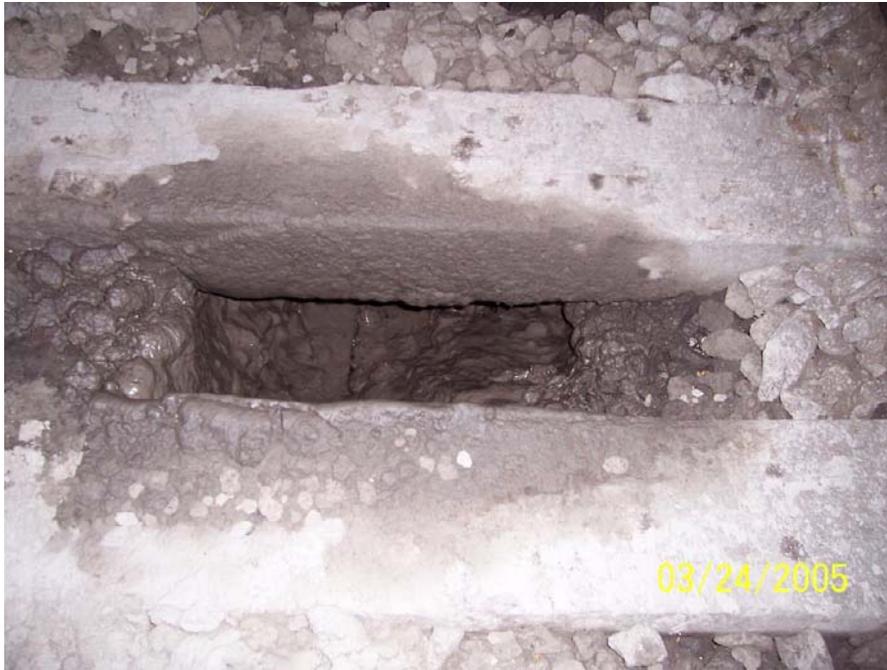
The track is of conventional design with wooden crossties and a stone ballast section. The rail is continuously welded 132 RE with a 19" tie spacing and 18" tie plates fastened with rail spikes and anchors at every tie. The ballast is approximately 2' from the top of the ties and in generally fair condition, with fouling noted in some areas. There is a sinkhole, under the tracks, located approximately 327' from the east portal on Main #2. The track is tangent for the entire length of the tunnel. The ballast from this tunnel was not tested, however ballast in the nearby Twin Branch No. 1 Tunnel was tested and classified as being "Very Strong", requiring many blows of a geological hammer to break intact rock specimens.

Photo5. Mud in Ballast

The preliminary design uses replacement of the liner crown. Additional investigation in the final design phase may determine that notching is feasible for some length of the tunnel. The existing track structure is planned to be flooded with ballast to the top of the rail to provide access into the tunnel for the contractor to work and to protect the track during the construction. The preliminary design also proposes to install a new drainage system and undercut the track to replace the fouled ballast.

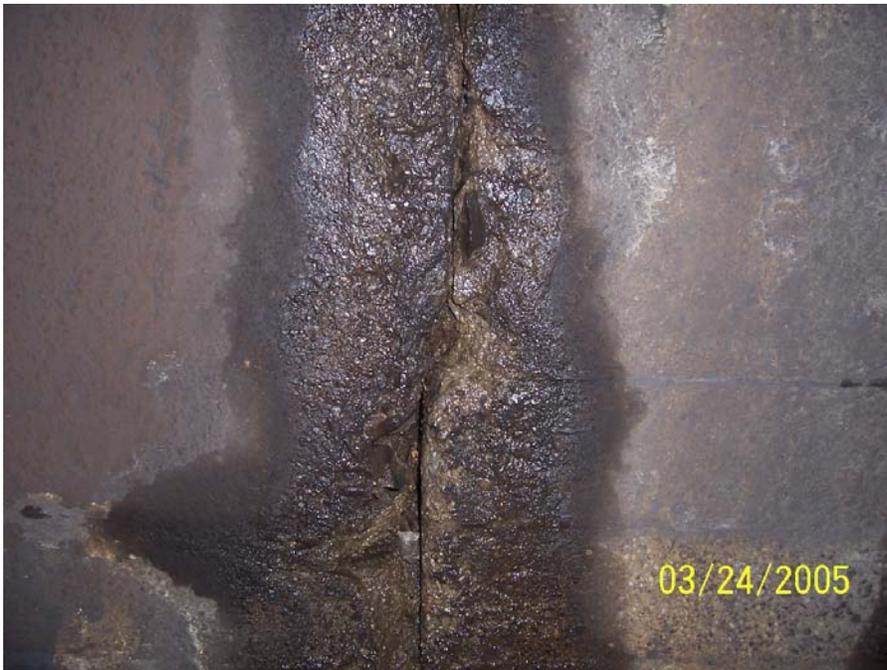
The tunnel is 1,113' long with a concrete liner and a nominal width of 28'. It is a double width tunnel for two tracks. The tunnel is in generally good condition; joints at the portals are mostly dry. The third joint from the west portal has running water from the crown of the tunnel. Some minor spalls and cracks were also observed. A track circuit cable is mounted on the south wall.

Photo 6. Slight Spalling with Water Leaking at Vertical Construction Joint

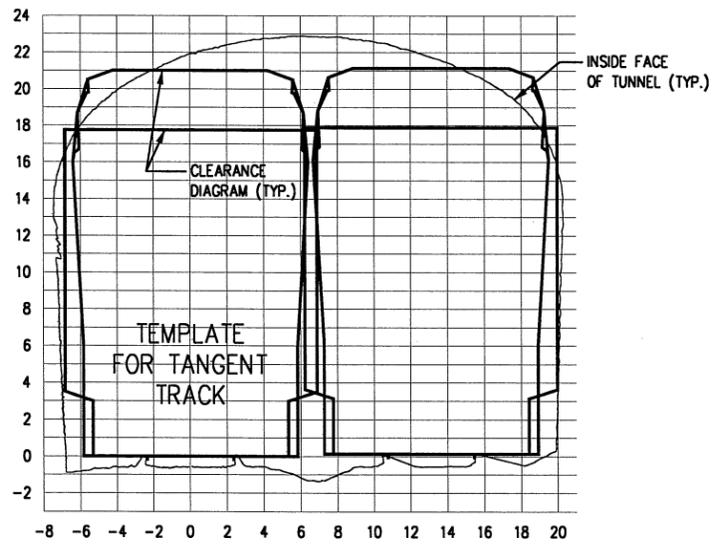
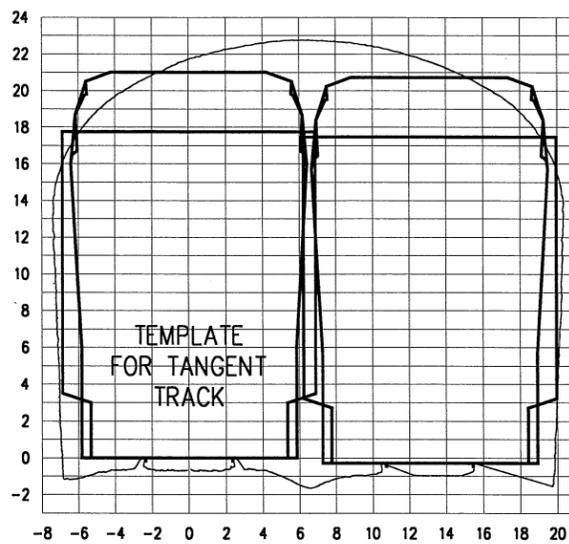
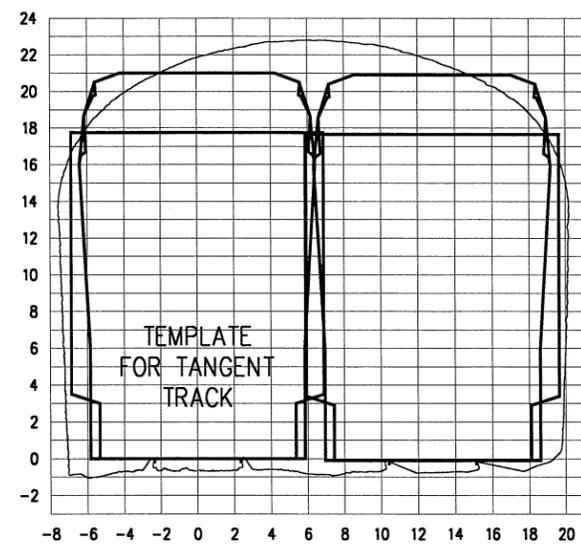
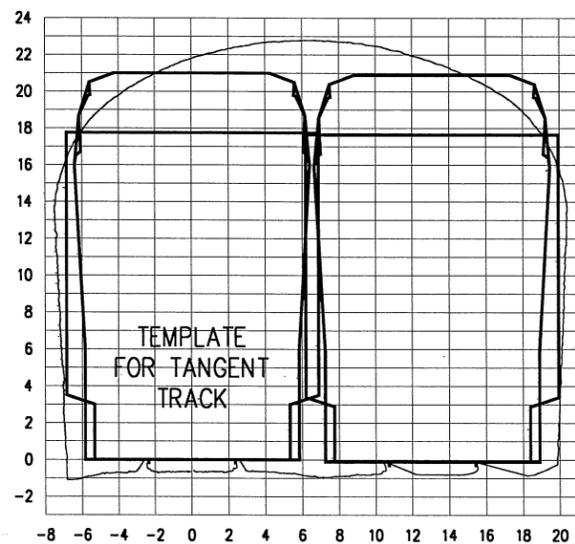
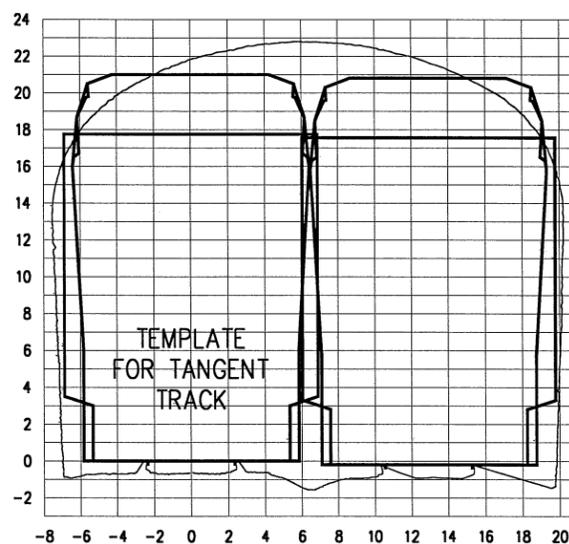
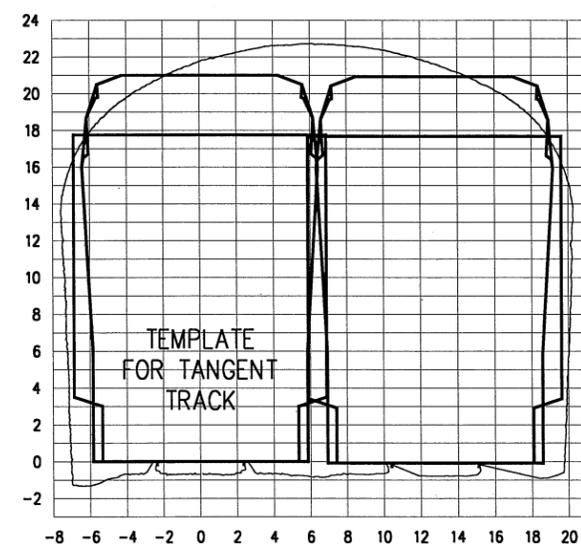
PI	DJL	7/29/05	PRELIMINARY ENGINEERING PHASE REPORT
REV	BY	DATE	DESCRIPTION
1			
LOCATION VAUGHAN TUNNEL, RODERFIELD, WV			
TITLE TUNNEL CLEARANCE CROSS SECTIONS - 1 OF 3			
DCW	FILE NO.	16293	TITLE POST N-412.08
DNW	FILE NO.		DRAWING NUMBER
CRK	DATE	APRIL 22, 2005

The laser car measurements indicate that the existing tunnel has adequate horizontal clearance for both the “High-Wide Load” and the “Double-Stack Load” portions of the composite clearance envelope throughout the tunnel. For vertical clearance, the “Double Stack” portion of the envelope encroaches on both sides of the tunnel crown for the entire length of the tunnel. The encroachment is similar on both sides, averaging about 16” and varying between 13” to 19”. The “High-Wide” portion of the envelope encroaches by similar amounts on both sides of the tunnel crown (at points lower than the “Double Stack” portion) by an average of about 6” and varies between 4” to 10”. Cross sections of the tunnel clearance encroachments are shown in the drawings at the end of this report. The maximum vertical encroachments are summarized in the table below:

Distance (ft) from East Portal	Crown Encroachment (radial inches)	
	Left Side	Right Side
0	18	19
103	19	18
203	18	17
303	17	17
403	18	17
501	17	16
604	15	15
702	16	14
801	16	16
903	17	16
1004	17	16
1102	13	17

Given the magnitude of the vertical encroachment, liner replacement of the tunnel crown is necessary to achieve the required clearance in the tunnel. Drainage improvements are also recommended.

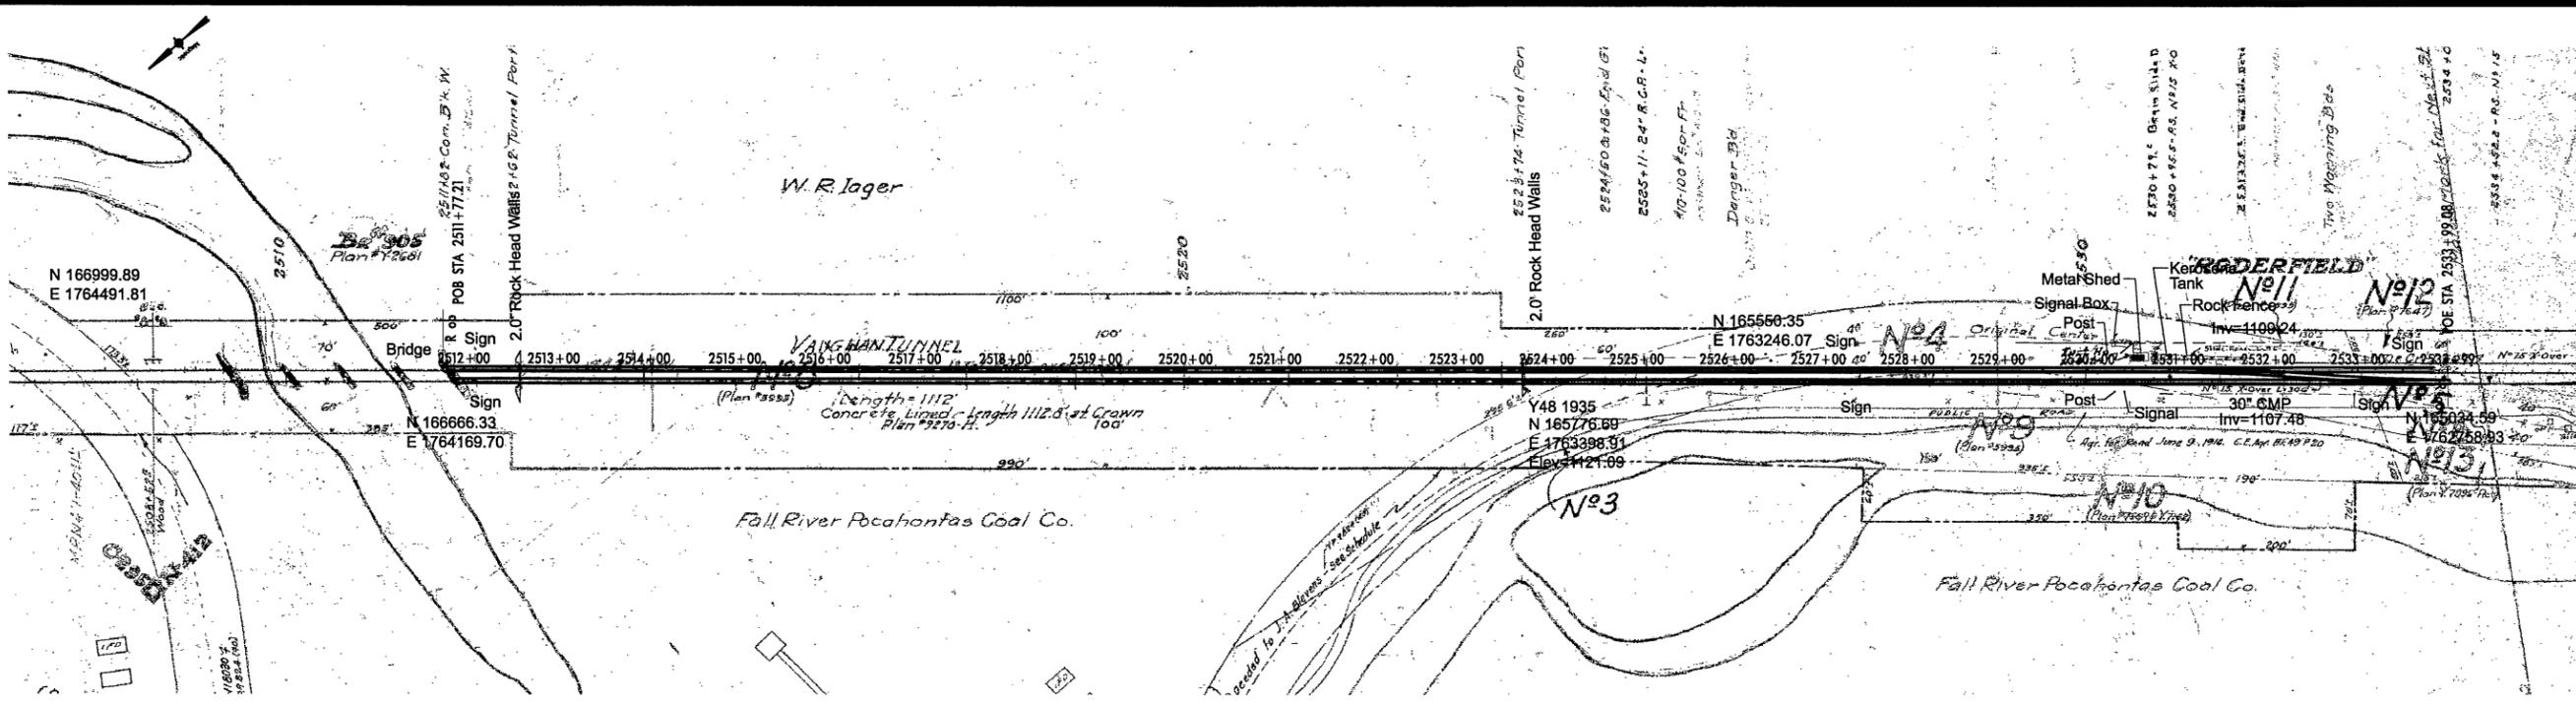
VAUGHAN PLAN
SCALE: 1"=100'

STATION	NORTHING	EASTING
POB (..... 2)	2511+77.21	166674.98
POE (..... 1)	2533+99.08	164986.00
Tangent Direction:	220°31'19"	
Tangent Length:	2221.87
