*Heartland Corridor, Walton Virginia to
Columbus Ohio*

Preliminary Engineering Phase Report

WEST VIVIAN
TUNNEL –
MP
N392.06
KIMBALL, WV

October 14, 2005, Rev. 2

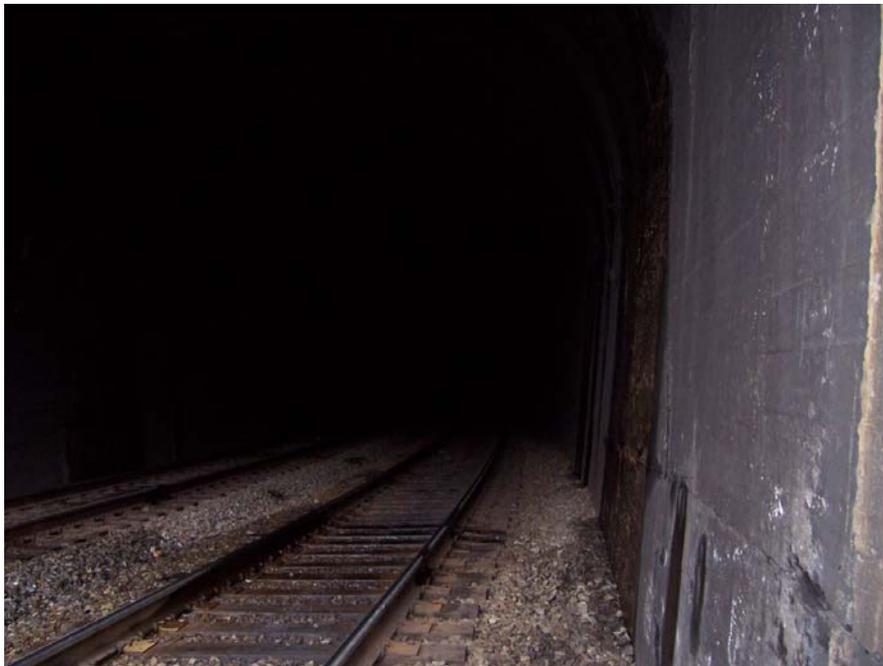
The tunnel is 680' long with a concrete lining and a nominal width of 30'. It is a double-width tunnel for two tracks. A slide fence circuit is mounted on the south wall. West of the tunnel, there are rock fences on both sides of the track and above the west portal. Ballast covers the top of the liner footing on the right side, however the top of footing is exposed on the left side for the entire length of the tunnel. The existing sub grade appears to be near to the bottom of the footing for the liners. Lowering the invert may undermine the liner. The liner is typically damp at construction joints. There are typical minor spalls and small cracks in each segment of the liner. At several locations, primarily near the portals, the joints are leaking and the track and ballast are wet or icy.

Photo 4. Typical view from just inside tunnel, note that ballast covers footing. Wet walls and track at construction joints.

The preliminary design uses replacement of the liner crown. The existing track structure is planned to be flooded with ballast to the top of the rail to provide access into the tunnel for the contractor to work and to protect the track during the construction. The preliminary design also proposes to install a new drainage system and undercut the track to replace the fouled ballast.

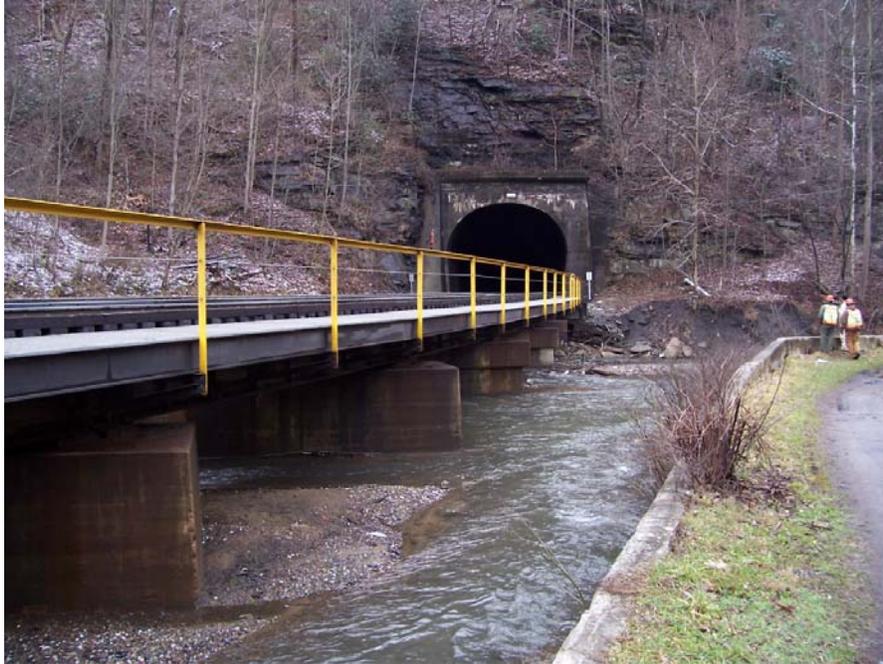
The tunnel is located in a sparsely populated area with good access to the east portal. No practical access to the west portal for vehicles was observed. The railroad has a yard adjacent to US Rt. 52 just east of the tunnel. This yard can serve as a good staging area. There is a siding track in the yard. A bridge over Elkhorn Creek is located immediately in front of the east portal, requiring equipment to access the tracks east of the bridge several hundred feet from the east portal. The bridge has a walkway on the right side. There are some nearby buildings on both sides of US Rt. 52, but most of the area around the tunnel is rocky, hilly, and wooded. There is another bridge over Elkhorn Creek about 800' west of the west portal.

Photo 5. Bridge over Elkhorn Creek east of tunnel.

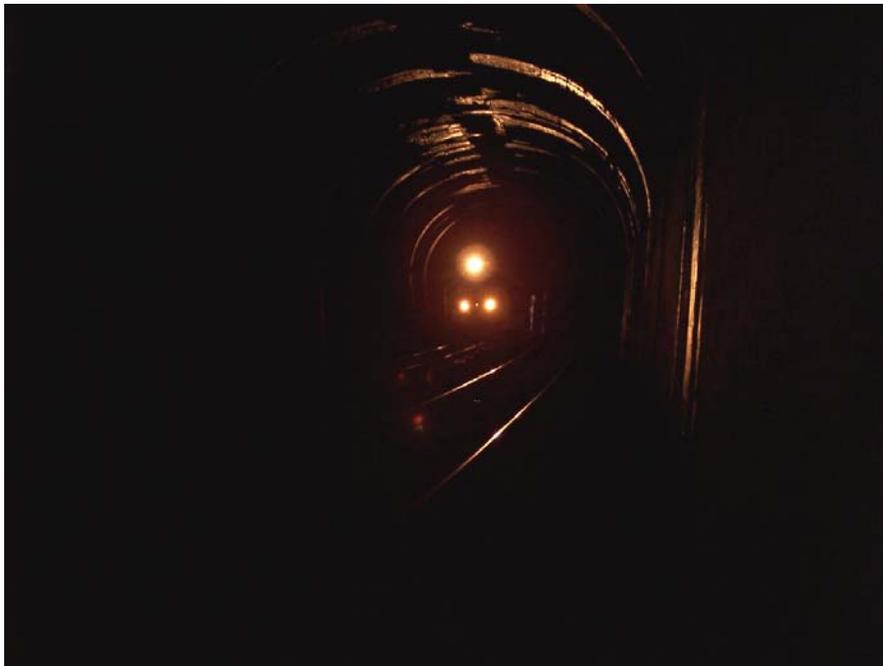
Photo 6. Train in tunnel. Note wetness at construction joints.

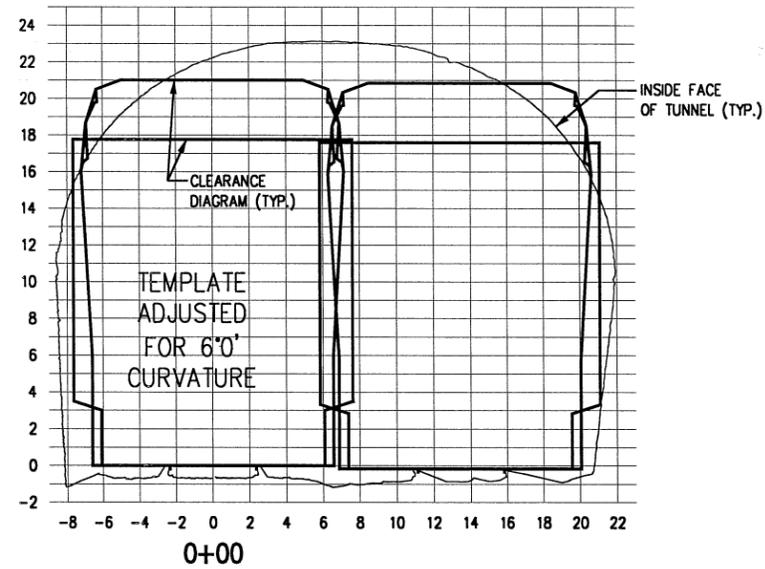
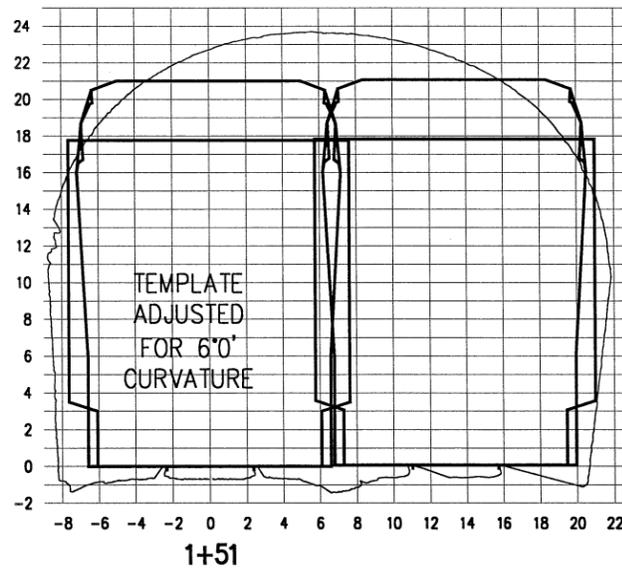
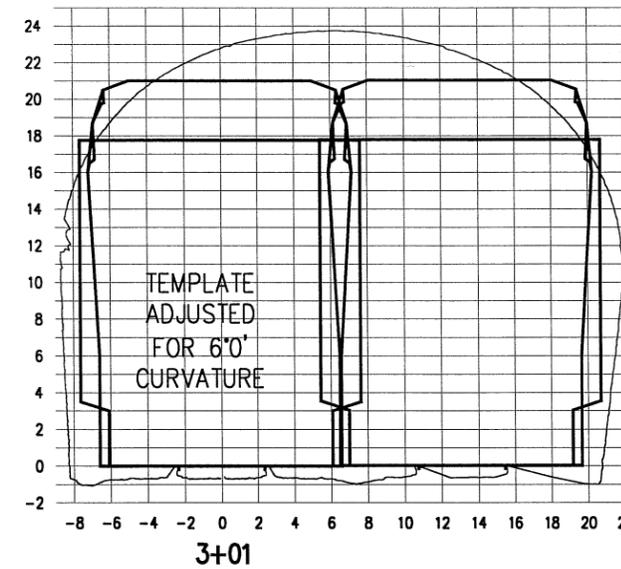
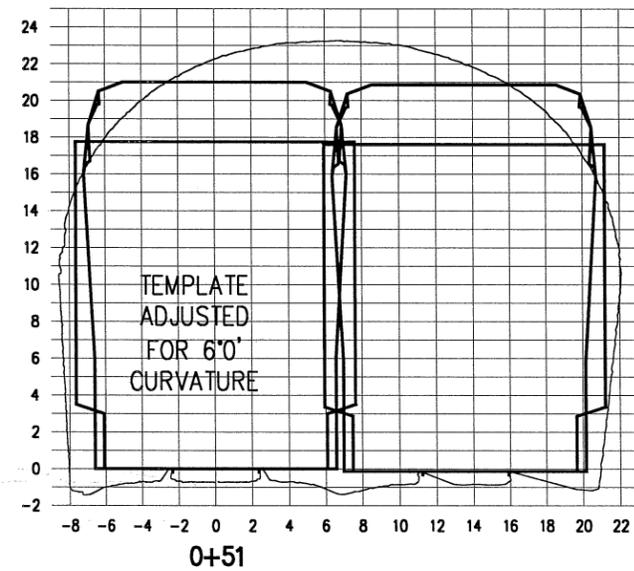
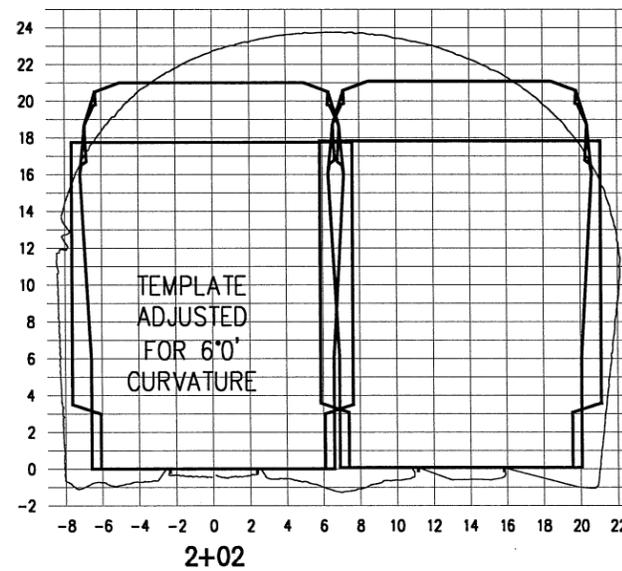
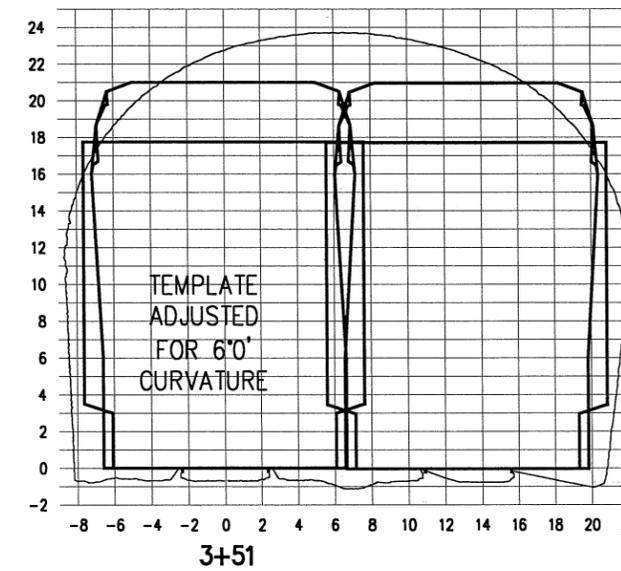
PT	DJL	8/5/05	PRELIMINARY ENGINEERING PHASE REPORT
REV	BY	DATE	DESCRIPTION
LOCATION: WEST VIVIAN TUNNEL, KIMBALL, WV			
TITLE: TUNNEL CLEARANCE CROSS SECTIONS - 1 OF 2			
DGN	PTD NO.	WRN	16276 & 16277
DWN	FILE NO.		N-392.06
CHR	DATE		APRIL 8, 2005

The laser car measurements indicate that the existing tunnel has adequate horizontal clearances for the composite design template with the exception of about 100’ near the west portal where the “High-Wide Load” may intersect the lower portion of the liner wall by less than 2”. The vertical clearance is deficient by an average of 20” (varies from 17”-25”) on both sides of the tunnel crown. The template encroaches the tunnel lining 10-11 o’clock and 1-2 o’clock positions. Cross sections of the tunnel clearance encroachments are shown in the drawings at the end of this report. The maximum vertical encroachments are summarized in the table below:

Distance (ft) from East Portal	Crown Encroachment (radial inches)	
	Left Side	Right Side
0	23	25
51	23	24
102	21	23
151	19	24
202	20	21
251	20	17
301	17	19
351	18	19
401	19	19
451	20	20
501	21	21
551	19	23
601	19	23
651	18	19

Given the magnitude of the vertical encroachment, liner replacement of the tunnel crown is necessary to achieve the required clearance in the tunnel. Minor notching to fix some horizontal encroachment on the right wall is also recommended. Additional investigations in the final design phase may determine that deep notching is an alternative to liner replacement for some of the tunnel. Drainage improvements are also recommended.

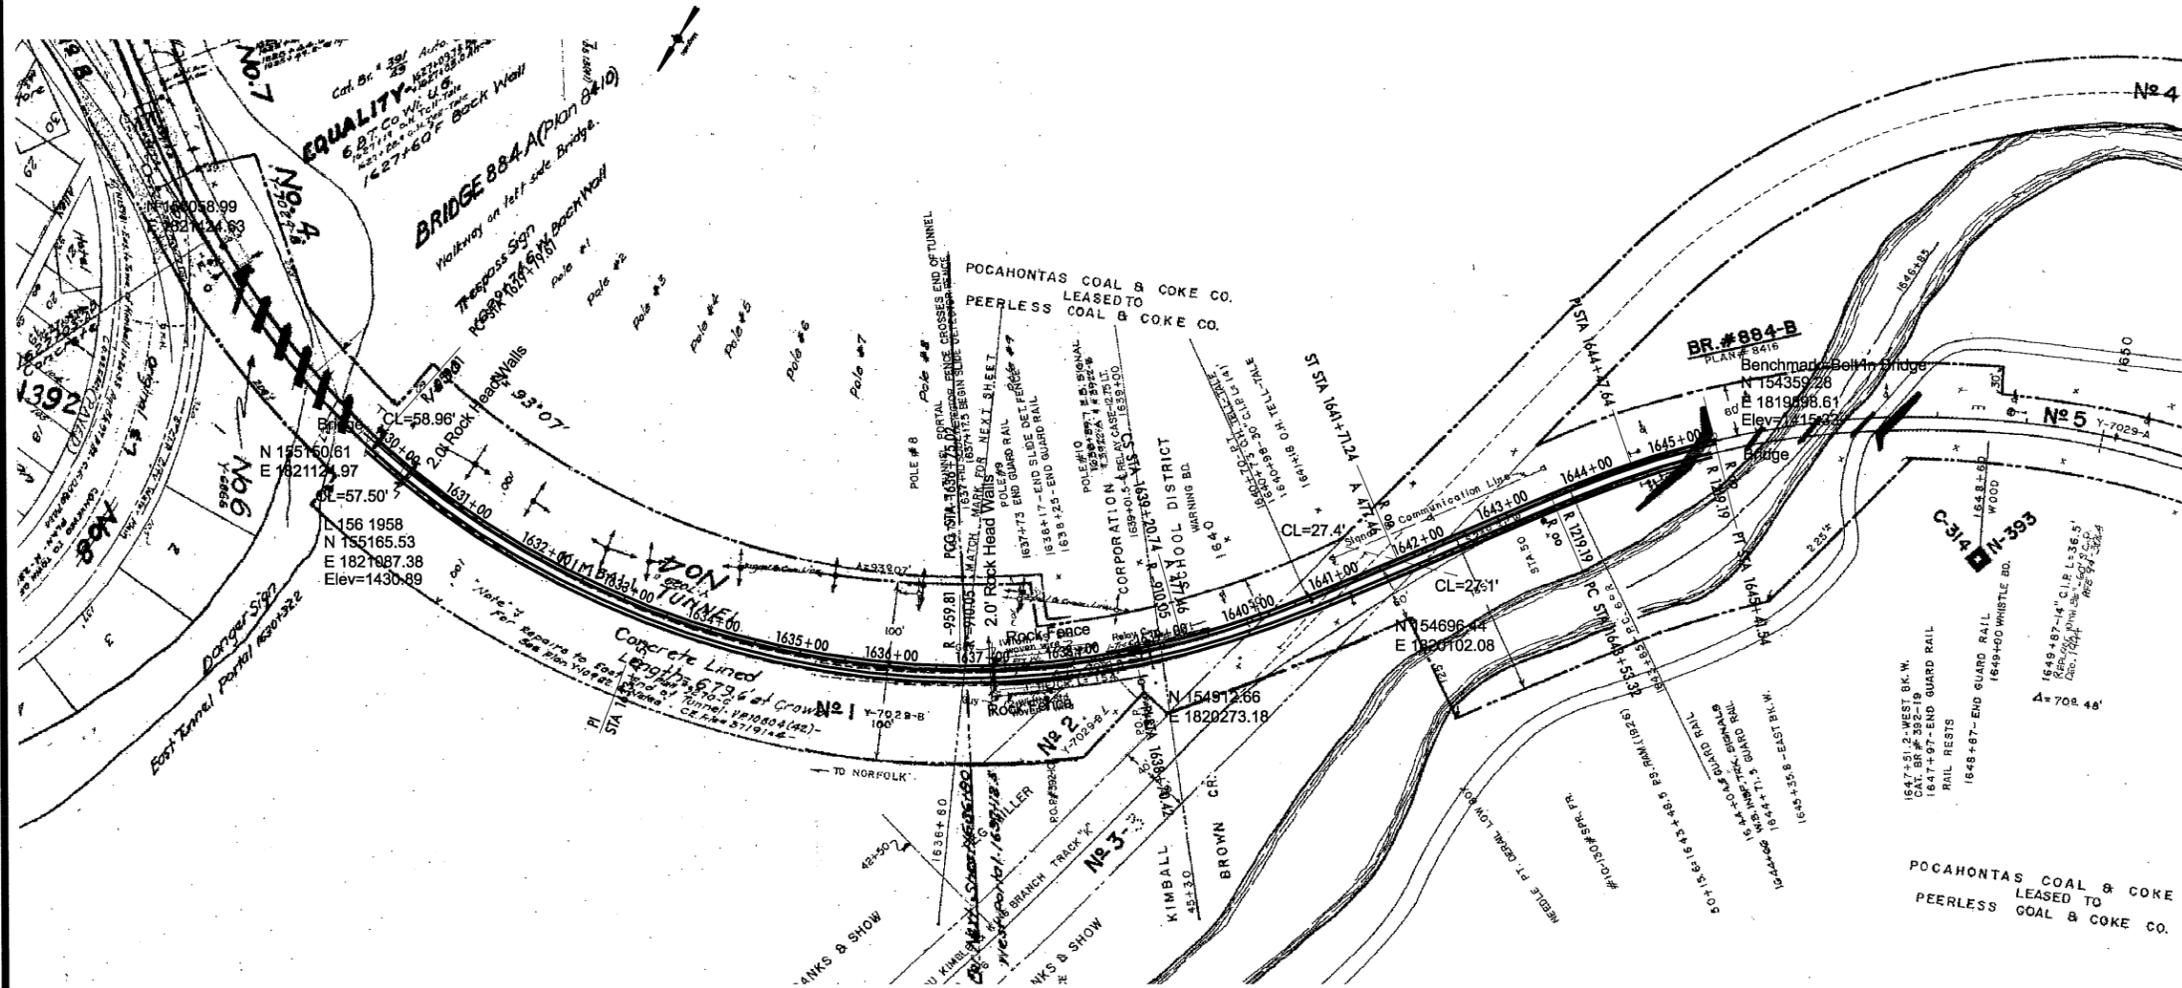
WEST VIVIAN PLAN
SCALE: 1"=100'

The track is continuously welded rail of conventional design with wooden cross ties at approximately 19" and a stone ballast section. The ballast is generally clean. The rail is typically 132RE or 141RE. The track is curved at 6.0 degrees to the left for the entire length of the tunnel.
