LITTLE TUNNEL, CUMBERLAND GAP, TN
FHWA/NPS

TITLE: LOG OF CONDITION OF TIMBER SETS AND LAGGING - PLAN

DRAWN RMS	SCALE AS SHOWN	DATE 2/13/95	
CHECKED	REVIEWED	JOB NO. 953-3720	
Golder Associates		DWG NO. 2	FIGURE 2

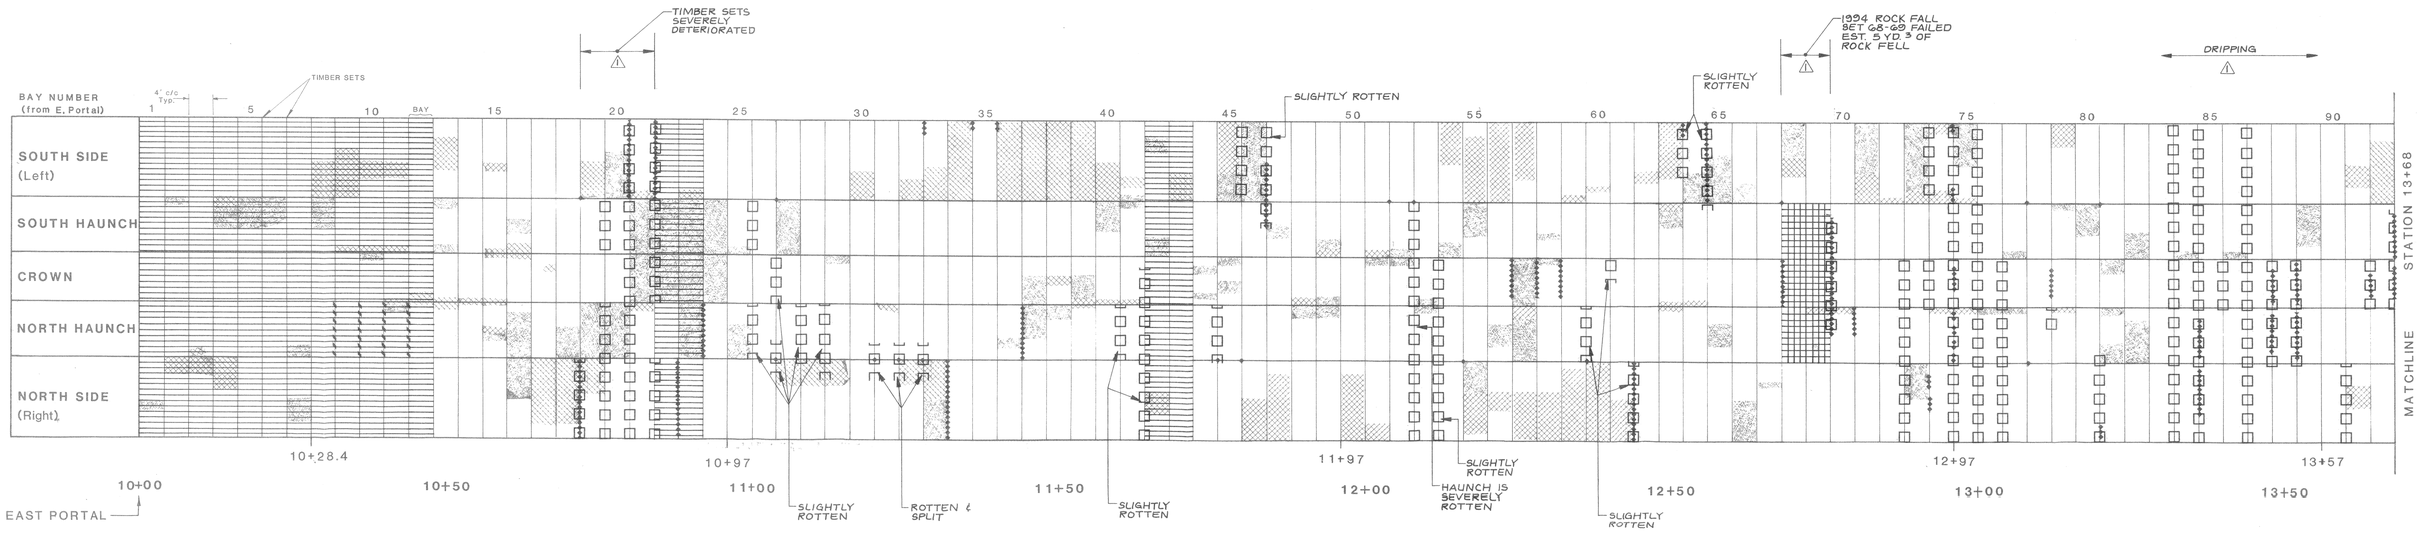
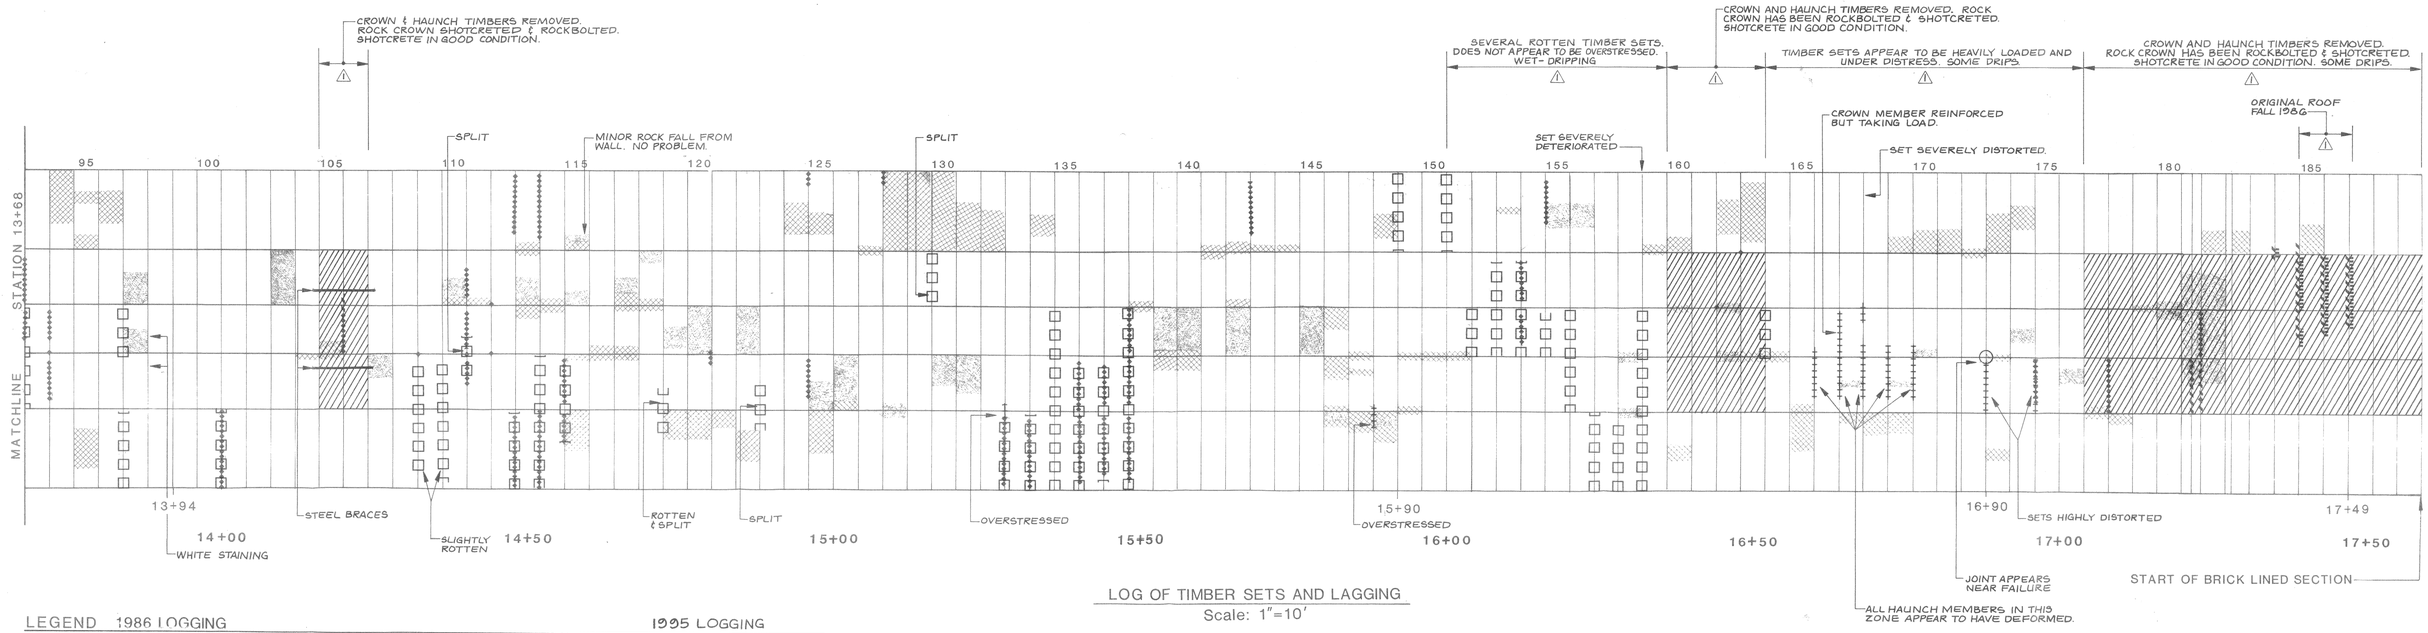
LOG OF TIMBER SETS AND LAGGING

1. THREE TIMBER SETS ARE PRESENT BETWEEN BAY 180 and BAY 181, TWO TIMBER SETS ARE PRESENT BETWEEN BAY 181 and 182.
2. HAND WRITTEN NOTES ADDED TO DRAWING INDICATE 1995 LOGGING. △1
