# 3D MODELING & ROVER USE BY THE MITCHELL INTERCHANGE CONSTRUCTION MANAGEMENT TEAM

August 22, 2012

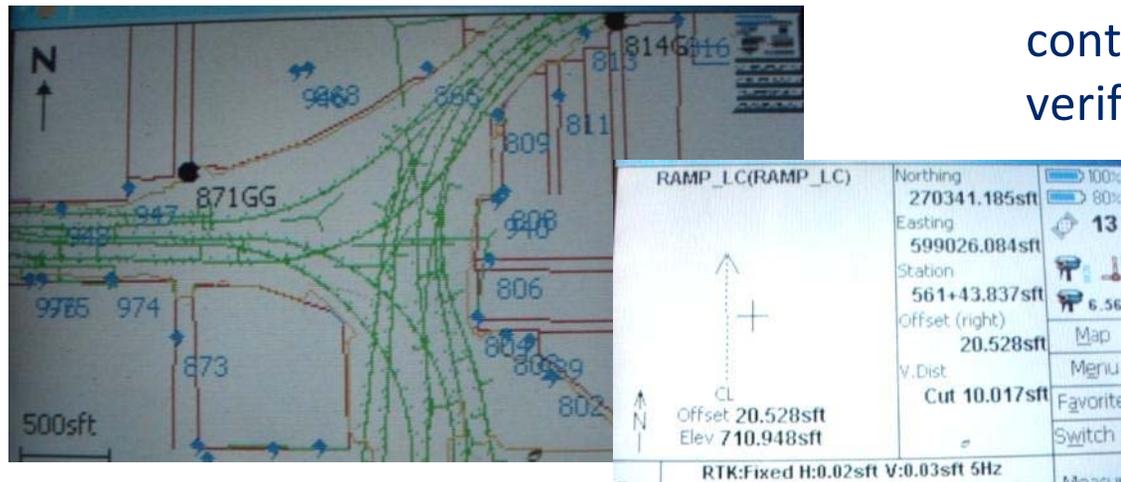
# Design Survey Control

- GPS using WisCORS was highly reliable horizontally
- GPS alone limited the vertical control required for the project
- Preconstruction CM team control checks / densification / vertical improvements
- Digital levels run through all primary control to allow tighter calibrations using corrections from WisCORS, and held Vt only calibration on primary Feno monuments
  - Calibration shared with the contractors and asked to verify and provide the checks

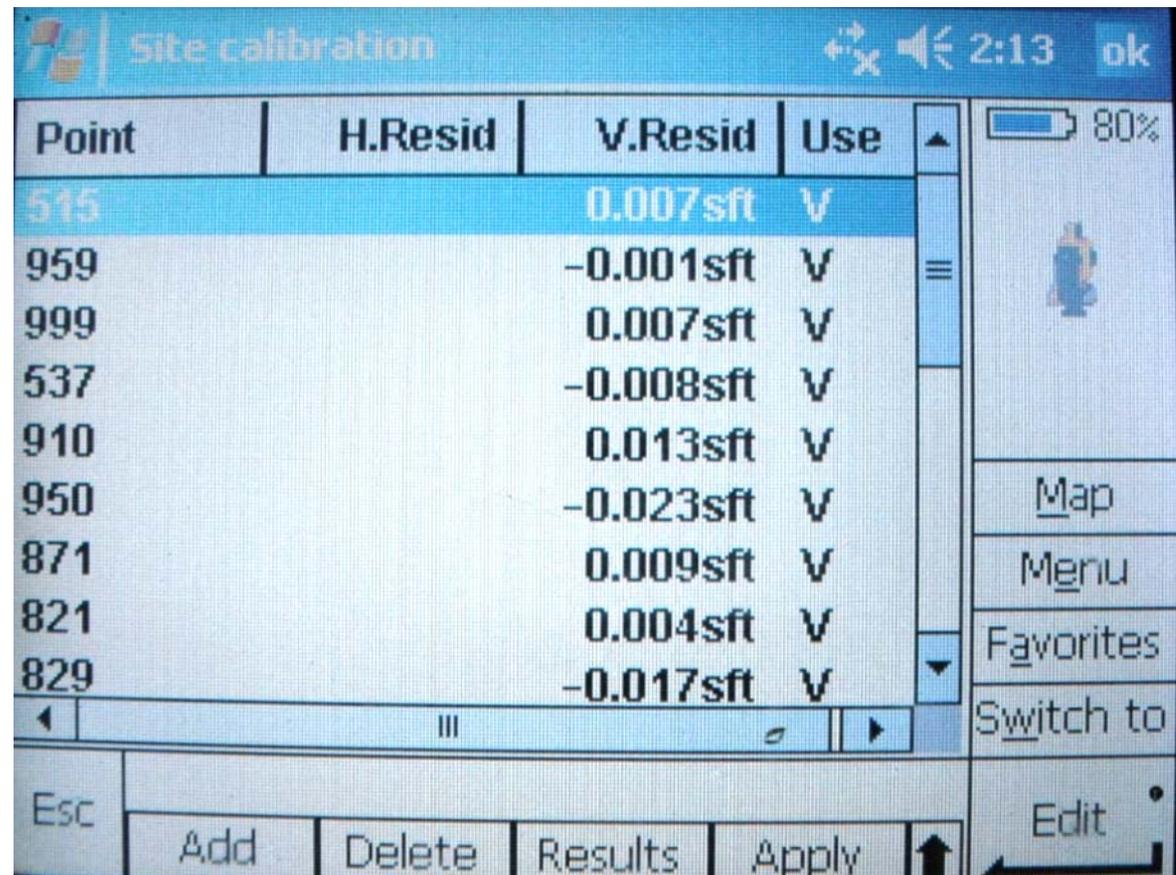
# Vertical Control

- Verification
- Densification
- Vertical improvements

The screenshot shows a 'Site calibration' application interface. At the top, there is a title bar with 'Site calibration', a back arrow, a signal strength icon, a battery icon at 80%, and the time '2:13'. Below the title bar is a table with the following columns: 'Point', 'H.Resid', 'V.Resid', and 'Use'. The table contains the following data:

Point	H.Resid	V.Resid	Use
515		0.007sft	V
959		-0.001sft	V
999		0.007sft	V
537		-0.008sft	V
910		0.013sft	V
950		-0.023sft	V
871		0.009sft	V
821		0.004sft	V
829		-0.017sft	V

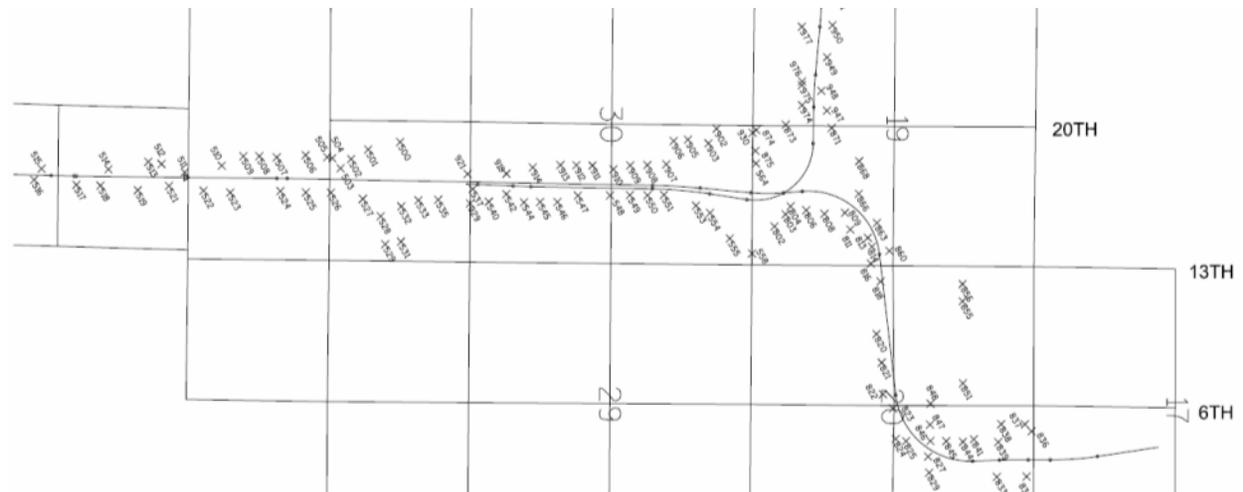
# Control Distribution

- Verified control published to all contractors
- In a highly GPS machine controlled environment, confidence of all parties in the site calibrations vertical solution is very important financially for both the owner and the contractor
  - Impact on pay quantities
  - Earthwork volumes
  - Subbase
  - Base course

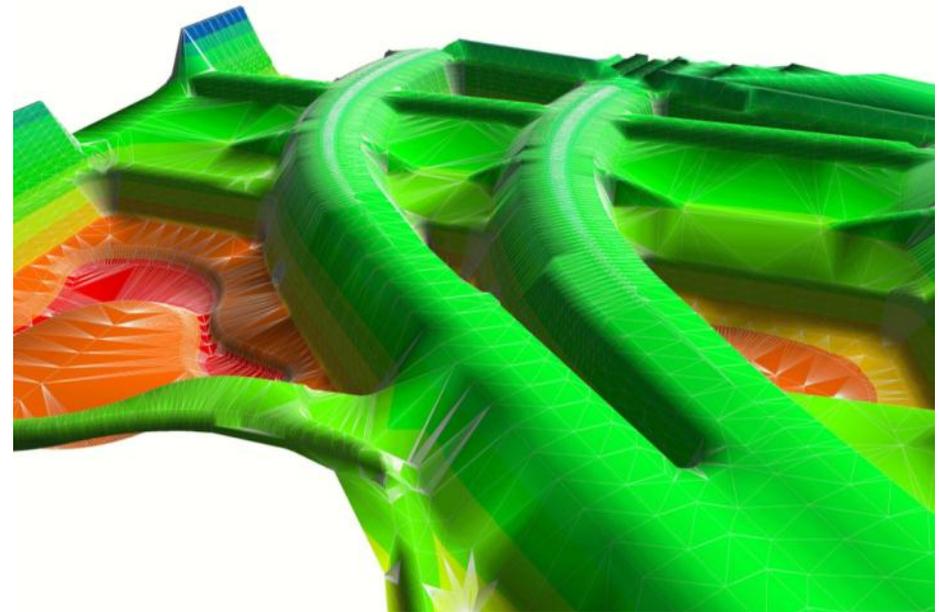
# Topo mapping and existing DTM

- Overall topographic mapping was very good, but did have areas of vertical error
  - DTM exported to inspection rovers for field checks
  - 894 west match – DOT and contractor impacts
  - Existing storm tie-in elevations off by 0.4-0.5'
  - \$75-100k in change orders

- Areas graded in between contracts 71 & 72
  - Volume disputes were managed with information where possible

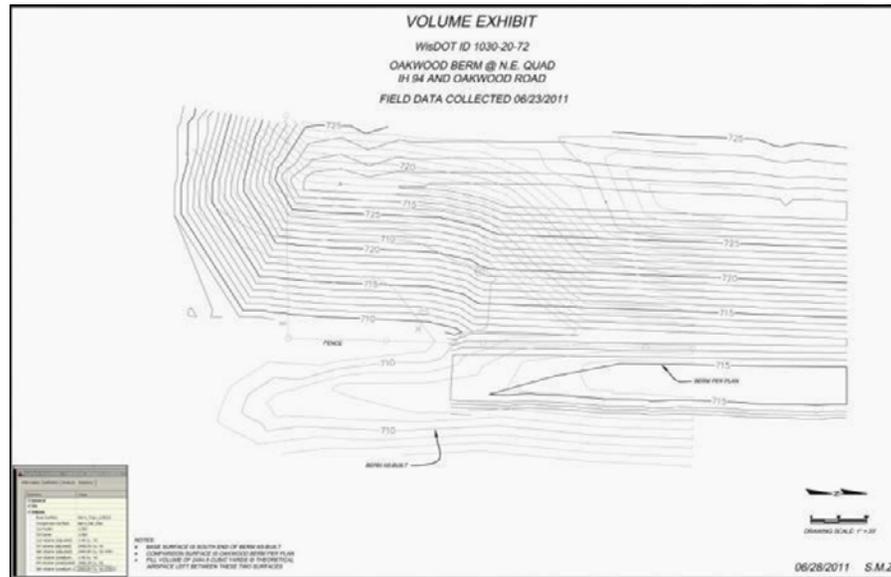
# Grading

- Some areas graded / changed in breakout contracts
- Disputes were resolved using models and as built shots
- Oakwood berm loss of space due to FTMS
- Villa Mann Creek fill pile

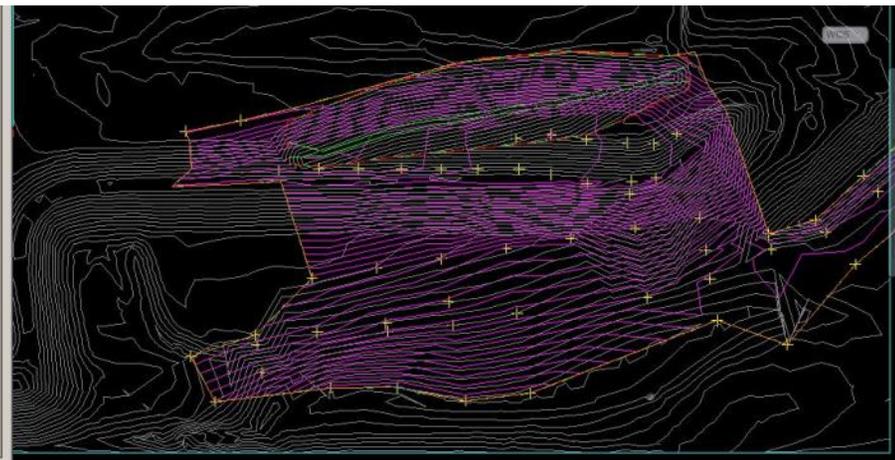
Statistics	Value
General	
TIN	
Volume	
Base Surface	143894-11
Comparison Surface	BERM_TOPO_101013
Cut Factor	1.000
Fill Factor	1.000
Cut volume (adjusted)	1857.65 Cu. Yd.
Fill volume (adjusted)	4300.93 Cu. Yd.
Net volume (adjusted)	2443.28 Cu. Yd. <Fill>
Cut volume (unadjusted)	1857.65 Cu. Yd.
Fill volume (unadjusted)	4300.93 Cu. Yd.
Net volume (unadjusted)	2443.28 Cu. Yd. <Fill>

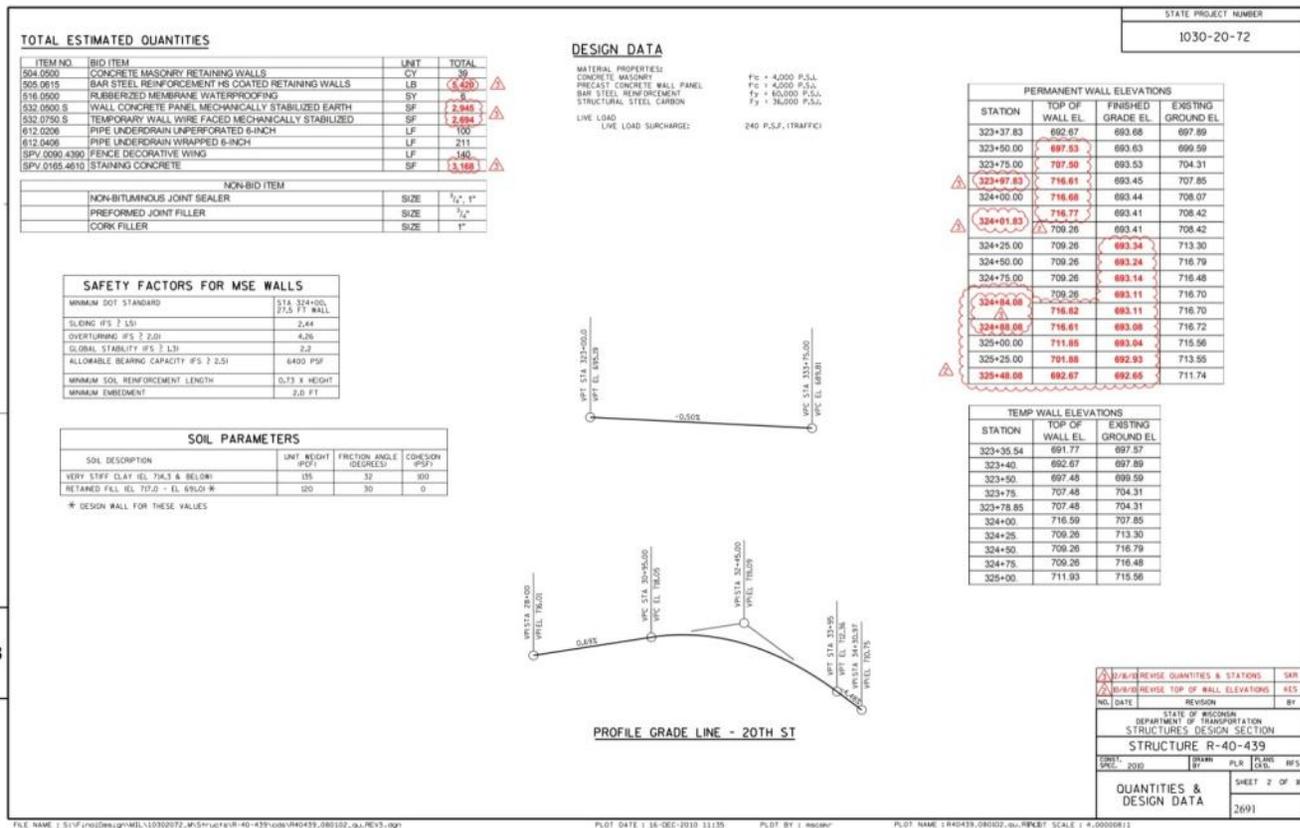
# Example Retaining Wall

- Preconstruction modeling identified 82 RFIs
- Wall plan missing vertical transition to match roadway above

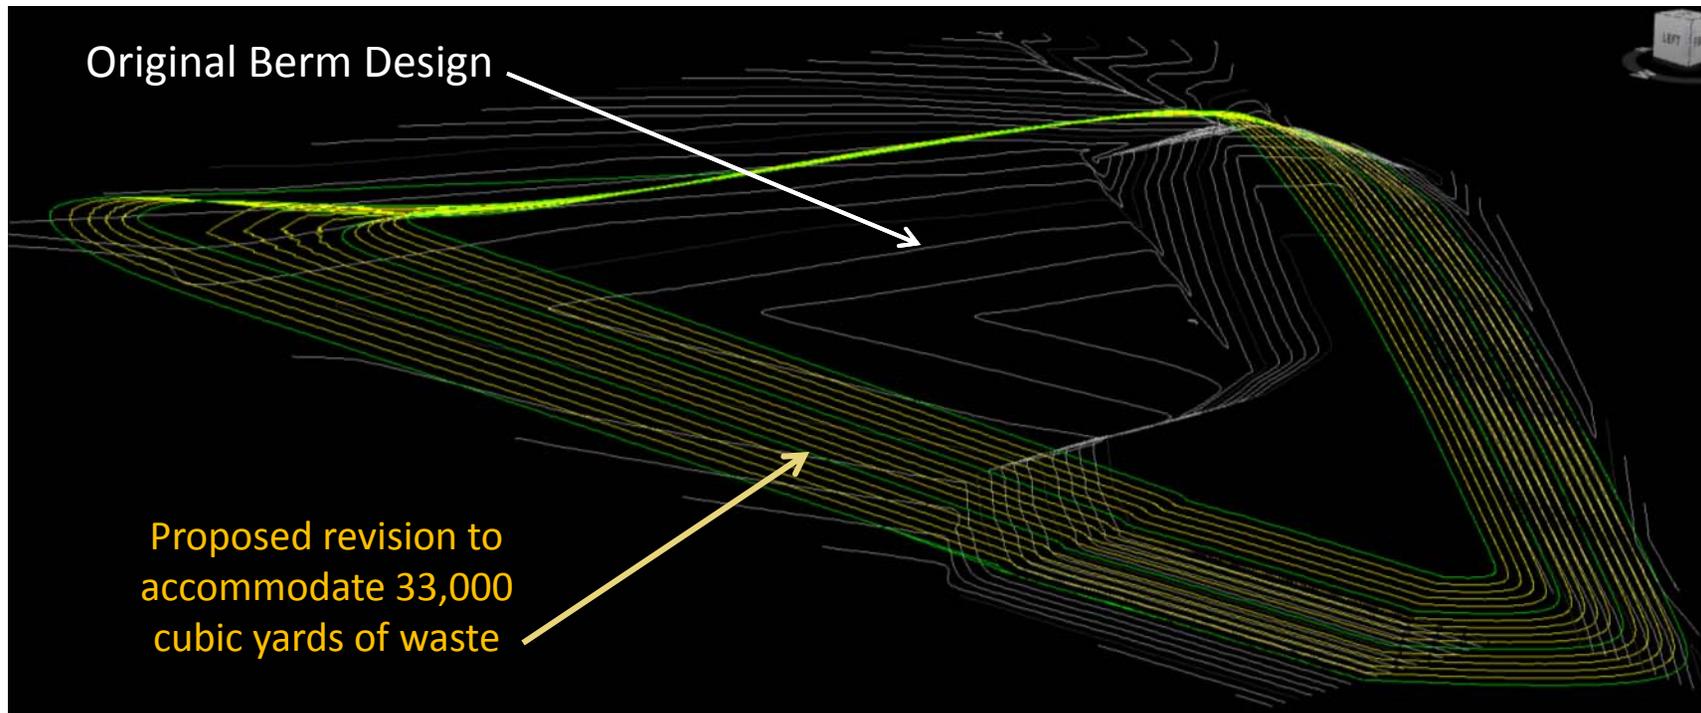
- Excess fill in 71 Contract
- Models modified to help CM staff accommodate excess waste

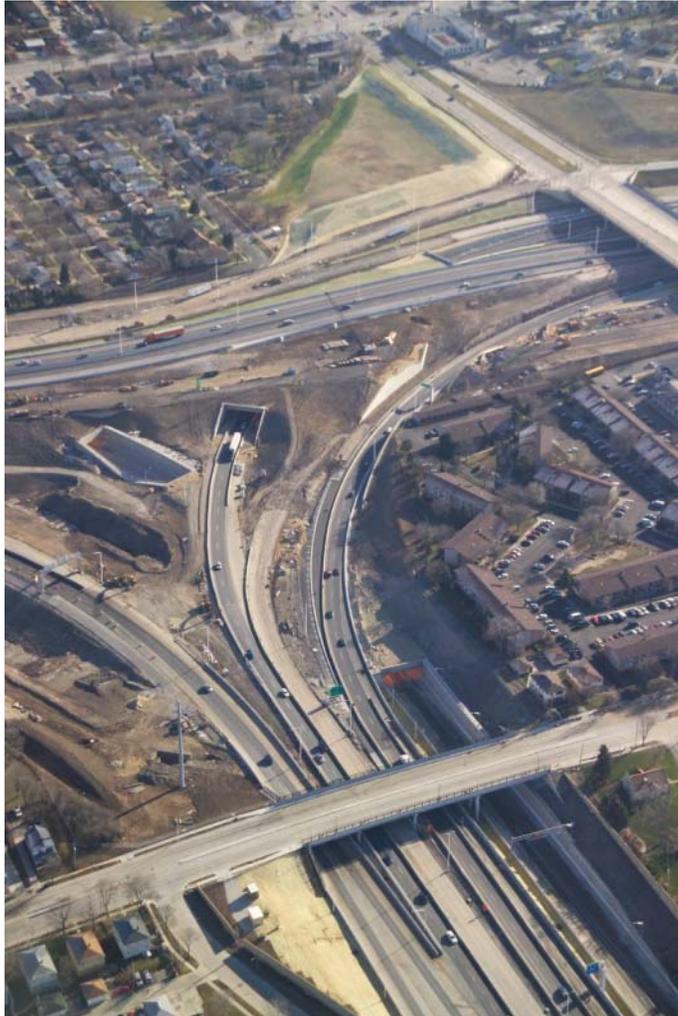
- **Staged Berm volume checks 71 contract vs. 72 contract**
- **Model and as built shots used to mediate disputes between contracts**

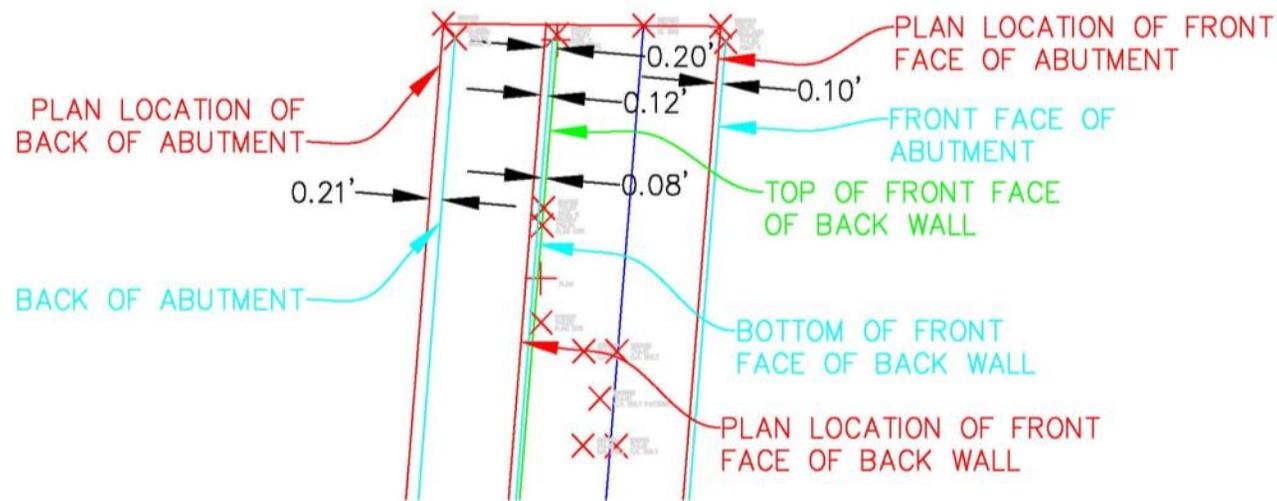
- Model of Plan of B-40-820 Layton Ave.
- Used to measure deviation of backwall construction and salvage abutment

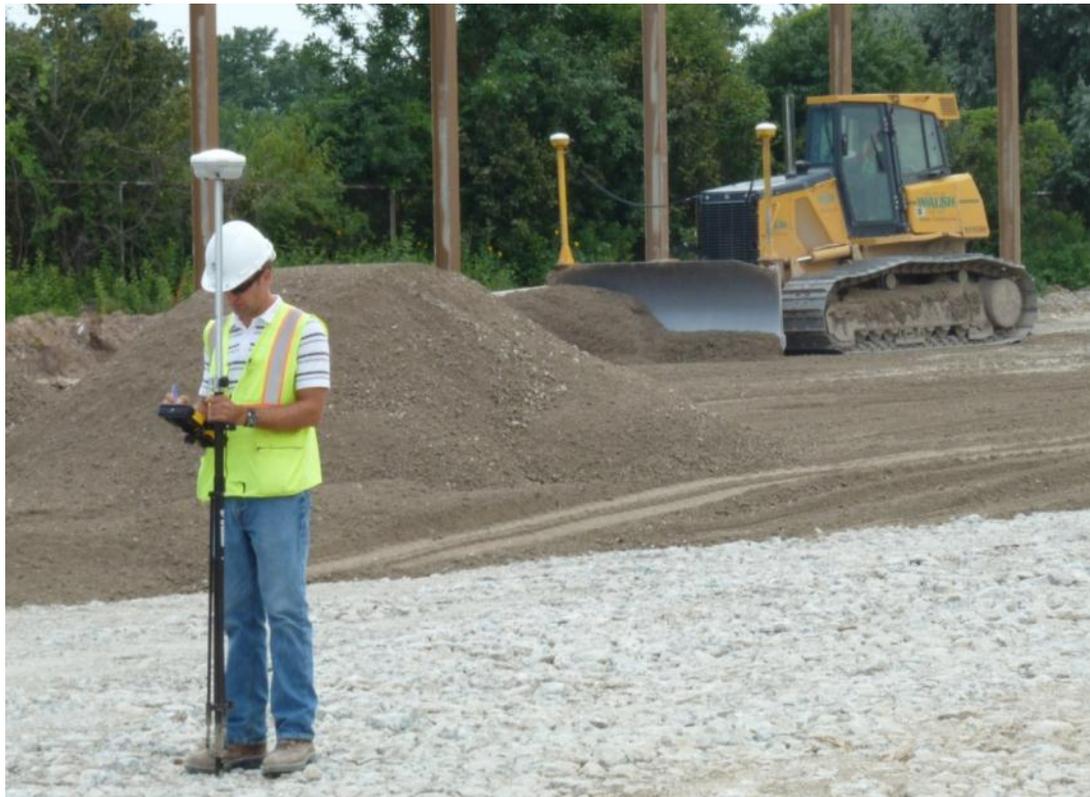
- Verification of subgrade and stone placement in real time

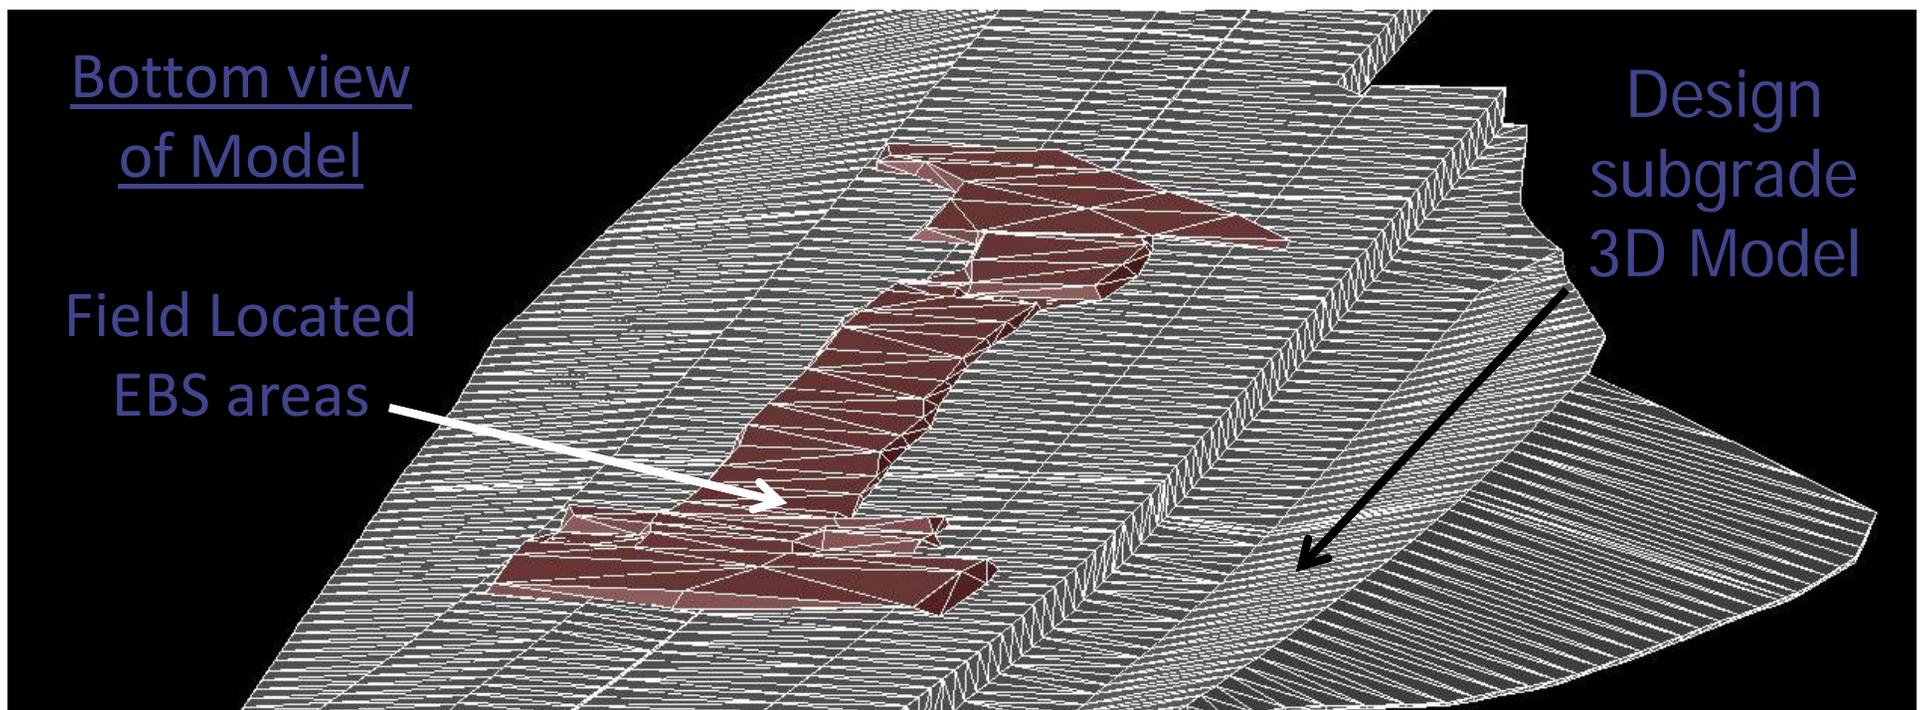
- Excavation Below Subgrade (EBS) measurement for pay quantity
- Structural Excavation. Verification of Location, Size and Depth
- MSE wall leveling pad alignment and elevation

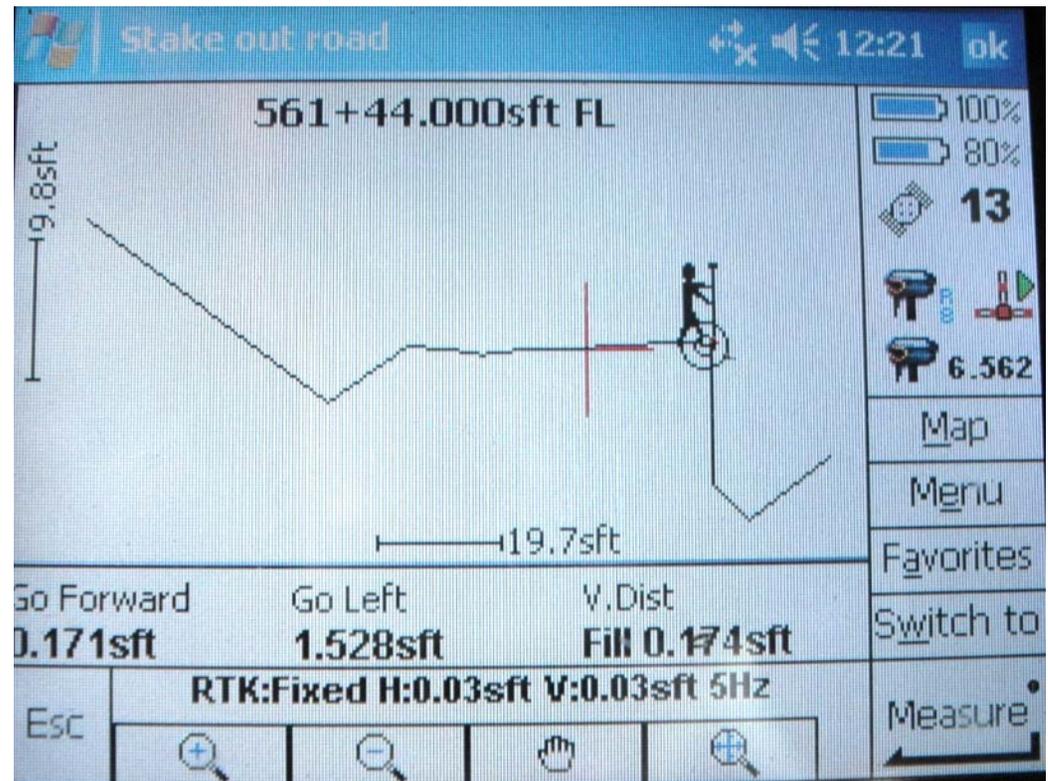
- Slope intercept adjustments in the field. Helped PI effort by allowing adjustments to be made in the field to save trees and other existing features at the project match.

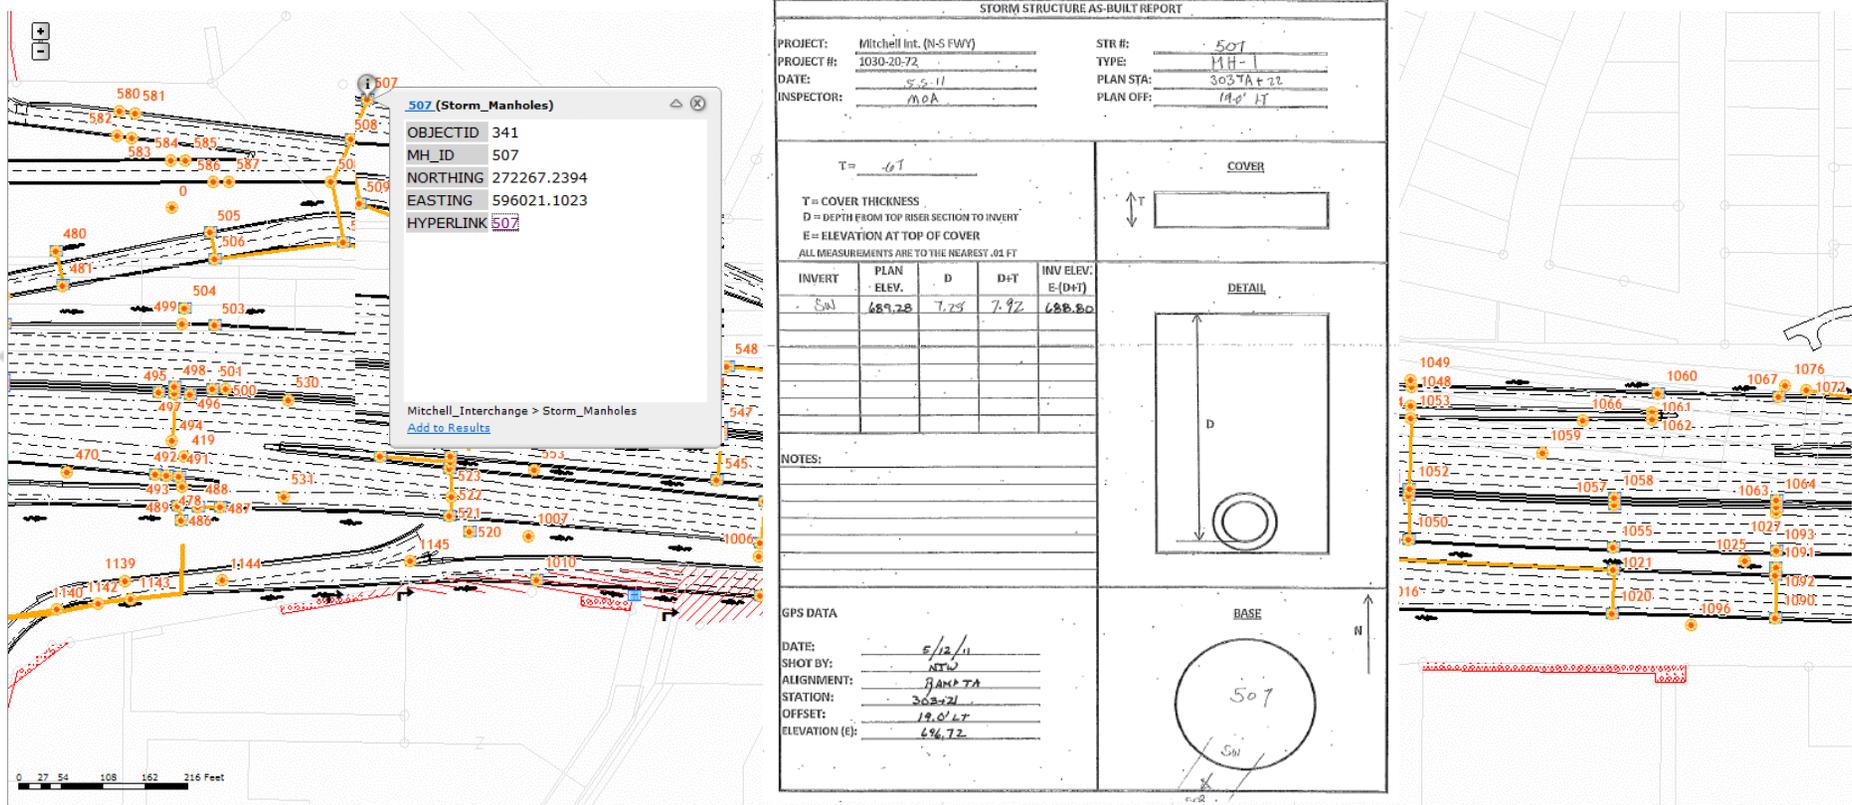
# Mitchell Storm As Built

Storm was as built as installed

- Rovers allowed verification in real time
- Created an experimental GIS to log inspection reports

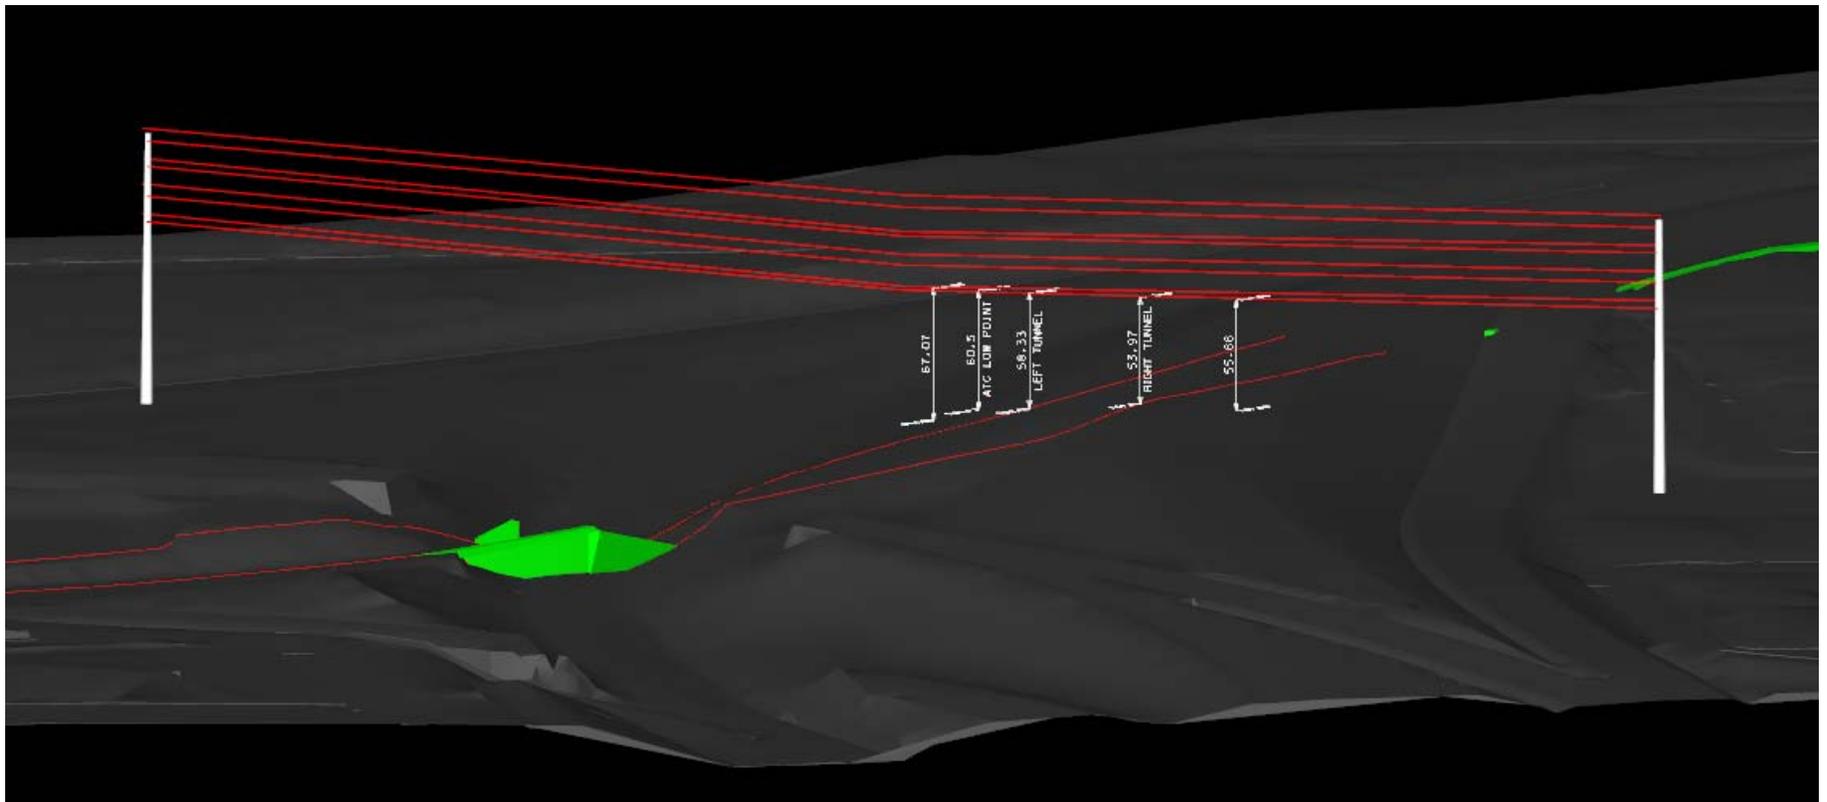
# As-Built Mapping

- Fiber optic cables located to document plan changes
- Transmission Lines scanned for drill rig clearance

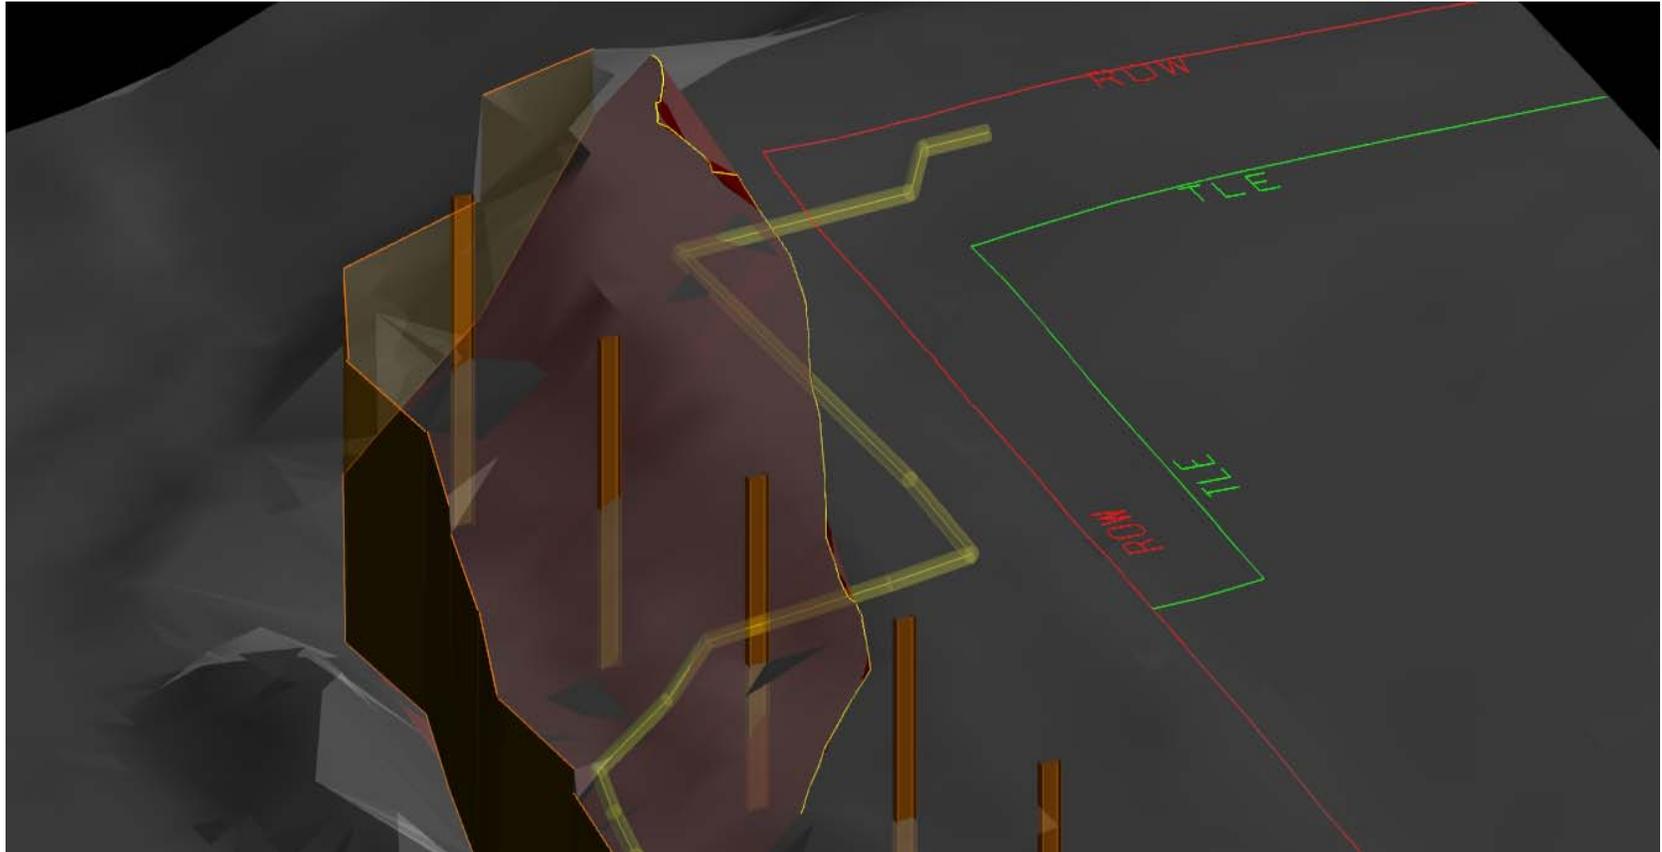
# Mitchell Interchange Gas Main

- Gas line as built was later used in an exhibit to determine cost sharing between GC, Utility and DOT
